# **IMPACT OF ANIMAL WASTE LAGOONS ON GROUND WATER QUALITY:**

**An Update on Data Collected from  
March 1998 through November 1999**

**Report of Groundwater Investigation Number 18**

**GROUNDWATER SECTION  
DIVISION OF WATER QUALITY**

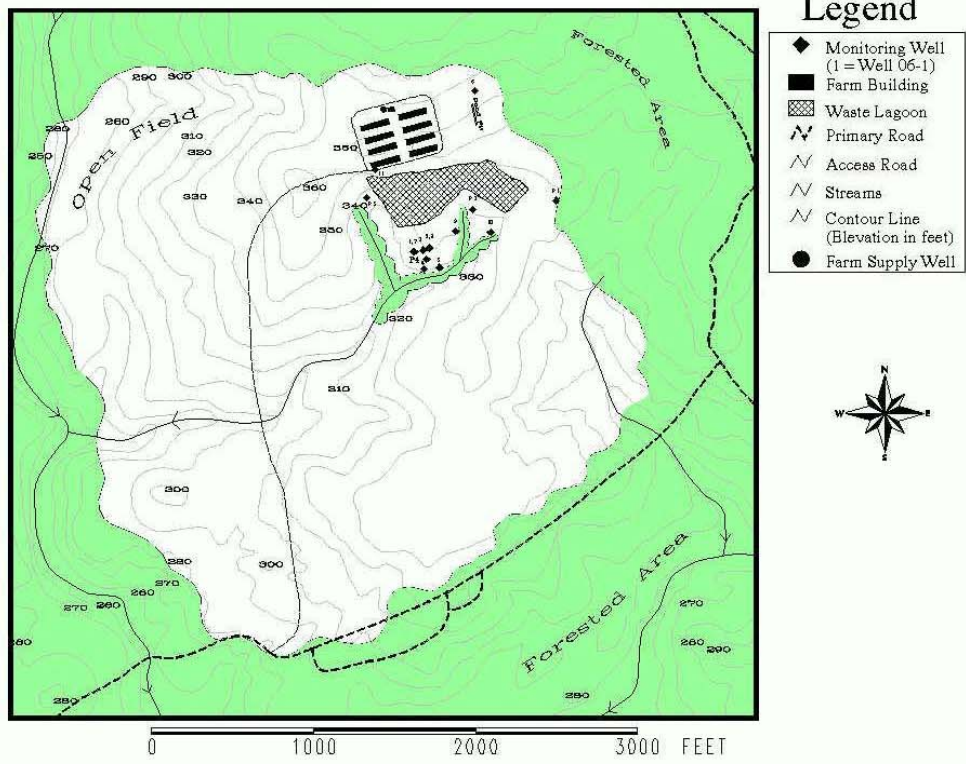
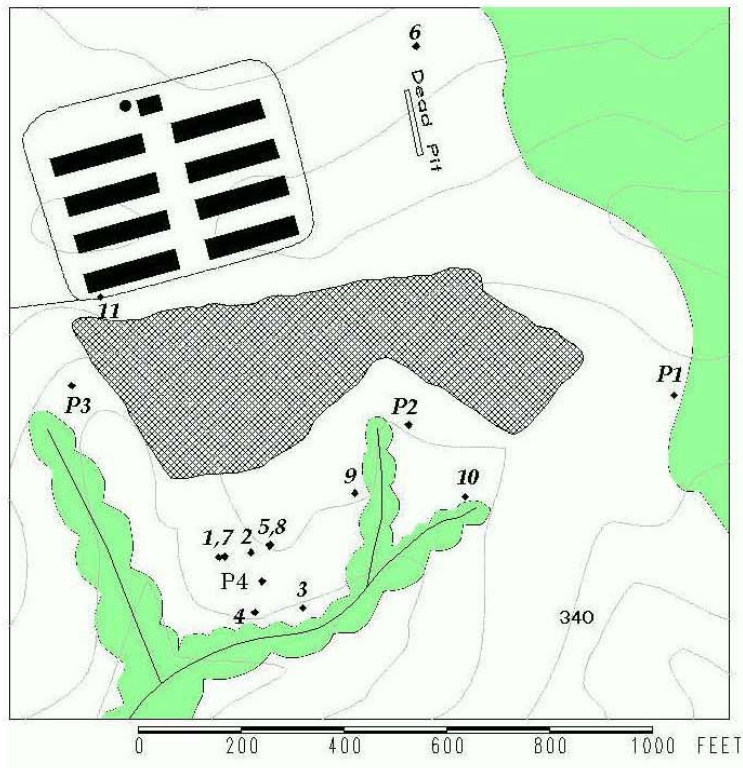
Figure 2

On February 9, 1999, GWS staff noted that pastureland for a small herd of cattle had been expanded to include the land where monitoring wells 06-1,2,3,4,5,7,8,9 and 10 are placed. The cattle manure may be contributing to shallow ground water concentrations of nitrogen and Cl in these wells.

GWS staff also noted the installation of a "dead pit" approximately 75 feet south-southeast of well 06-6 while visiting the site on February 9, 1999. A dead pit is a long trench excavated to a depth of about 6 feet, which is used to dispose of dead hogs. Leaching from the dead pits could eventually impact ground water quality in the shallow downgradient wells. If concentrations of K, Cl and NO<sub>3</sub> rise in these wells, additional water analyses would be necessary to determine if the source is the lagoon, the cattle, or animal decomposition.

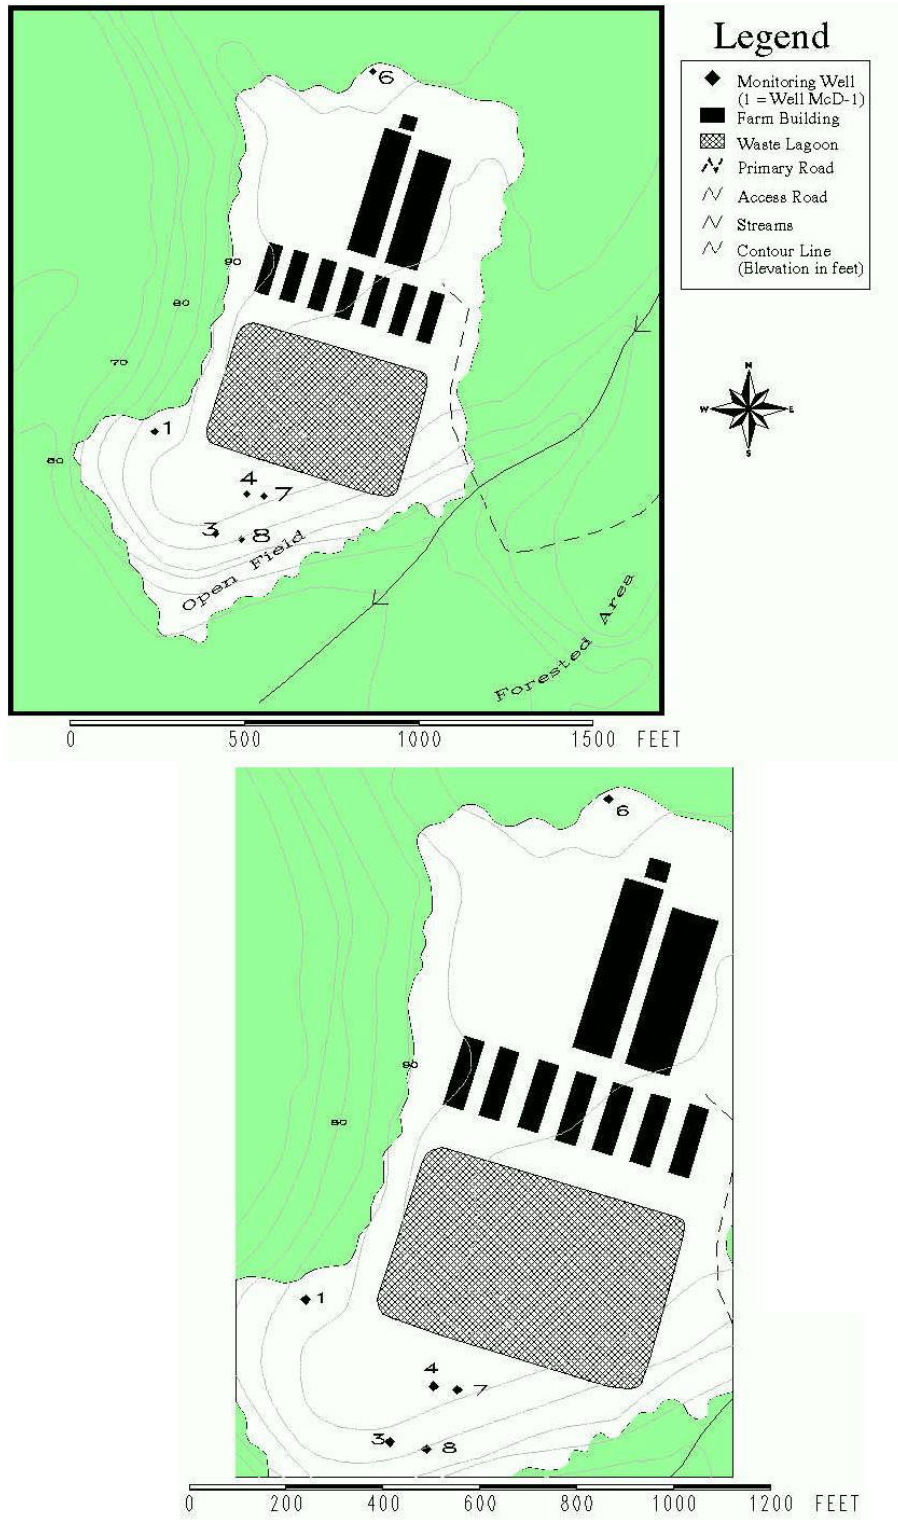
Figure 40

Lagoon seepage indicators have been detected in well McD-4 on a somewhat continuous basis. The ground water flow direction from well McD-4 would need to be determined and monitoring wells placed downgradient in the shallow aquifer to determine if seepage indicators are decreasing. Additional monitoring wells would also need to be placed to the west-northwest and the southeast of the lagoon to monitor shallow ground water before any determination could be made about whether ground water is being protected from lagoon leakage (fig. 40).

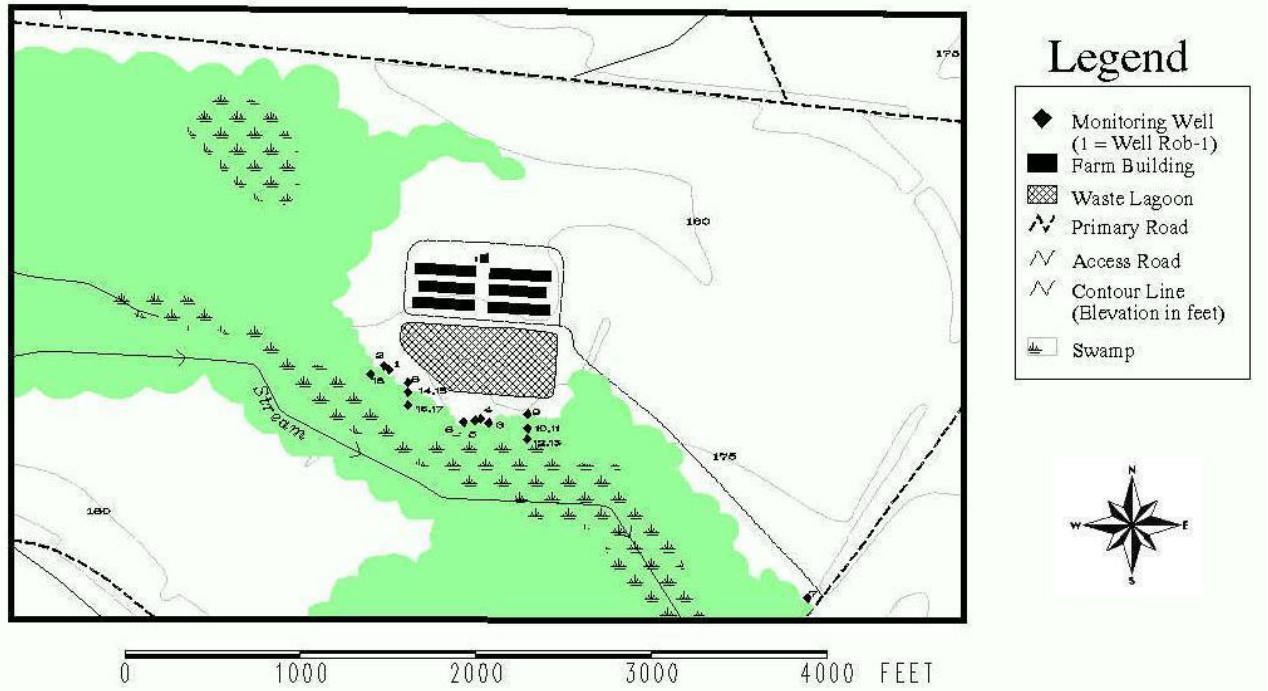
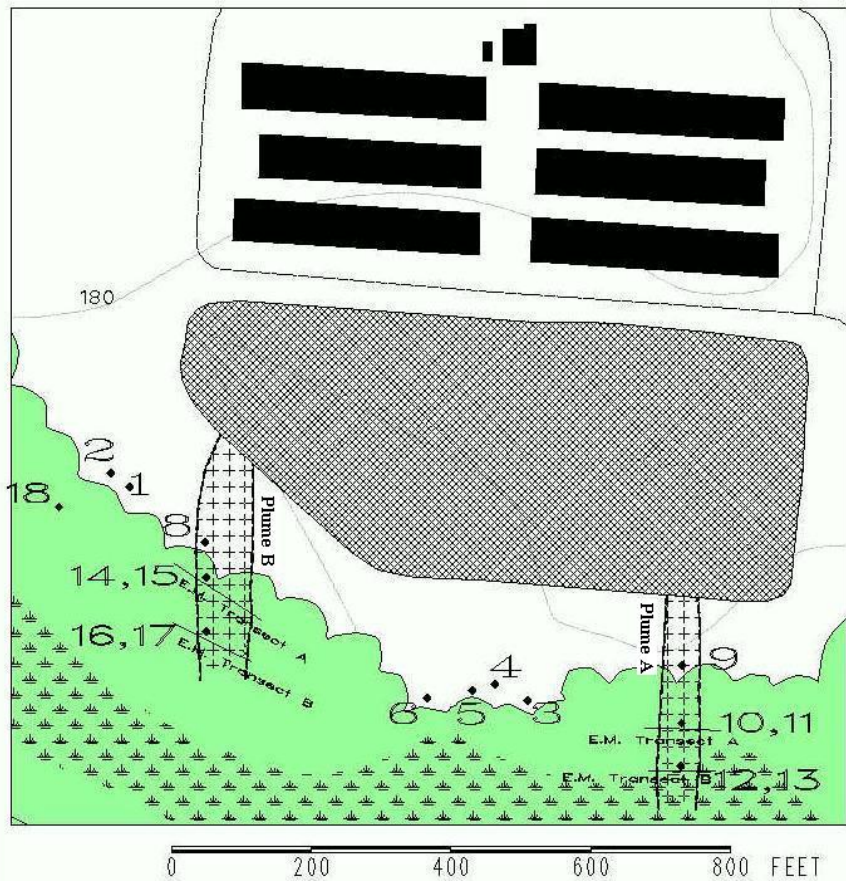
Figure 55

Contaminants from the lagoon are leaking into the ground water, and North Carolina ground water standards are being exceeded 250 feet from the lagoon. EM surveys detected the presence of the ground water contaminant plumes originating from this lagoon, and these surveys were successfully used to place additional monitoring wells to measure contaminant concentrations at this site.

The material used in the liner was obtained on site. GWS staff noted that the soils in the "borrow pit" contained too much silt to be considered suitable for use as a clay liner. In addition, a clay liner must be of a certain moisture content to be properly installed and compacted to form a very low-permeability liner. Groundwater Section staff were told by farm personnel that ground water was standing in the newly dug lagoon when installation of the clay liner was attempted.

Ground water is not being adequately protected from lagoon seepage at this site; however, NRCS standards were not adhered to during construction of the lagoon.
