Impact of Animal Waste Lagoons on Ground Water Quality

Section 319, Clean Water Act
Grant Year, FY 94
Final Report

Division of Water Quality, Groundwater Section
June, 1998

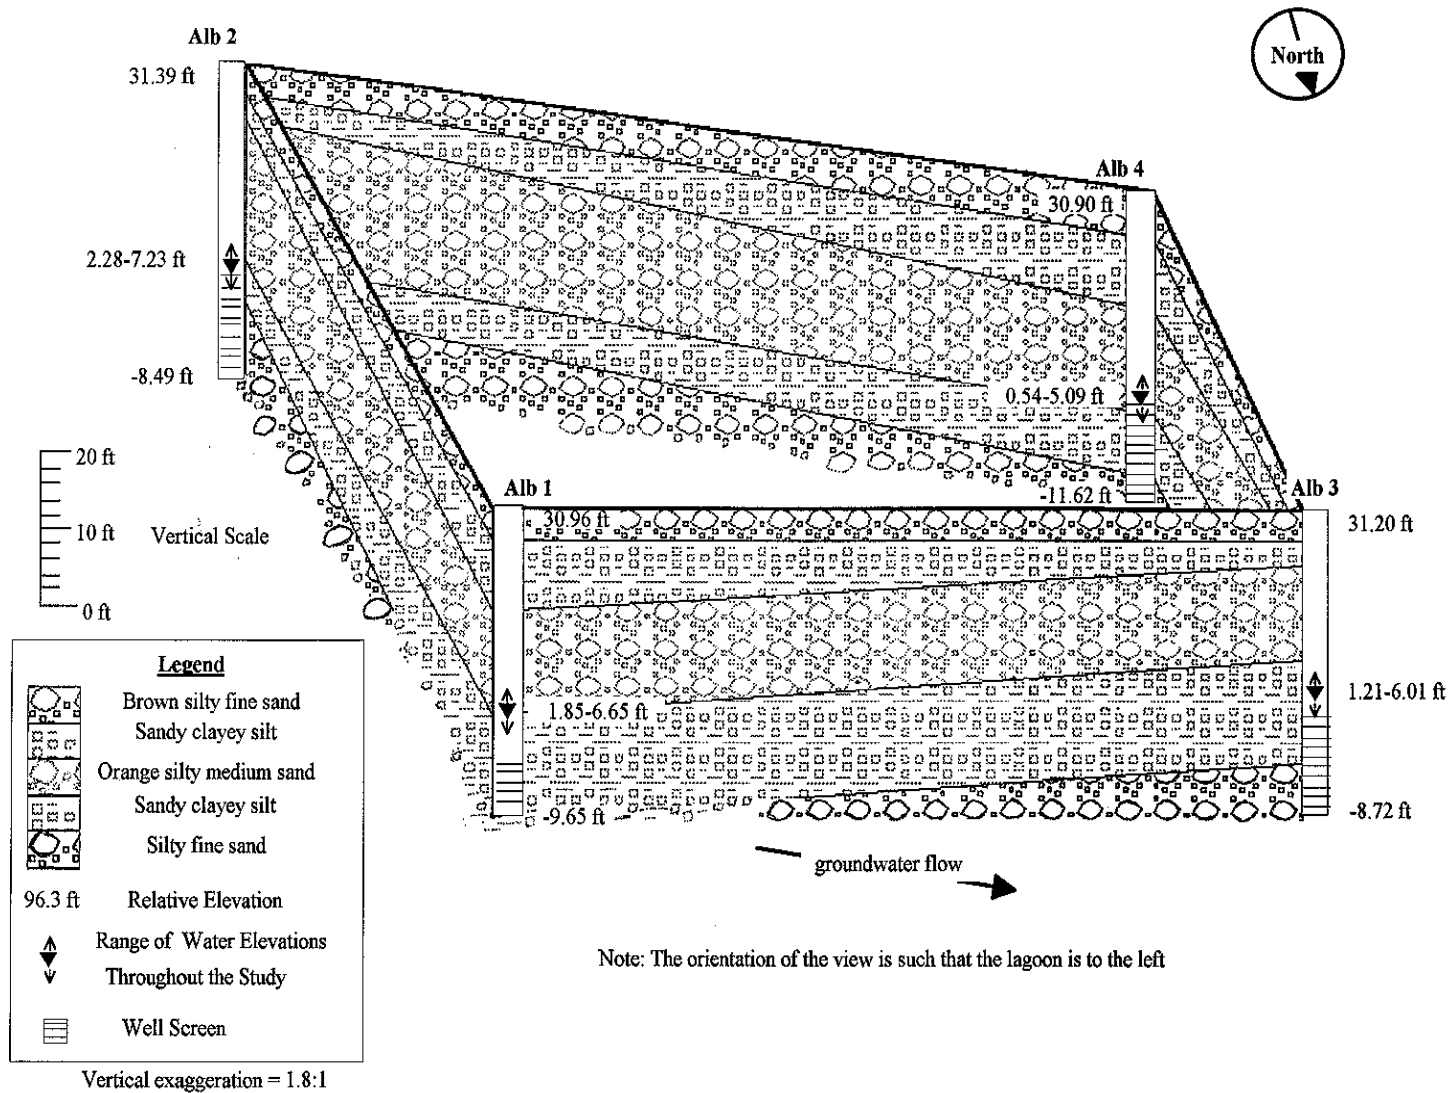
Borehole Stratigraphy of the Albertson Site in Duplin County

Measured elevations of the water table in the wells show a general ground water flow direction from the lagoon toward the shallow downgradient monitoring wells (also shown on the fence diagram).

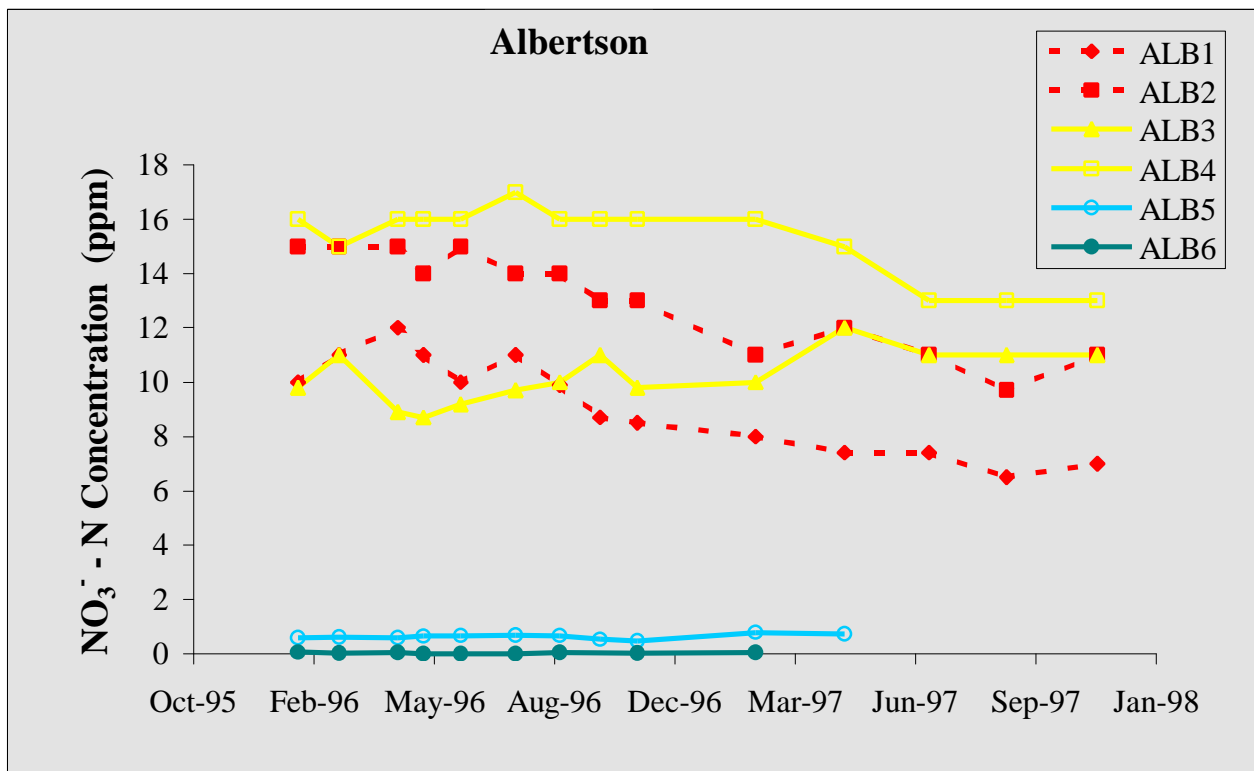
None of the seepage indicators except for nitrate-nitrogen were found in the wells at Albertson at concentrations that indicate lagoon seepage has occurred. The presence of nitrate in ground water at this site appears to be related to previous agricultural activities rather than the lagoon because the concentration levels were relatively consistent from the first sampling event through the first 18 months of the study. Also, no other seepage indicators were present in the ground water samples. In order to form conclusions about the potential for lagoon seepage to contaminate ground water, sufficient time must be allowed for movement of ground water beneath the lagoon to the monitoring wells.

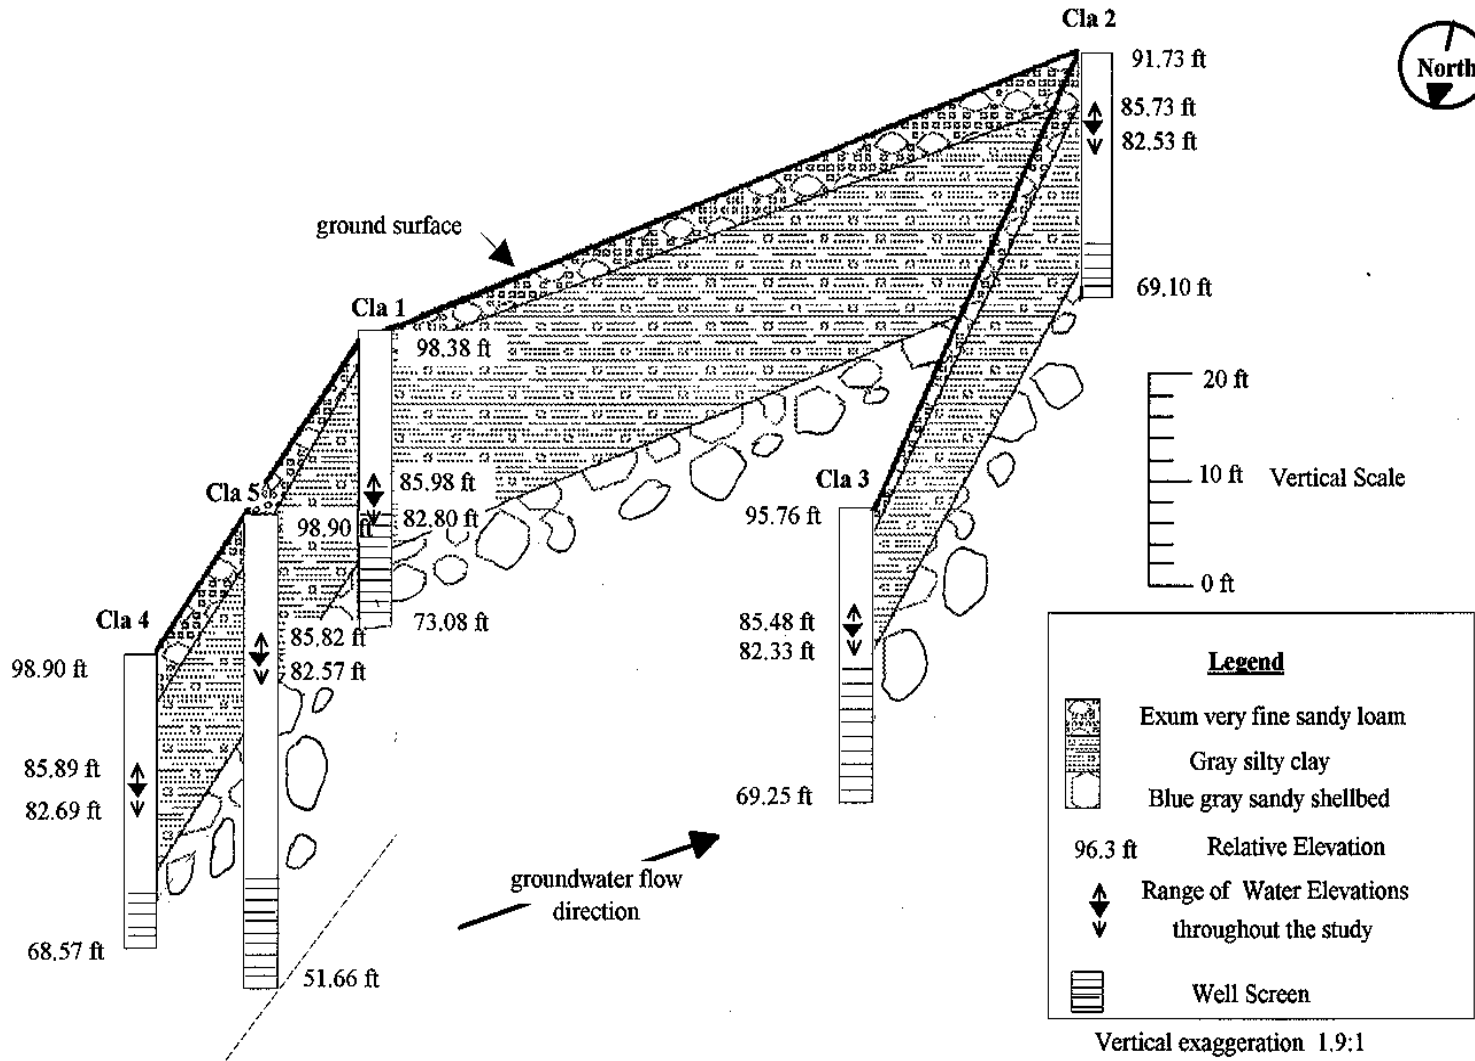
Borehole Stratigraphy of the Clarkton Site in Bladen County

The separation distance between the lagoon bottom and the water table was estimated to be more than 15 feet. A significant clay layer that was 10 to 20 feet thick (see fence diagram) was found in each of the wells. Based on this limited information, the Clarkton site would generally be considered to have less potential for lagoon seepage to contaminate ground water.

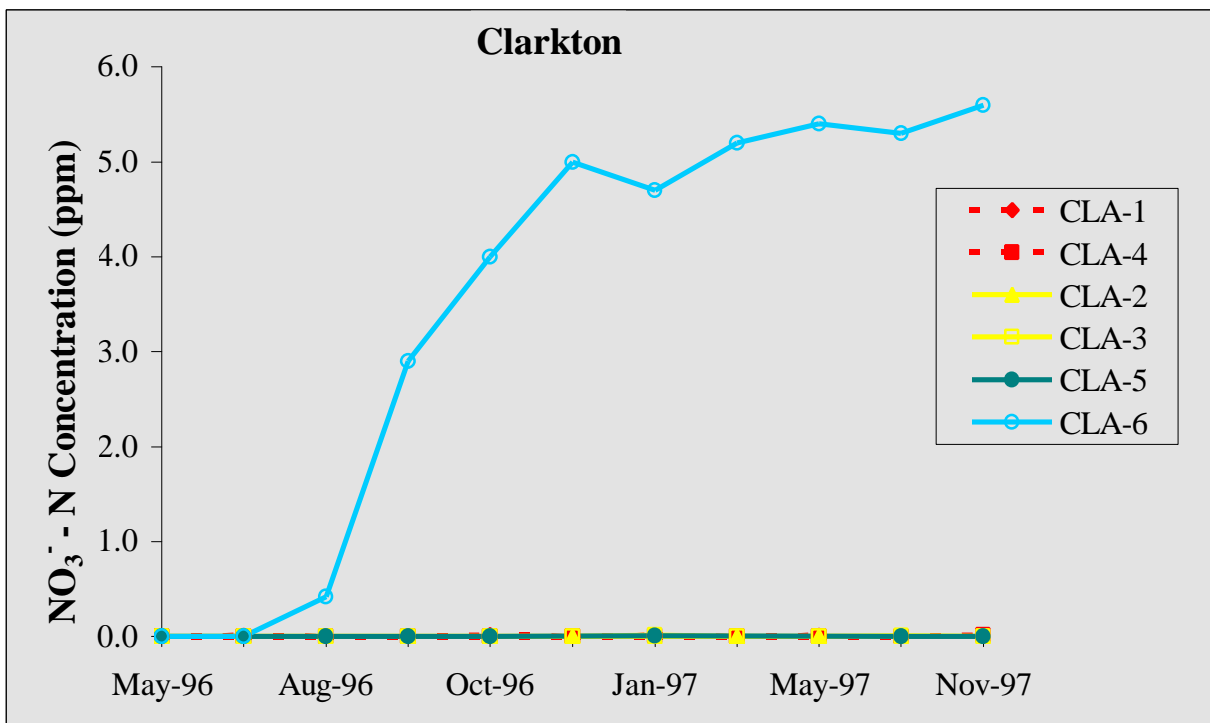
Clarkton

None of the indicators of lagoon seepage were consistently found in the four downgradient wells at Clarkton. The upgradient well, CLA-6, does show an increasing trend of both nitrate-nitrogen and chloride concentrations. These increasing trends may be the result of influence of the spray irrigation practices. This well was sited near spray irrigation activities because there was no other location suitable to the cooperator.

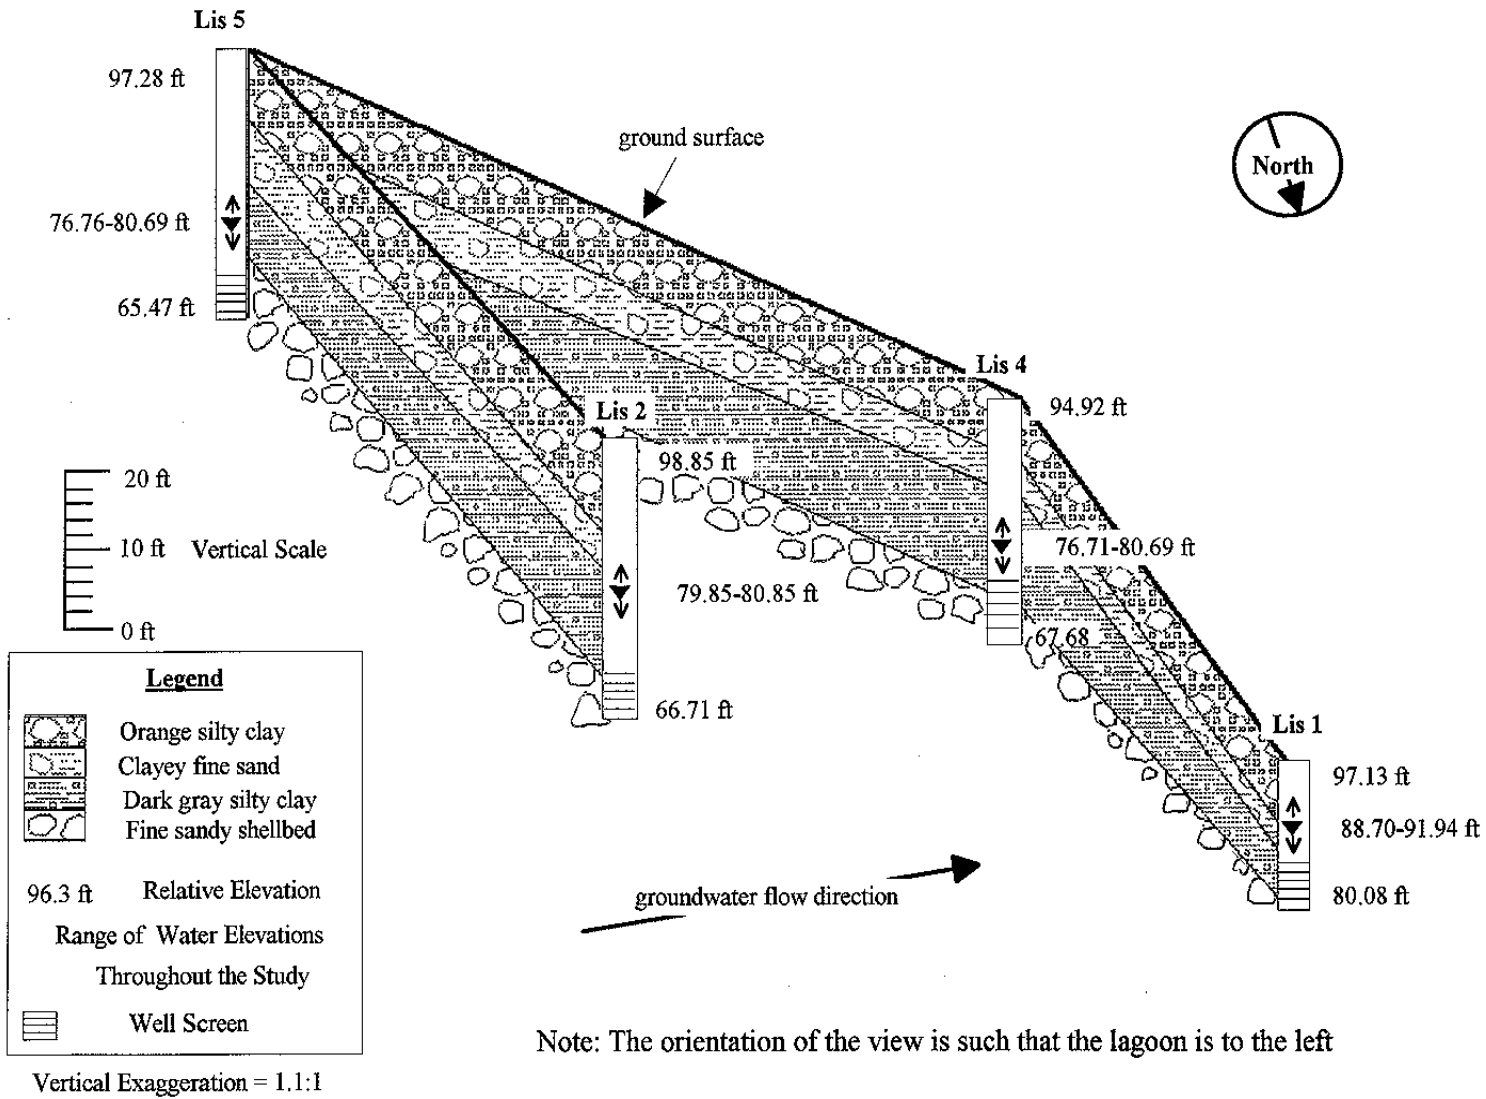
Borehole Stratigraphy of the Lisbon Site in Bladen County

The separation distance between the lagoon bottom and the water table was estimated to be more than 8 feet. A significant clay layer that was about 10 feet thick (see fence diagram) was found in each of the wells. Based on this limited information, the Lisbon site would generally be considered to have less potential for lagoon seepage to contaminate ground water.

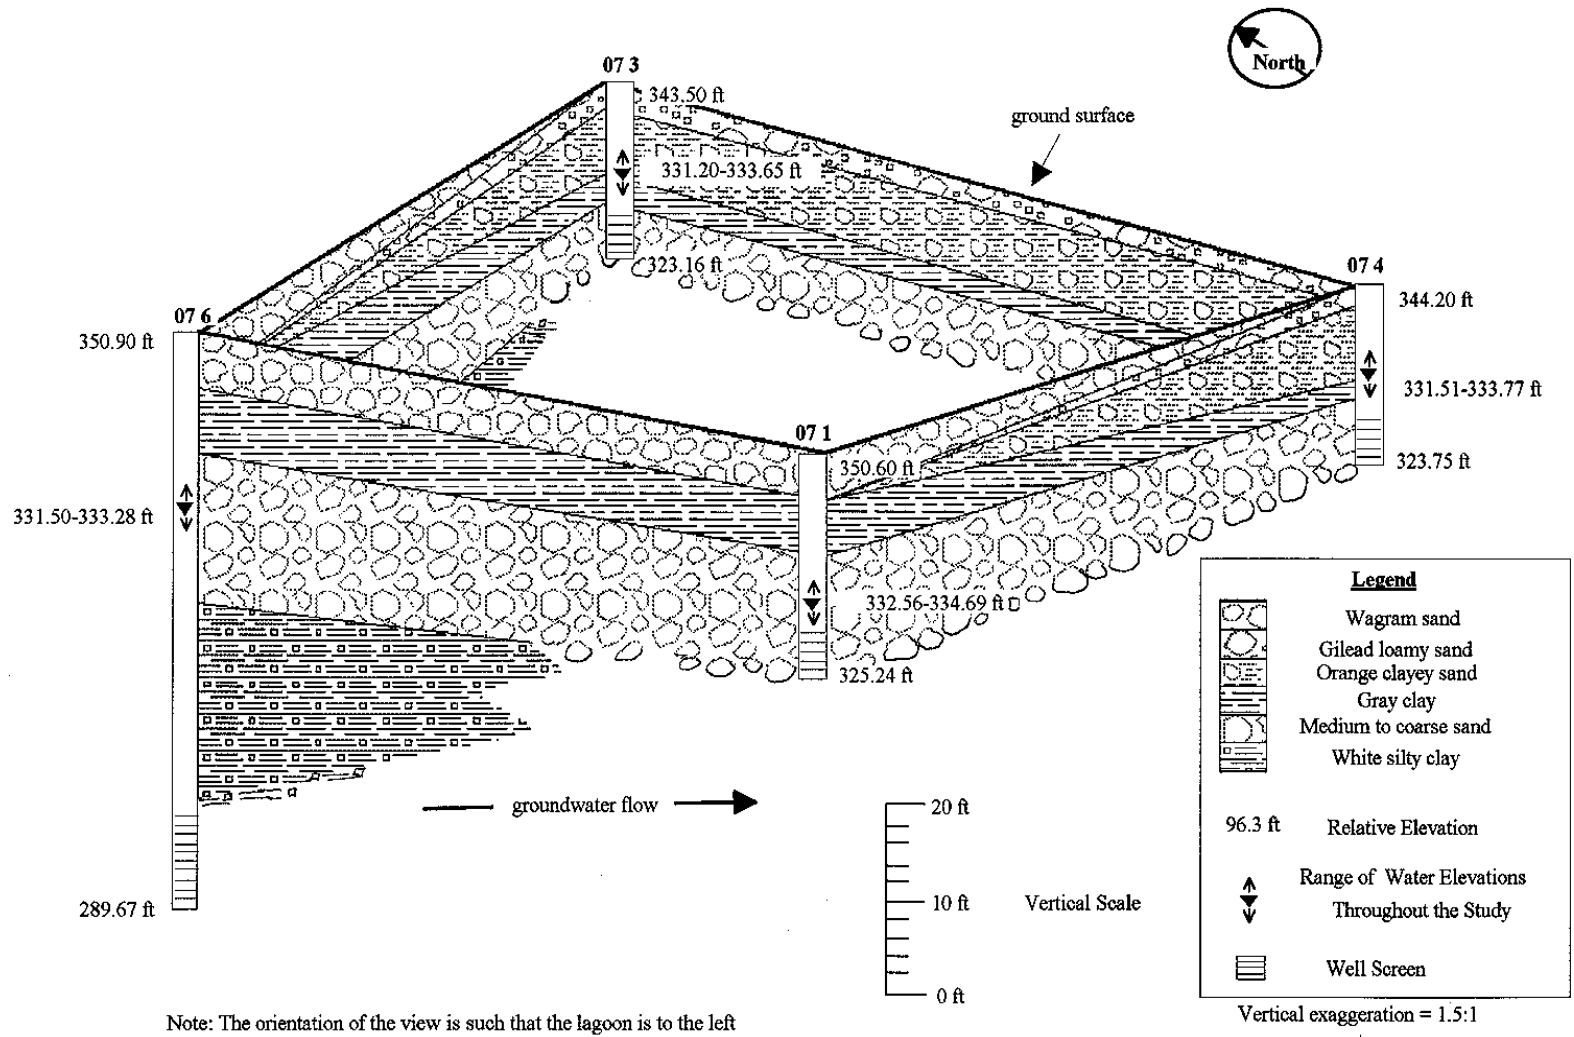
Borehole Stratigraphy of the 07 Site in Scotland County

Results of the EM survey did not show any significant changes in conductivity in the subsurface that would be indicative of ground water contamination. The separation distance between the lagoon bottom and the water table was estimated to be more than 13 feet. A significant clay layer was found in each of the shallow downgradient wells that was about 5 to 10 feet thick (see fence diagram). Based on this limited information, the 07 site would generally be considered to have less potential for lagoon seepage to contaminate ground water.

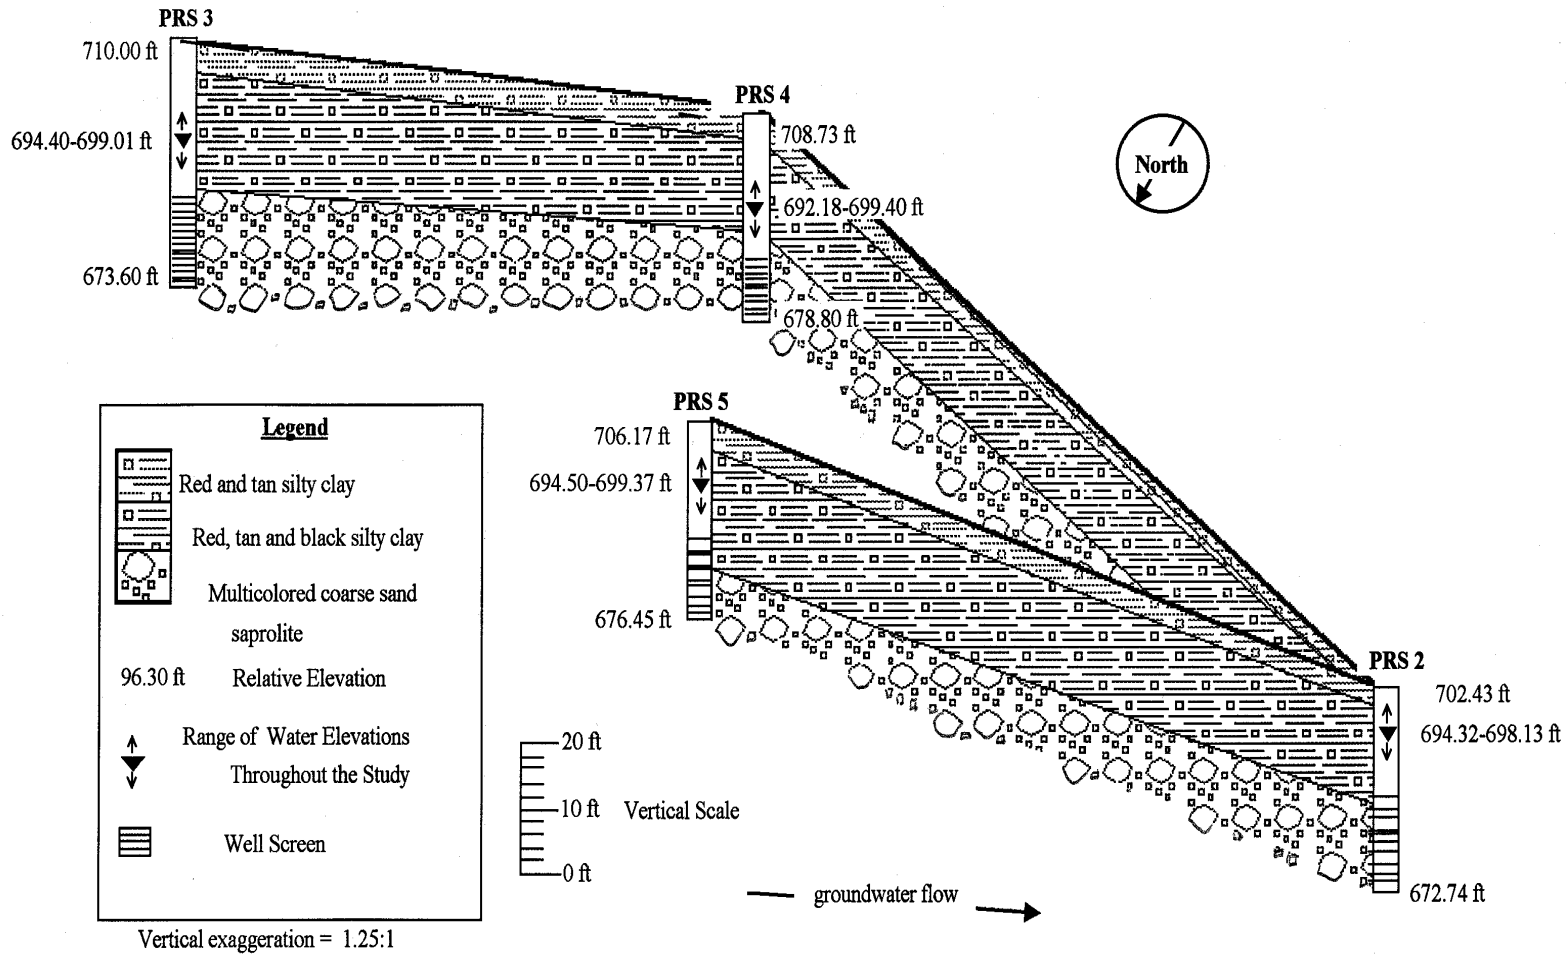
Borehole Stratigraphy of the PRS Site in Rowan County

The separation distance between the lagoon bottom and the water table was estimated to be more than 6 feet. A significant clay layer more than 15 feet thick was found in each of the shallow downgradient wells (see fence diagram). Based on this limited information, the PRS site would generally be considered to have less potential for lagoon seepage to contaminate ground water.

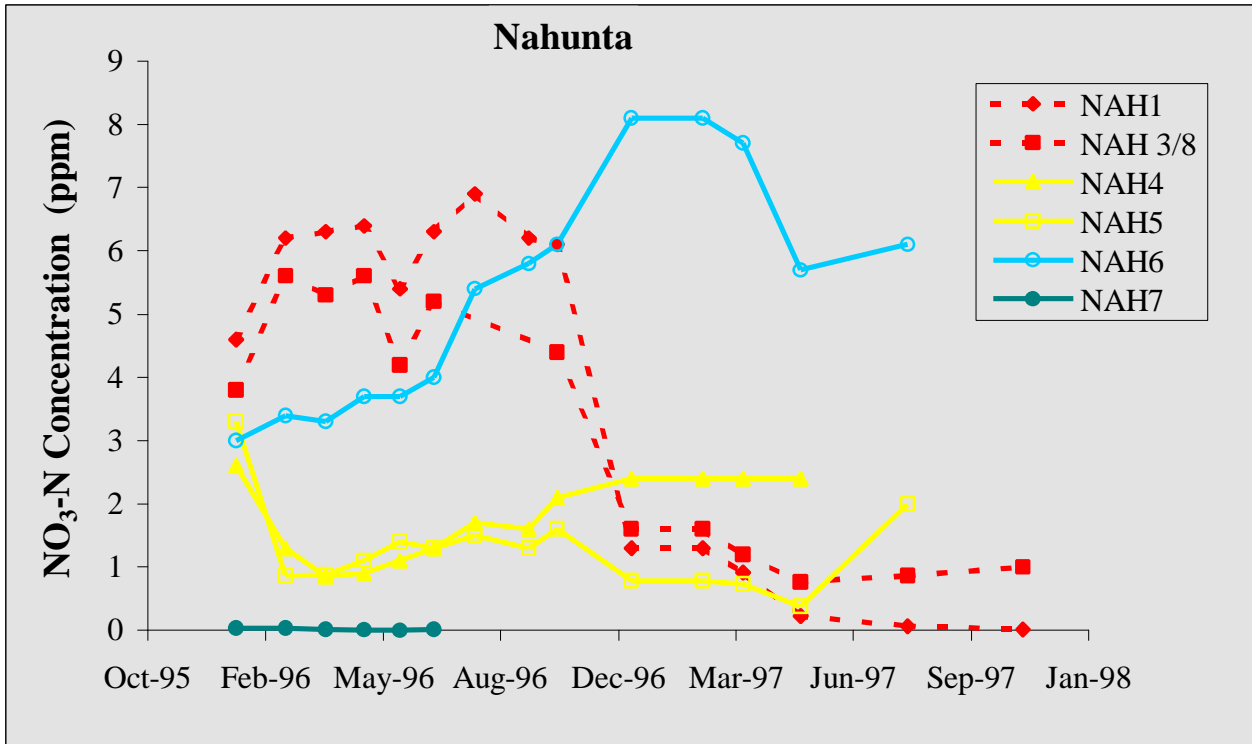
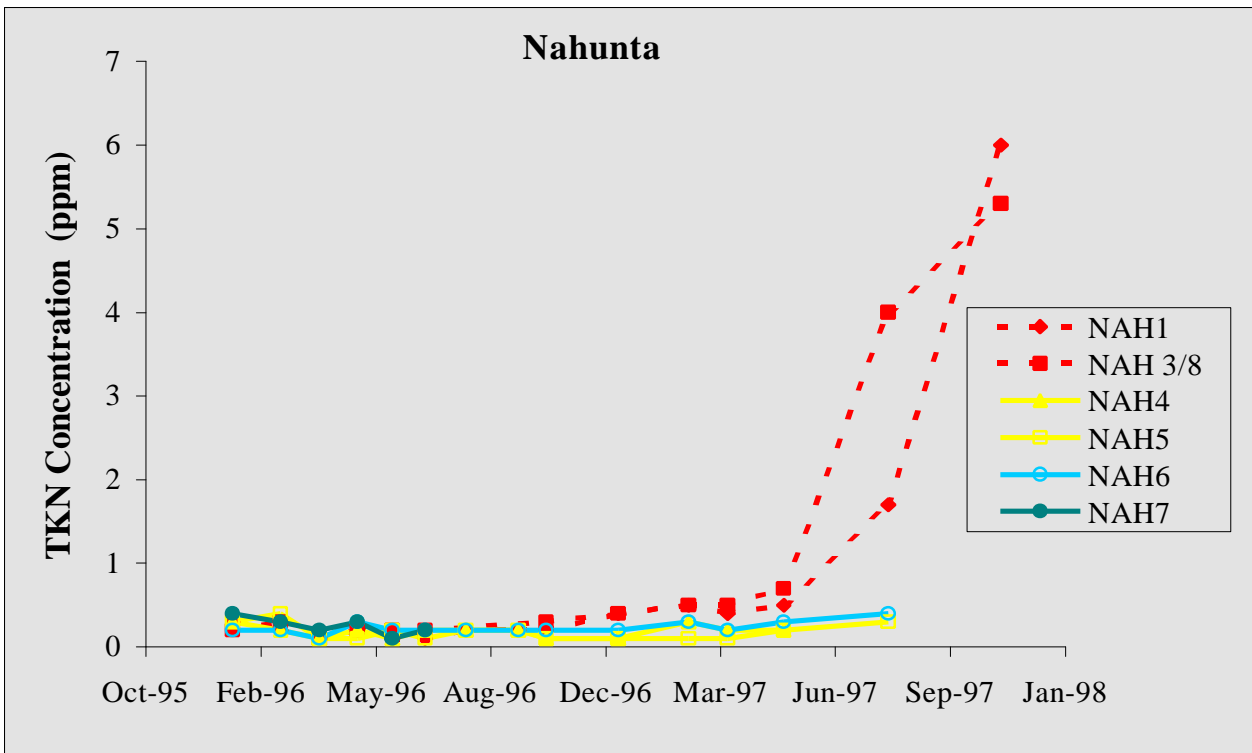
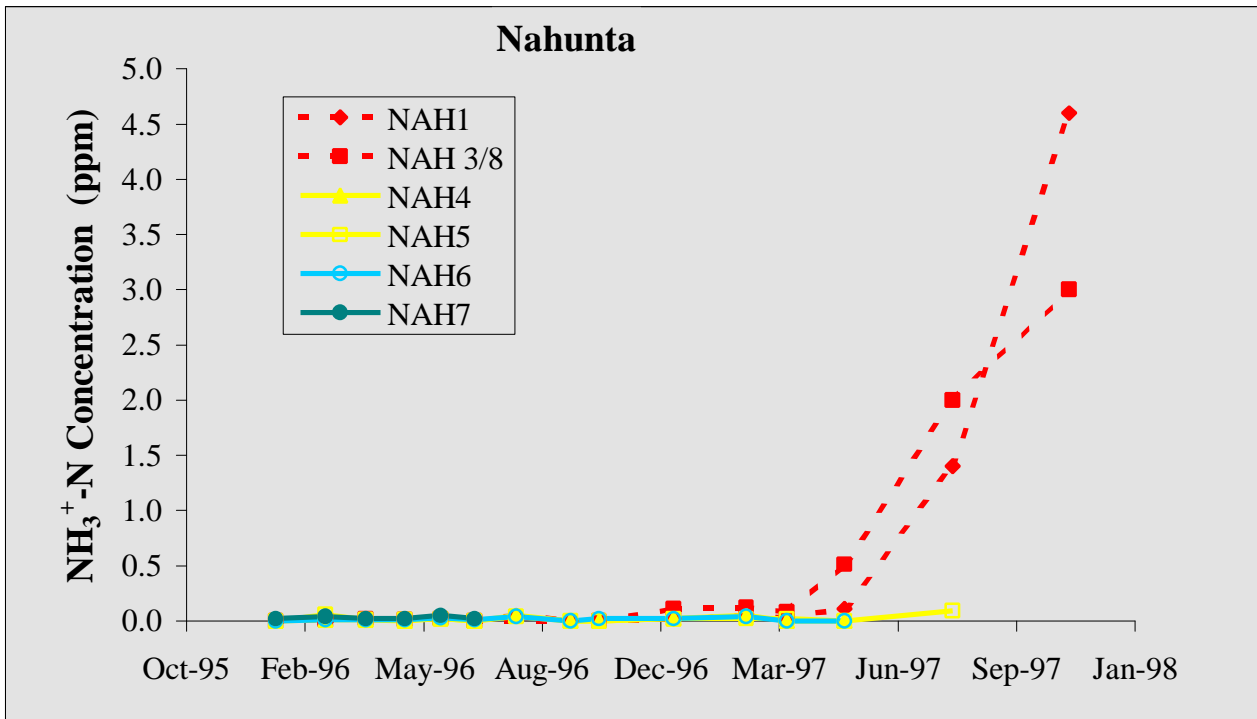
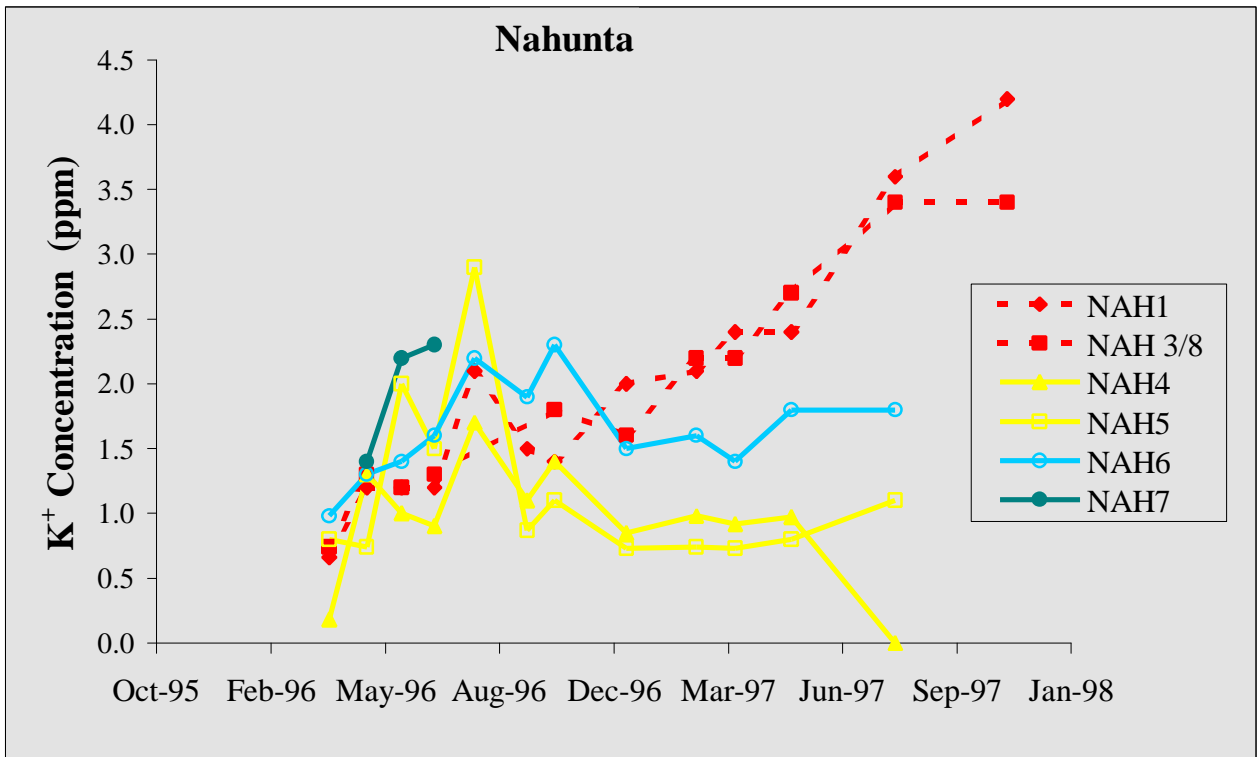
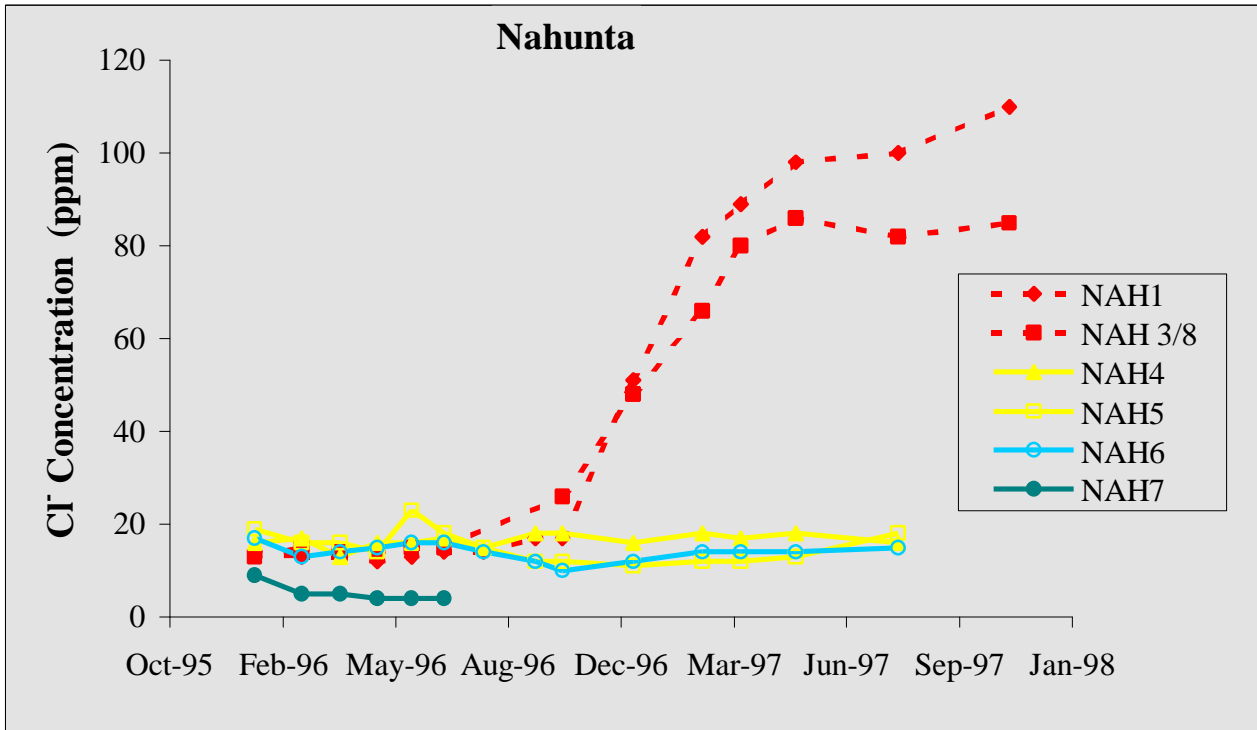
Two of the shallow wells were affected by this waste release. Chloride is the first constituent to be detected at high concentrations in the shallow ground water. Potassium, ammonia-nitrogen and TKN-nitrogen are showing an increasing concentration trend as well. These wells also show a corresponding decreasing nitrate-nitrogen trend over the same sampling period. This appears to indicate a change in the subsurface environmental conditions where dissolved oxygen has been depleted. Further monitoring of the wells should show a decrease in lagoon seepage indicator constituents since the source of the waste has been eliminated.
