# Arsenic in Groundwater Investigations – Eastern Slate Belt (ESB): Nash and Halifax Counties, North Carolina

- Jeffrey C. Reid
- Walter T. Haven \*
- David D. Eudy
- Raymond M. Milosh
- Ellen G. Stafford

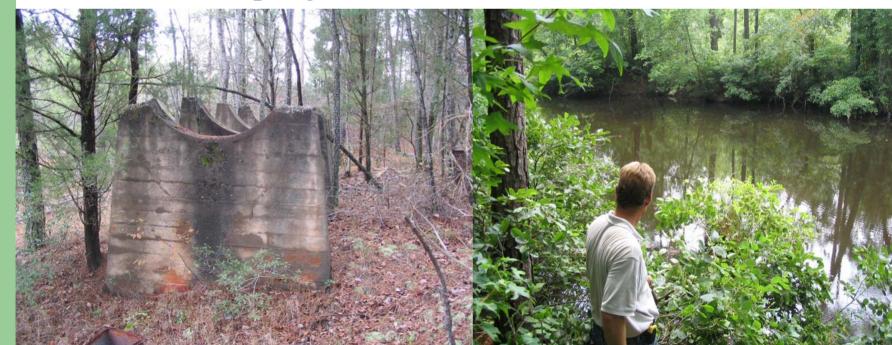
- ➤Old gold mines (gold/sulfide minerals occurrence)
- ➤ Ore dump sampling
- ➤ Biased sampling for As and sulfides

e Selection Per Pump F	_
Rock	Arsenic (ppm)	Arsenic (ppm)
Sample	(ICP)	(HAS)

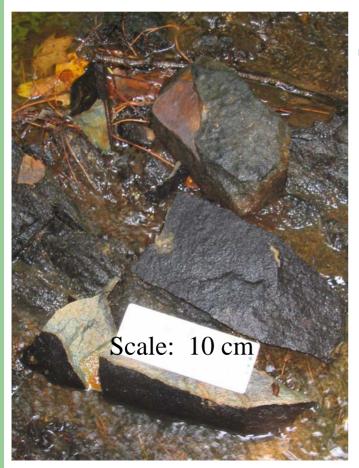
Stream rock coating sampling

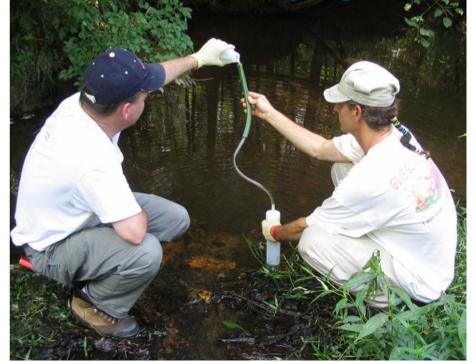
>Filtered water sampling

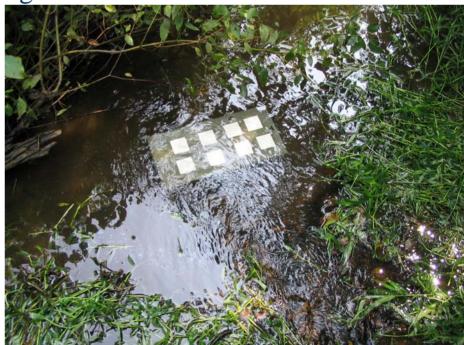
- ➤ Acid-cleaned ceramic tiles (~ 32.5 cm<sup>2</sup>)
- ➤ Silicone caulked to cement block
- ► Placement into stream for oxide collection
- ► Induce Eh change

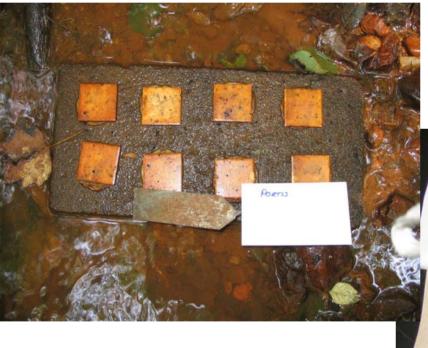
Tiles after deployment
