# **IMPACT OF ANIMAL WASTE LAGOONS ON GROUND WATER QUALITY:**

**An Update on Data Collected from  
March 1998 through November 1999**

**Report of Groundwater Investigation Number 18**

**GROUNDWATER SECTION  
DIVISION OF WATER QUALITY**

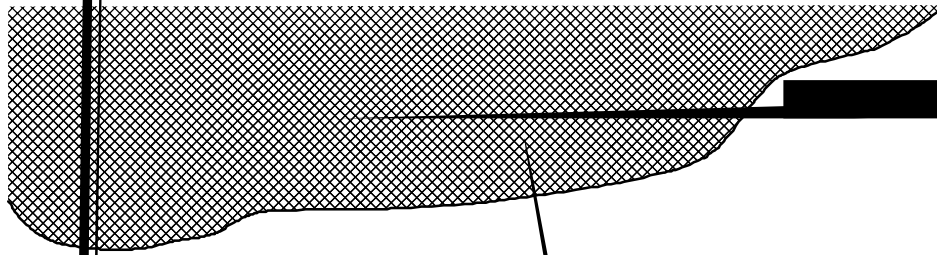
Figure 3

There is strong indication that the onsite supply well is affecting ground water flow at this site (fig. 3). The extent of this interference with the natural gradient in both aquifers is unknown, so no accurate determination of ground water flow velocity can be made.

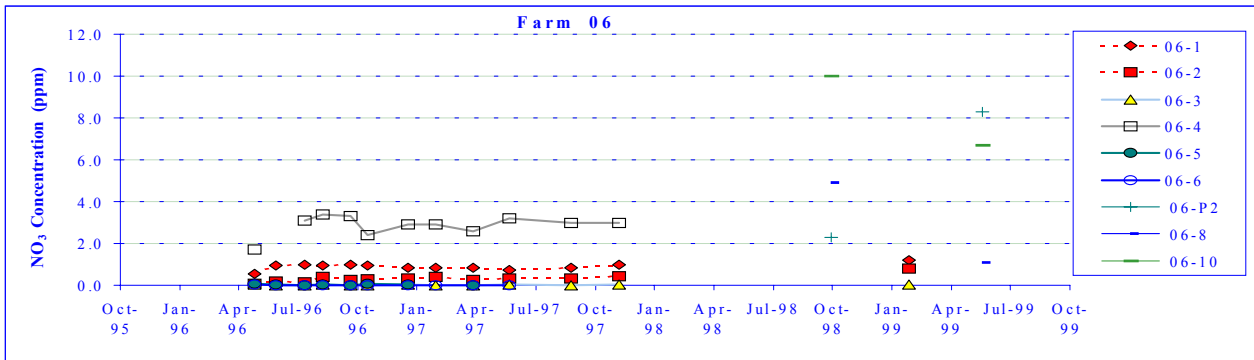
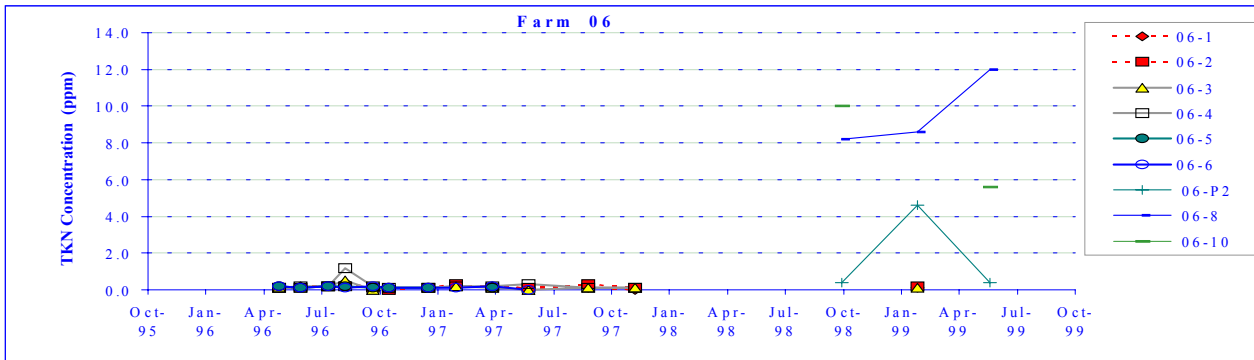
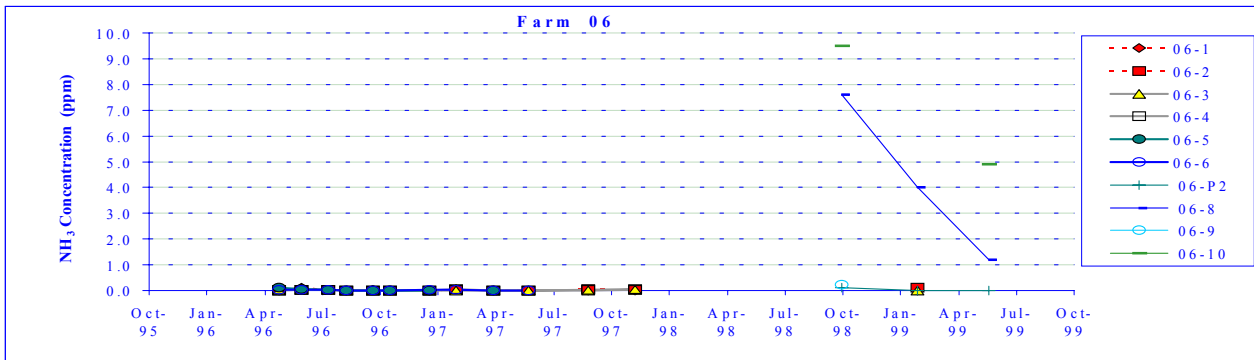
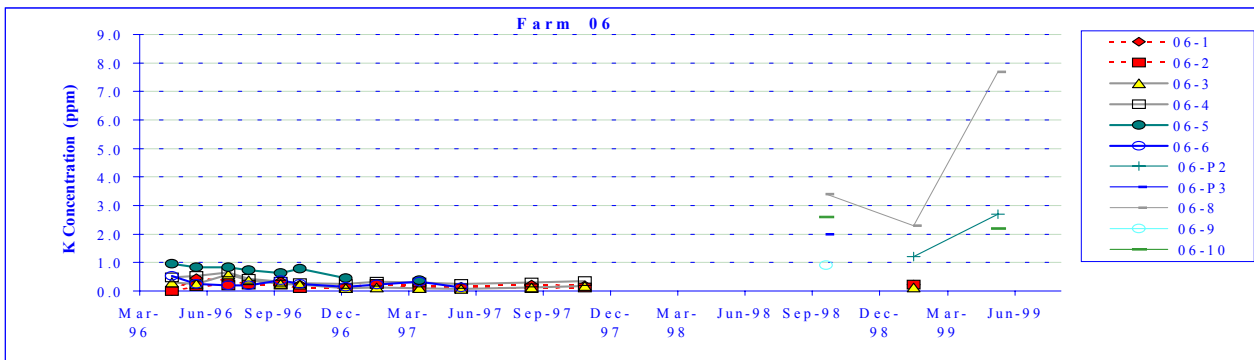
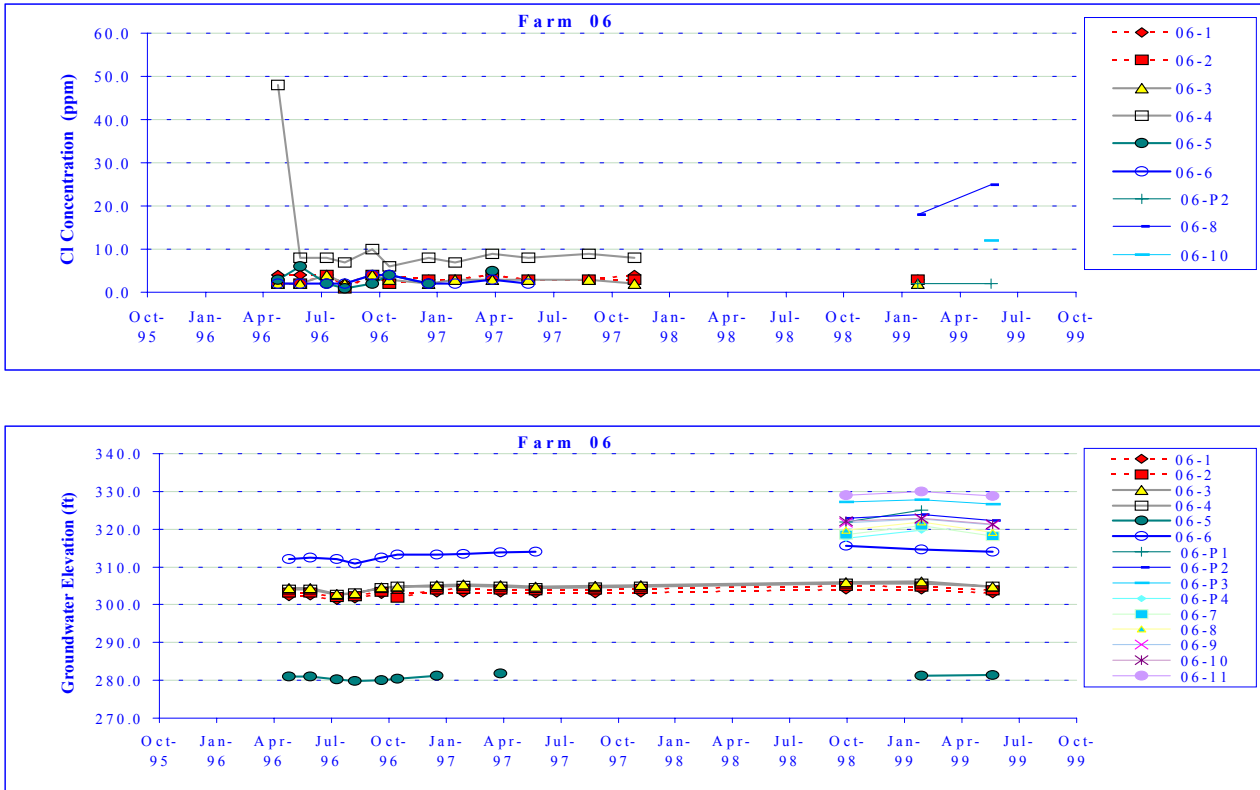
Figure 7 (1 of 2)

Monitoring wells at this site were sampled three additional times since publication of the original report (fig. 7). Nutrient analyses indicate that the ground water in the surficial aquifer has higher concentrations of lagoon seepage indicators, but these nutrients may be coming from another source as discussed below.

On February 9, 1999, GWS staff noted that pastureland for a small herd of cattle had been expanded to include the land where monitoring wells 06-1,2,3,4,5,7,8,9 and 10 are placed. The cattle manure may be contributing to shallow ground water concentrations of nitrogen and Cl in these wells.

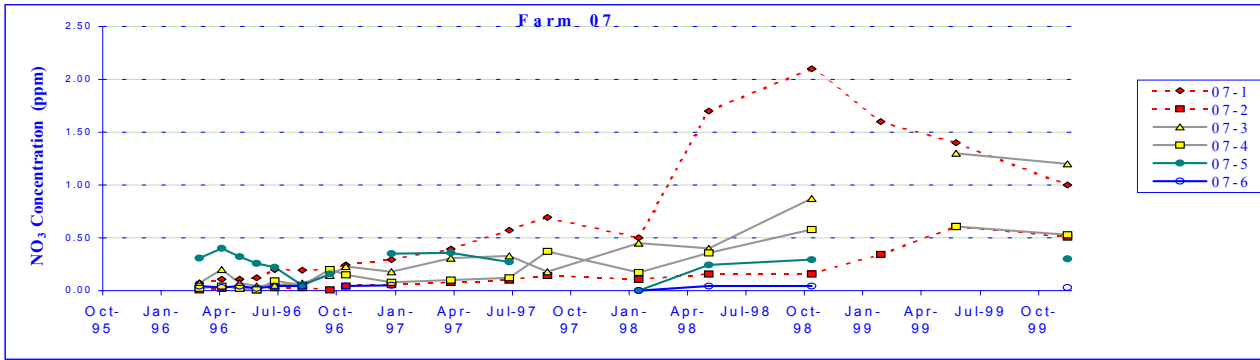
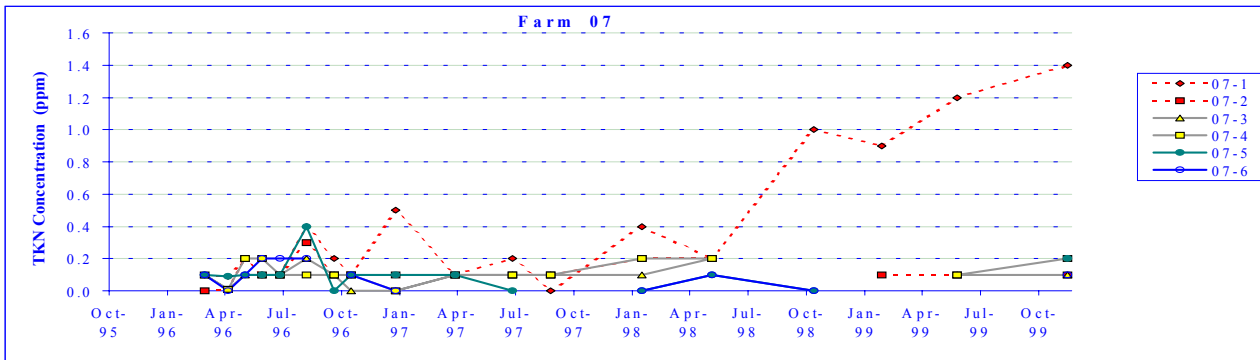
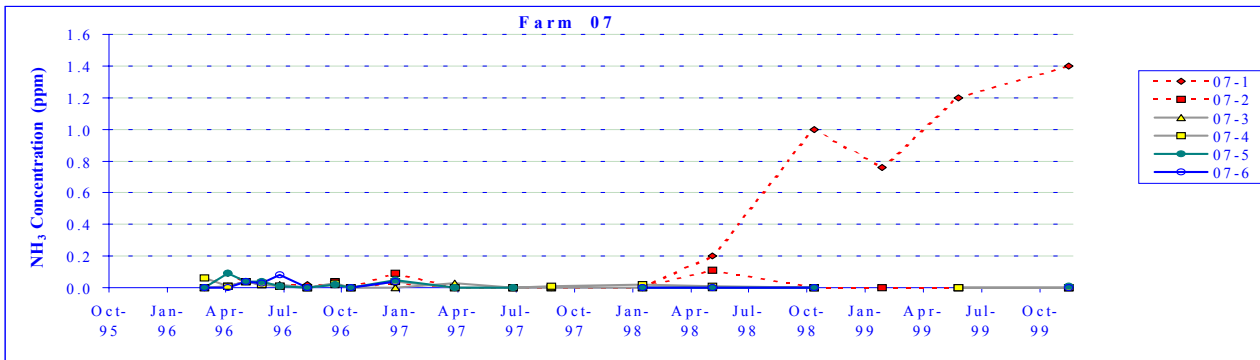
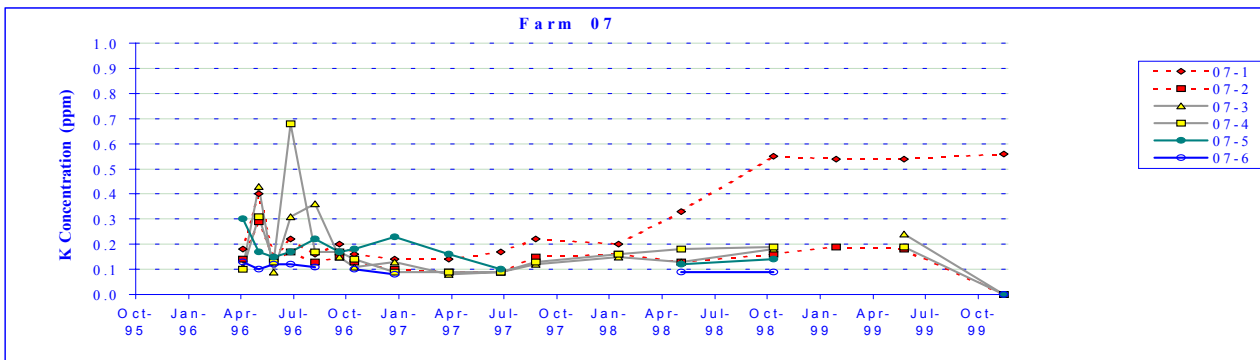
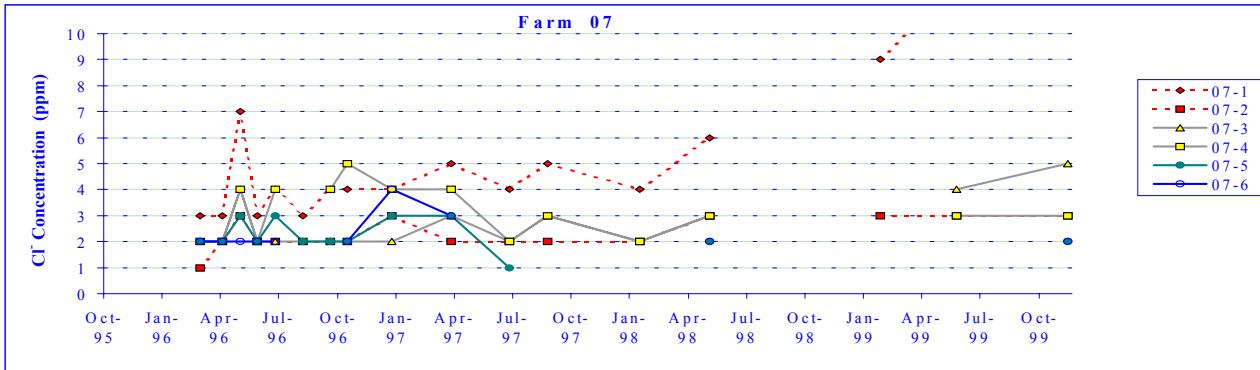
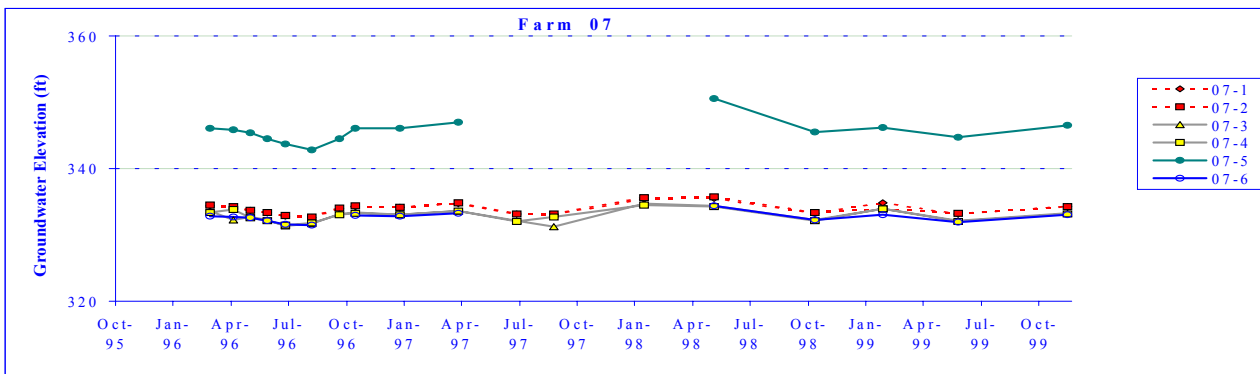
Figure 12 (1 of 2)

Monitoring wells at this site were sampled three additional times since the publication of the original report. There was a very slight increase of analyte levels in well 07-1, but NO<sub>3</sub> and Cl concentrations were well below the state's ground water standards (fig. 12). This could indicate some lagoon seepage, but more monitoring would be required to determine if this is the case and to what extent the seepage may be occurring.

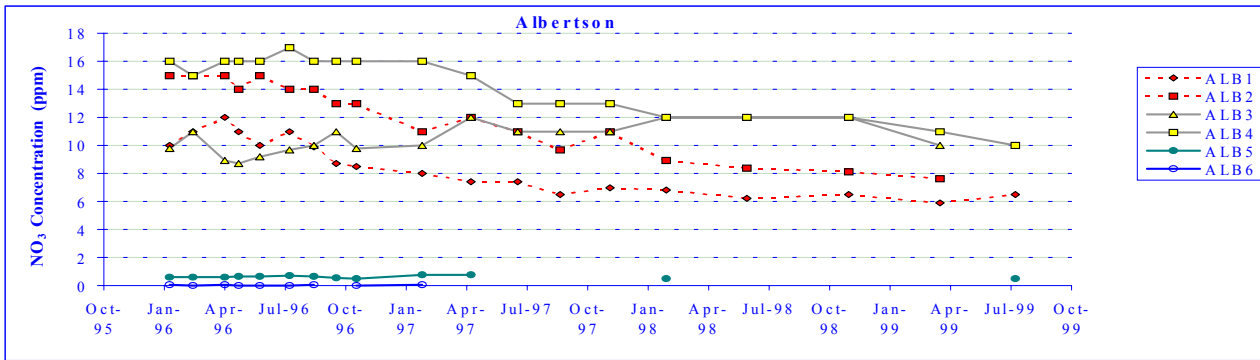
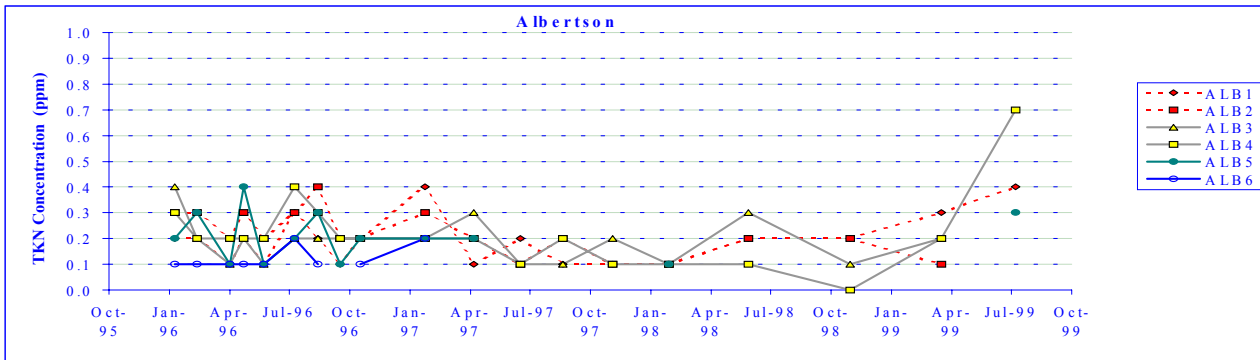
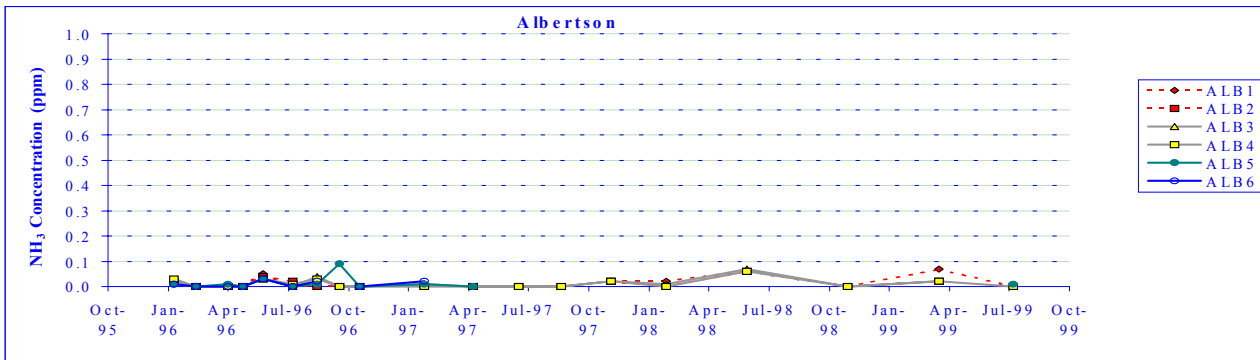
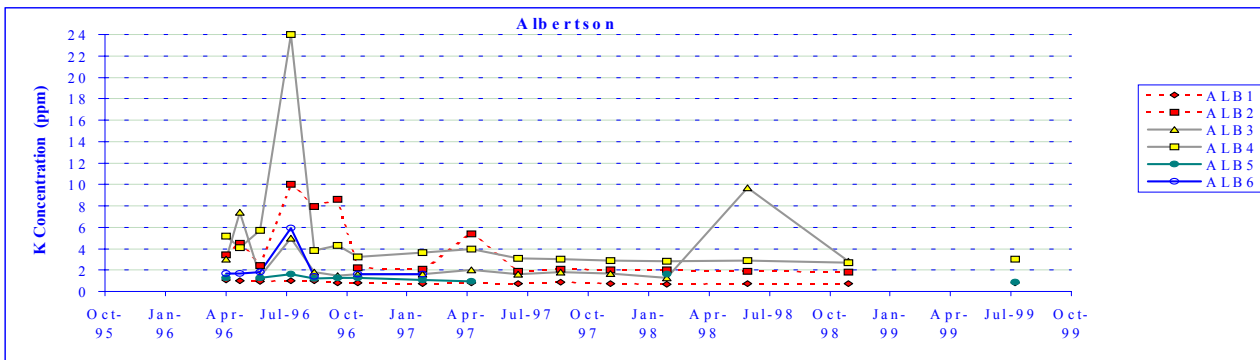
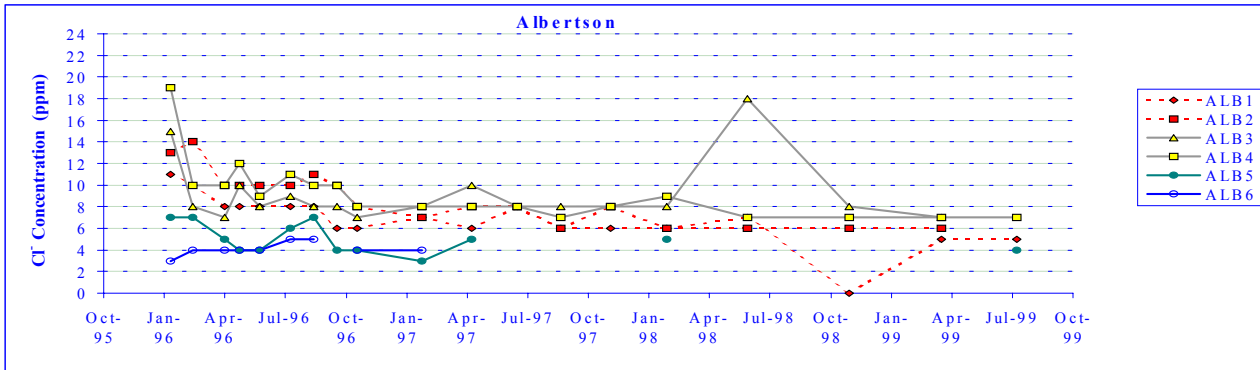
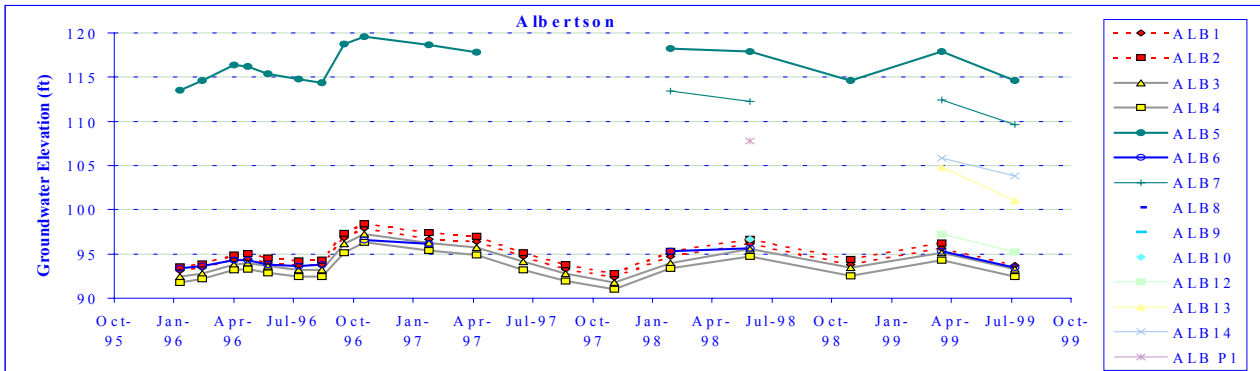
Figure 17 (1 of 2)

Monitoring wells at this site were sampled four additional times since the publication of the original report, and there have been no significant changes in analyte concentrations (fig. 17). NO<sub>3</sub> has continued to decline in wells Alb-1, 2, 3, and 4. Analyses of stable nitrogen isotope  $\delta^{15}\text{N}$  values at this site by USGS staff indicate that fertilizer from previous applications appears to be the source of the nitrate in ground water at this site (Timothy B. Spruill, U.S. Geological Survey, Oct. 4, 2001, personal commun.). No other lagoon seepage indicators have been detected in significant amounts in the wells.

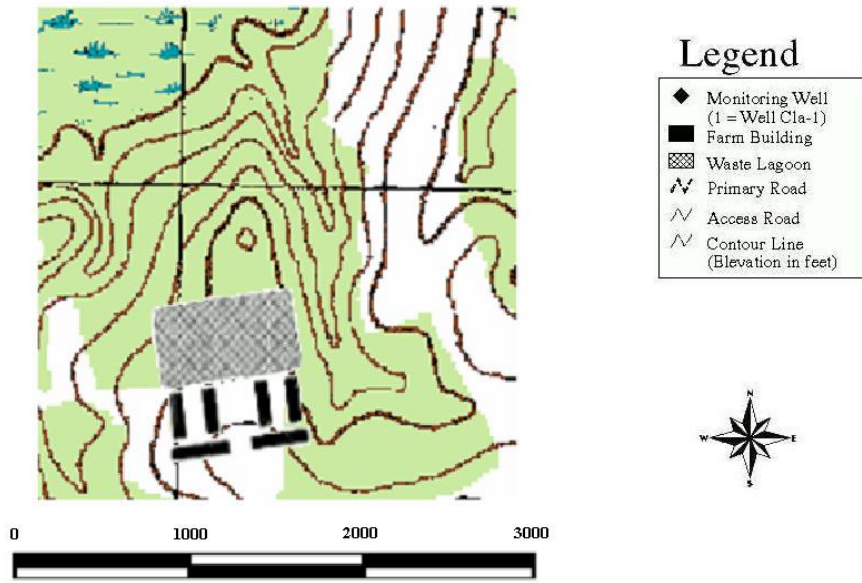
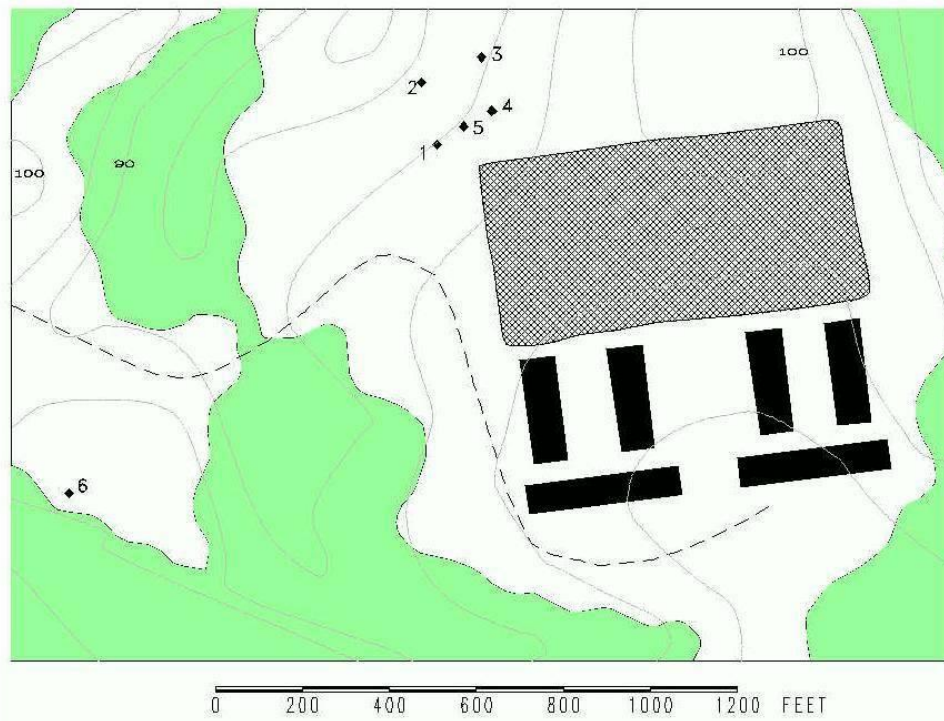
Figure 18

Wells were located in the estimated direction of ground water flow based on topographic relief. As figures 18 through 22 show, ground water flow is not perpendicular to topographic contour lines, but more toward the direction of the swamp to the north and the drainage feature to the east (fig. 18). Ground water flow was calculated using data from four sampling events during different times of the year with the same results (fig. 20). Due to the unanticipated flow direction, wells were not placed in a location where lagoon seepage indicators would be detected.

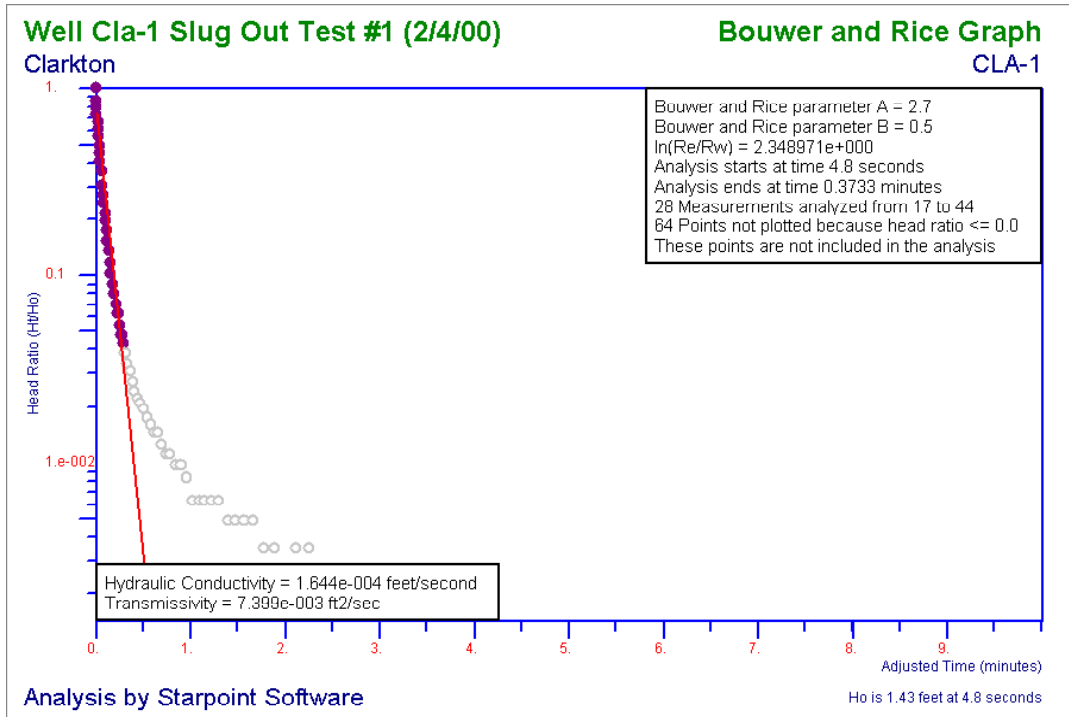
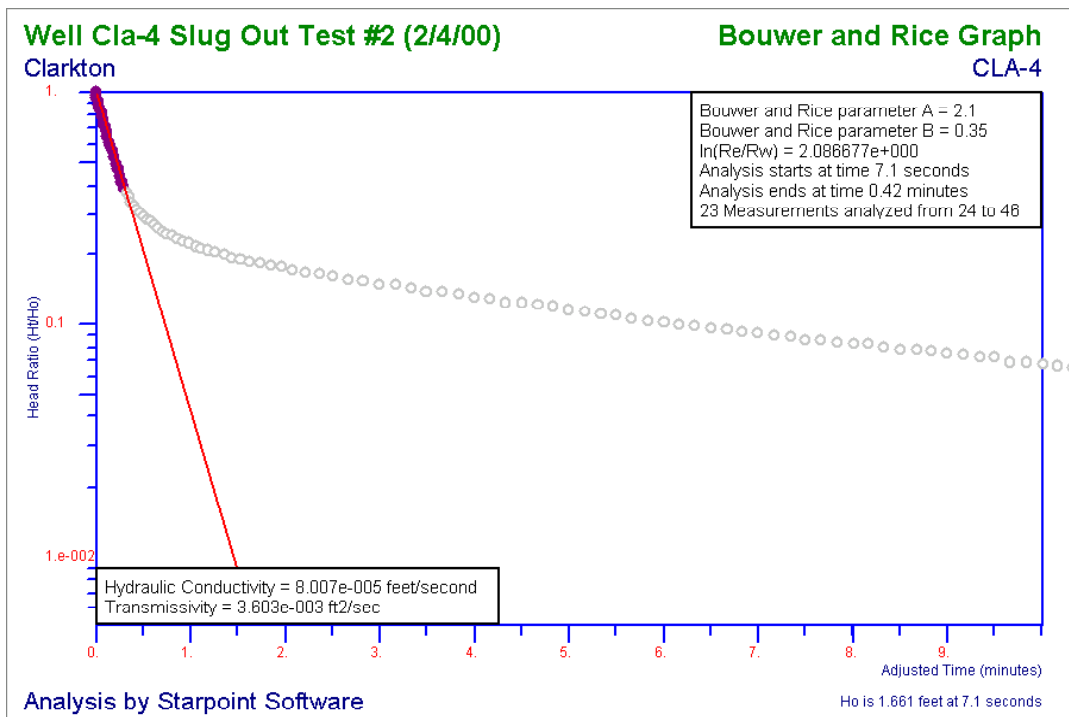
Figure 21

Ground water is flowing northeast at 0.02-0.15 feet per day. It is unclear whether this wide range of ground water velocities shown in figure 21 results from variations in the aquifer media or slug test inaccuracies. According to boring logs, these wells are screened in the same aquifer, so it is probable that inaccurate slug test data causes this variance.

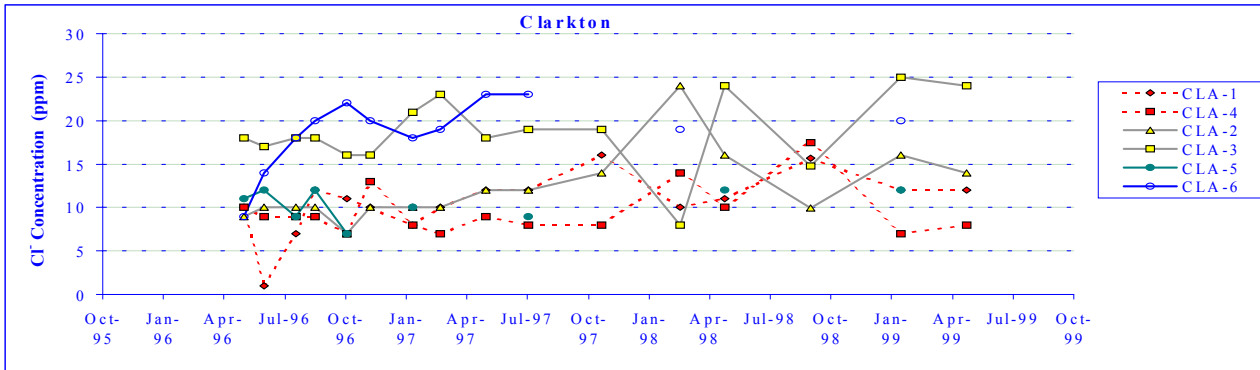
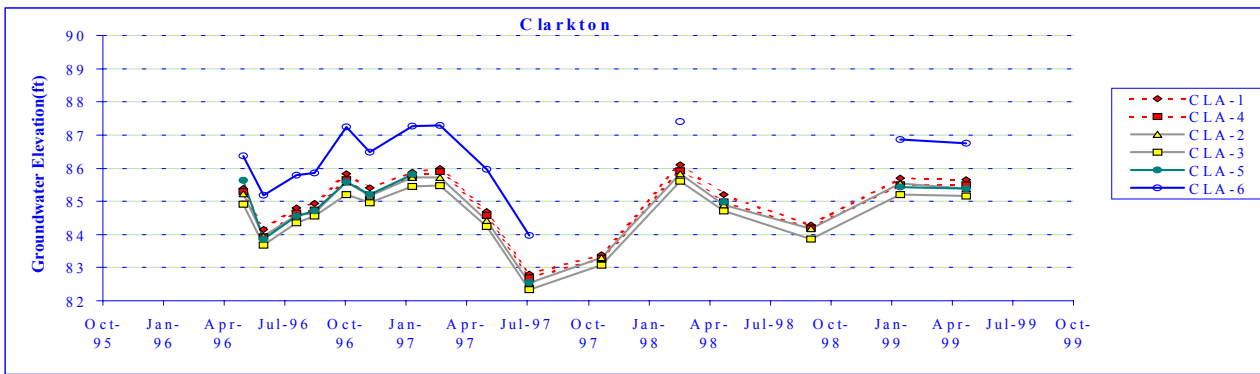
Figure 23 (2 of 2)

Monitoring wells at this site were sampled three additional times since the publication of the original report, and there have been no significant changes in analyte concentrations except for NO<sub>3</sub> in the background well (fig. 23). The background well, Cla-6, is located at the edge of a field which began receiving hog waste shortly after its installation. The higher concentrations of lagoon seepage indicators are presumably due to the impact of the sprayed effluent on the ground water.

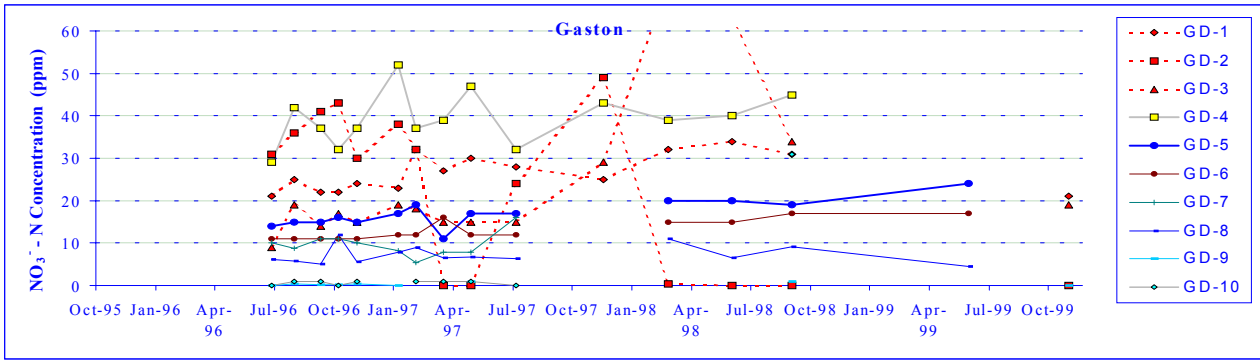
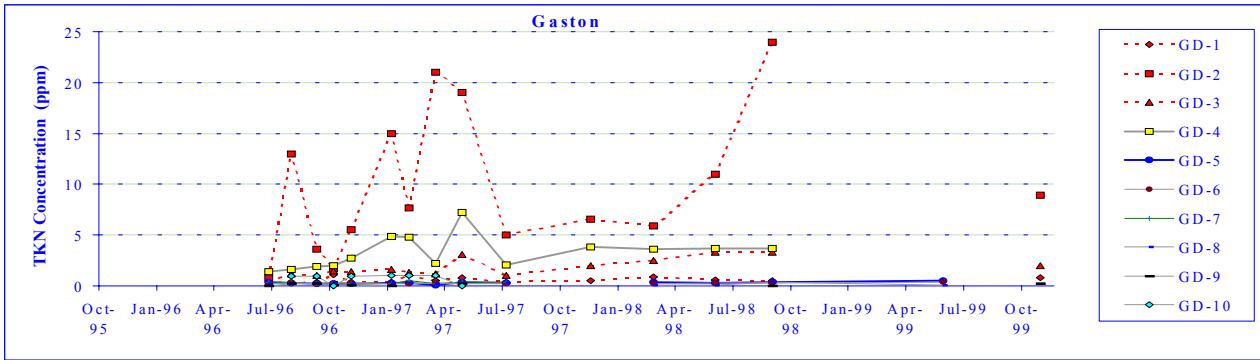
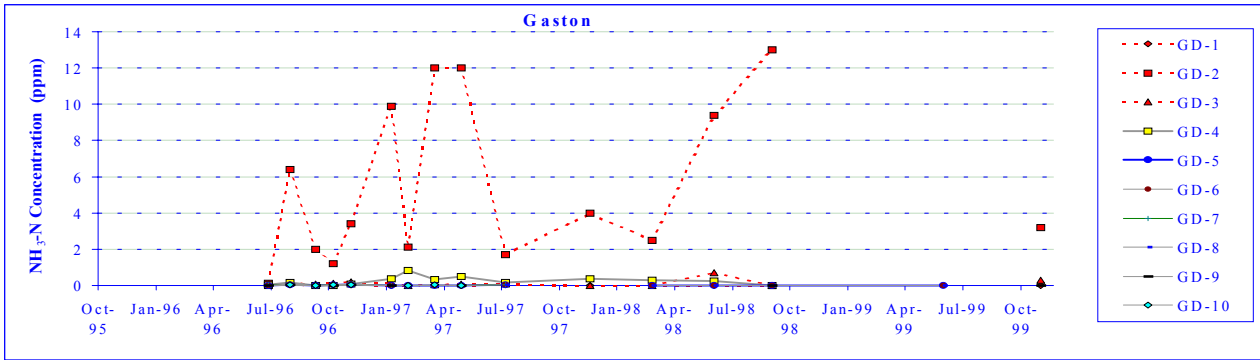
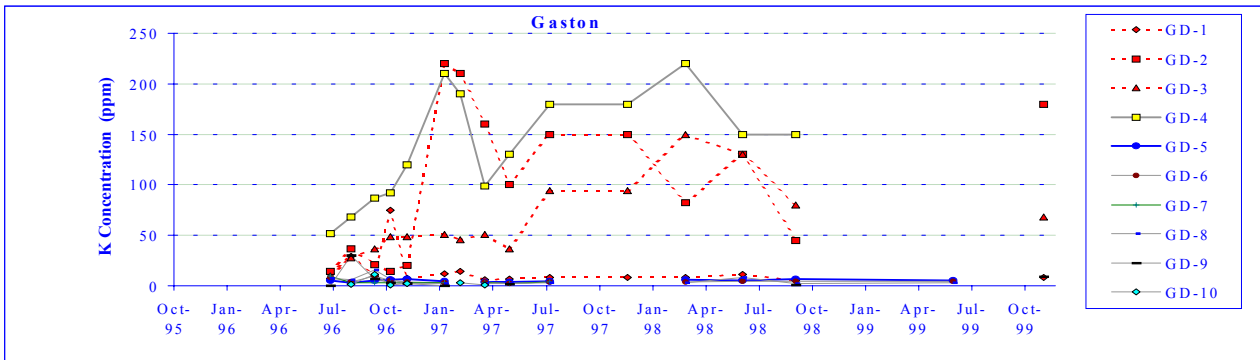
Figure 28 (1 of 2)

Monitoring wells at this site were sampled four additional times since publication of the original report. NO<sub>3</sub> concentrations are still above the state ground water standard of 10 parts per million (ppm), but they are decreasing or stable in the sampled wells (fig. 28). TKN and NH<sub>3</sub> are also decreasing or stable in the sampled wells. Chloride concentrations in well GD-2 increased significantly during the final sampling event, but all other sampled well concentrations showed little change.

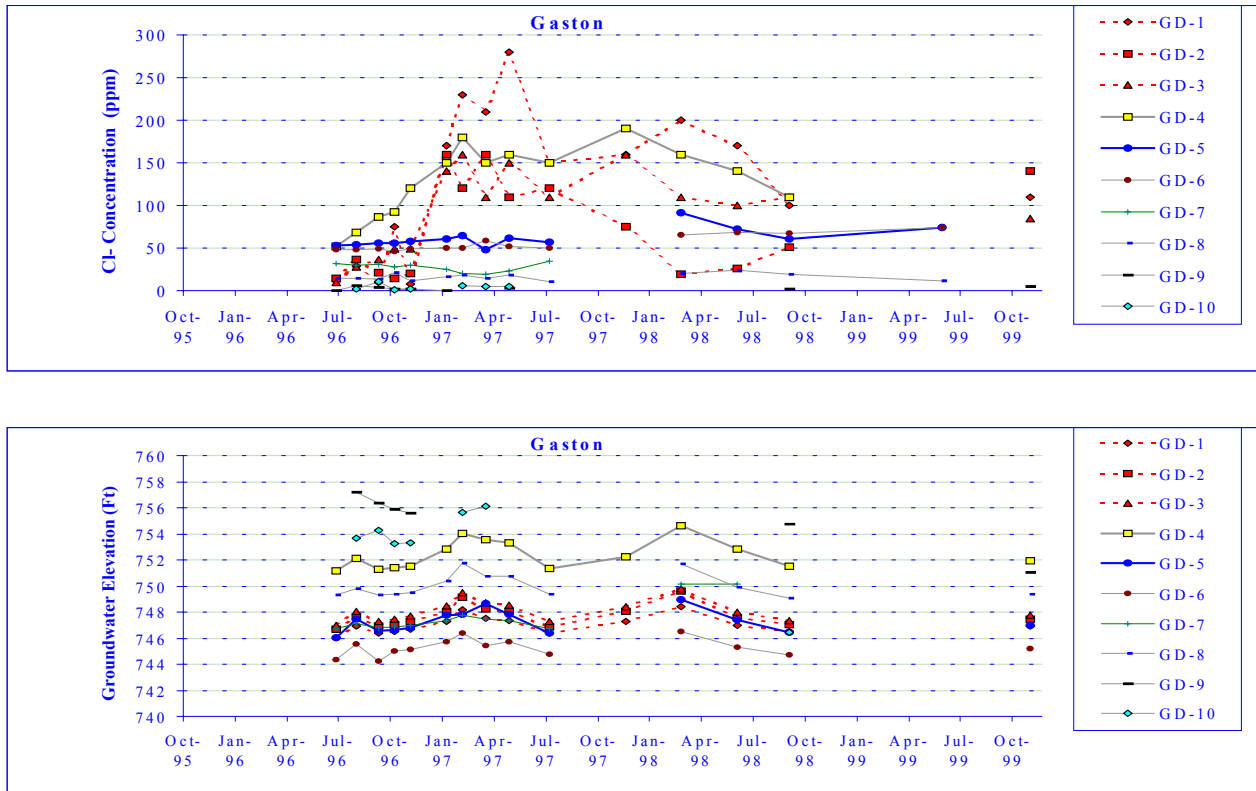
Figure 28 (2 of 2)

Wells GD-1 and GD-3 continue to have elevated concentrations of seepage indicators, but have not undergone the chemical change from oxidized to reduced conditions characteristic of lagoon seepage plumes. Despite the unusual chemical composition of the ground water, however, the high concentration of seepage indicators over the three and a half years of sampling leads the authors to conclude that the ground water in these wells is being impacted by either seepage from the lagoon or by concentrated wastewater infiltrating the ground water between the milking parlor and the lagoon. The arrival of the plume 4.2 years after completion of the lagoon correlates tightly with estimation of the ground water flow rate and points to the wastewater storage pond as the source.

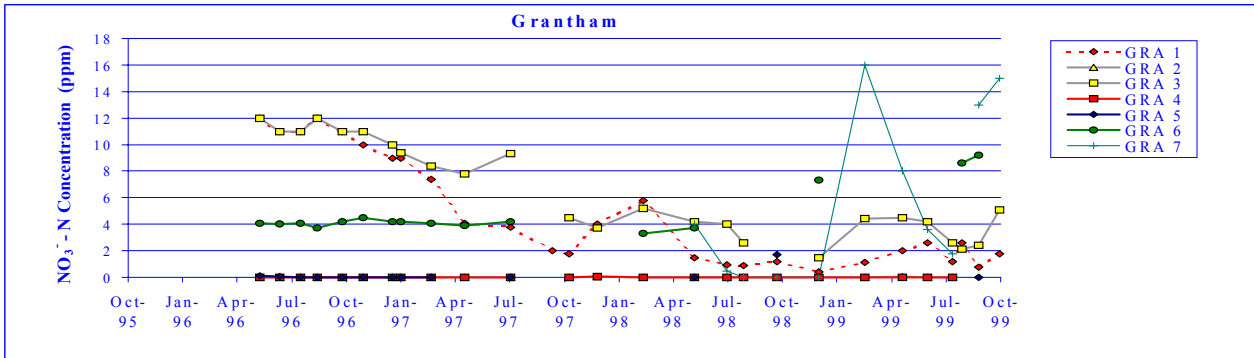
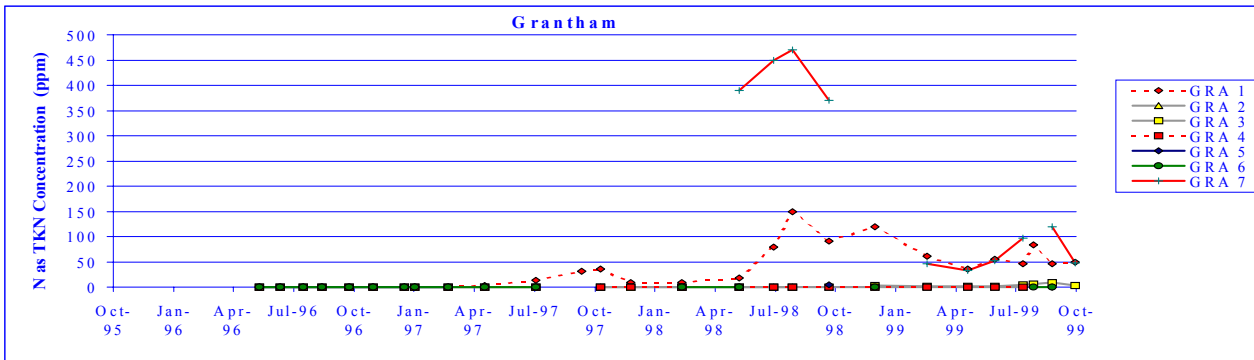
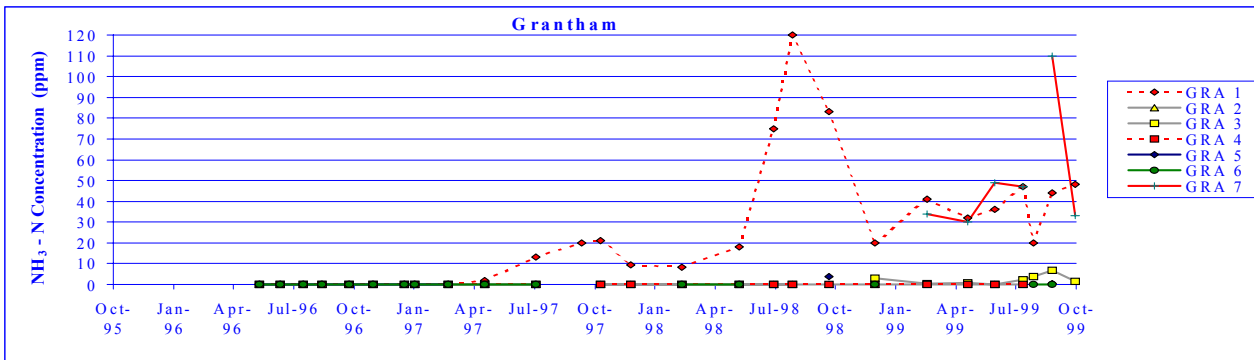
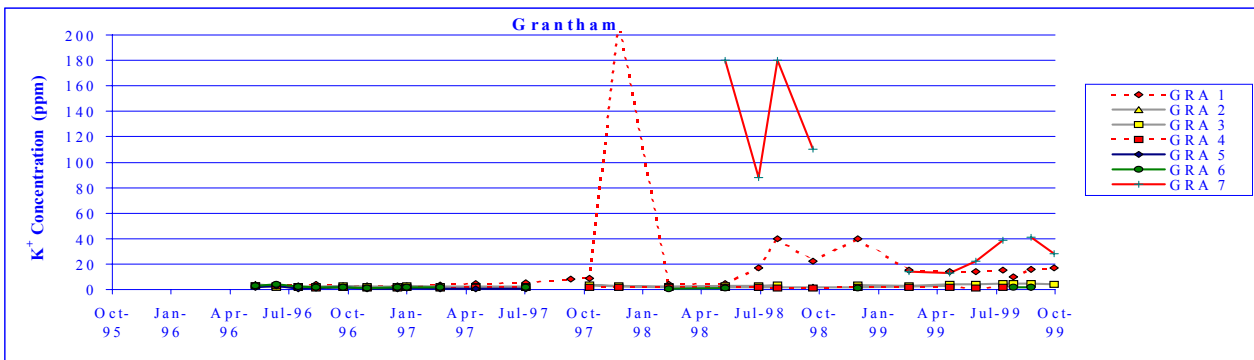
Figure 34 (1 of 2)

Beginning in October 1996, nitrate concentrations in well Gra-1 began to drop from slightly above 10 parts per million (ppm) to a low of 1 ppm by May 1998 (fig. 34). In March 1997, the chloride concentrations began a steady rise from less than 20 ppm toward a peak of 130 ppm by July 1998. Total nitrogen concentrations of 270 ppm nitrogen and the high concentrations of other seepage indicators such as chloride and dissolved solids were also reached in August 1998.

Well Gra-3 is screened in the same shallow system as Gra-1, but is 125 feet further downgradient from the lagoon. In October 1997, chloride concentrations increased from a constant concentration near 20 ppm to near 100 ppm for the remainder of the study (fig. 34). Other seepage indicators such as declining nitrate levels and rising levels of reduced forms of nitrogen were also noticeable by December 1998. Concentrations of these other seepage indicators points to a change in ground water chemistry at this well similar to changes found in wells impacted by lagoon seepage.

In the two wells closer to the lagoon (Gra-1 and Gra-7), the seepage indicator concentrations peaked in August 1998 and then fell until August 1999, indicating that the lagoon may have seeped for a period of time while it was new and eventually underwent physical or biological sealing referred to in literature (Ritter, et al, 1984; Miller, et al, 1985). NO<sub>3</sub> concentrations have been on the increase again since August 1999 in wells Gra-1, Gra-3, and Gra-7; however, no corresponding increase of Cl is noted prior to this NO<sub>3</sub> increase.

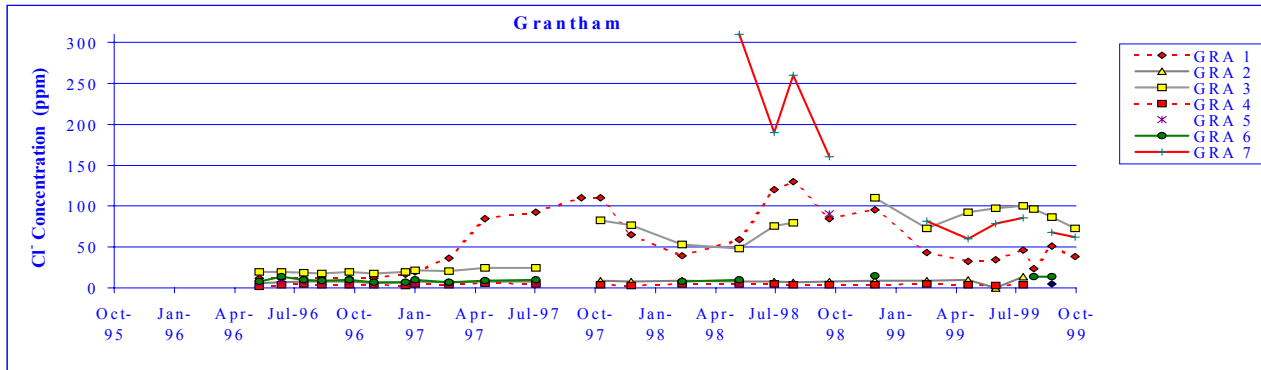
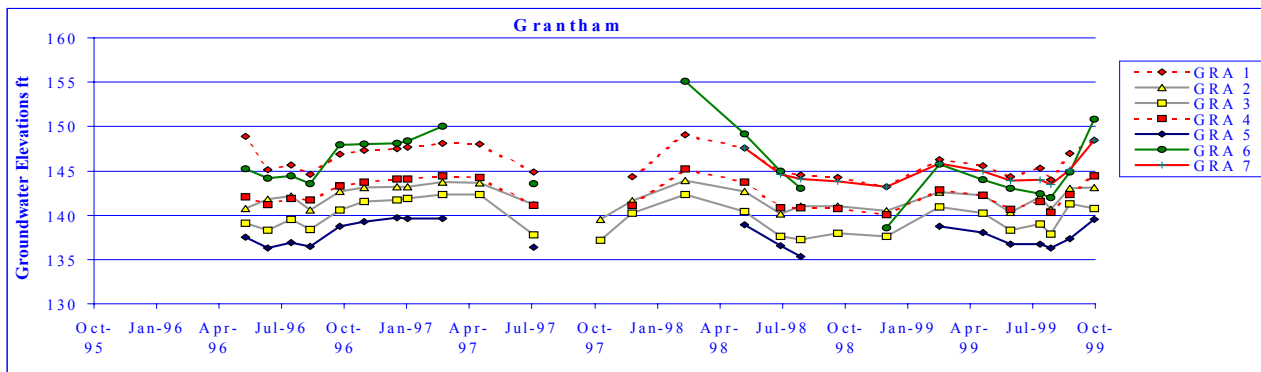
Figure 34 (2 of 2)

The changes observed in Gra-3 were strongest in December 1998. There was roughly a four or six month delay in both the rise in chloride concentration and the change in nitrogen chemistry and concentration between the two wells located 125 feet from the lagoon and the one located 250 feet from the lagoon. An estimation of ground water movement between wells Gra-1 and Gra-3 using constituent concentration changes as a marker shows movement of 125 feet in five months or 300 feet per year. Results of slug tests performed on Gra-1 estimate ground water movement at about 350 feet per year. Considering the rough estimation nature of both of these calculations, these results support each other.

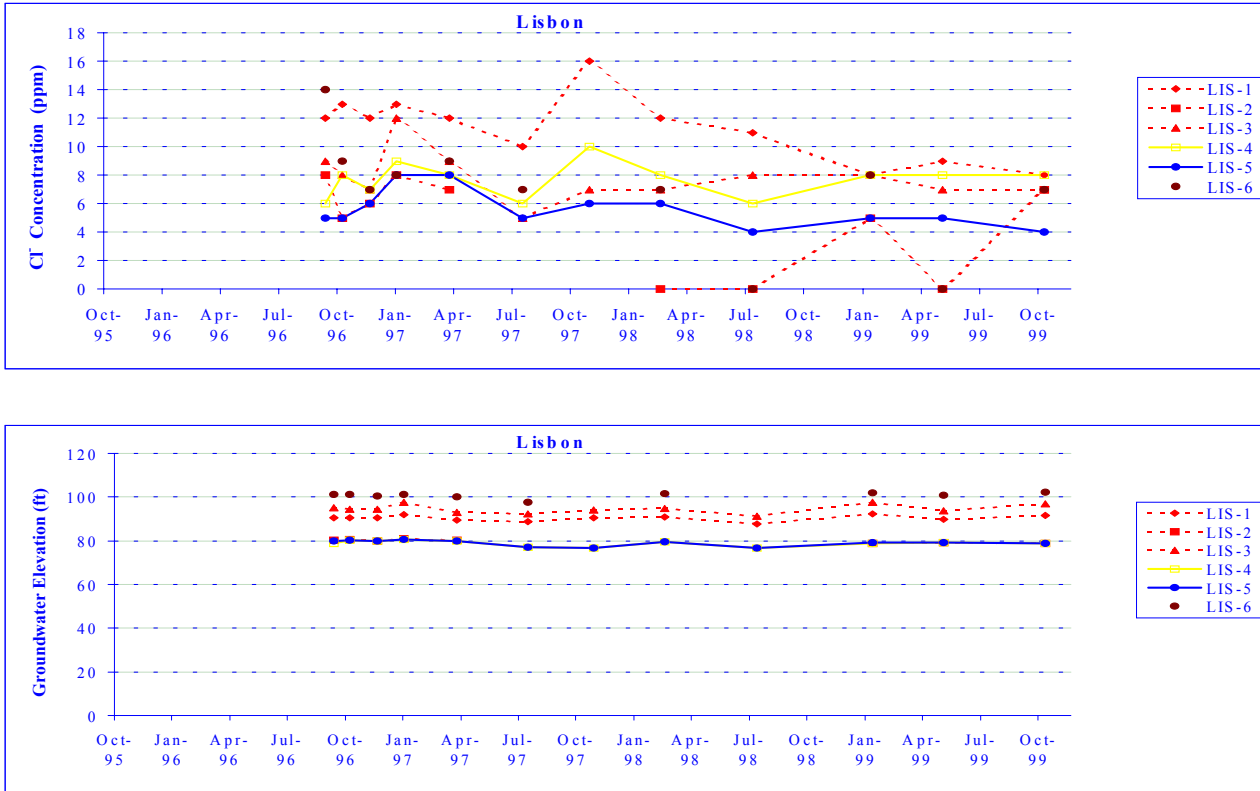
Figure 39 (2 of 2)

Monitoring wells at the site were sampled four additional times since the publication of the original report, and there have been no significant changes in analyte concentrations (fig. 39).

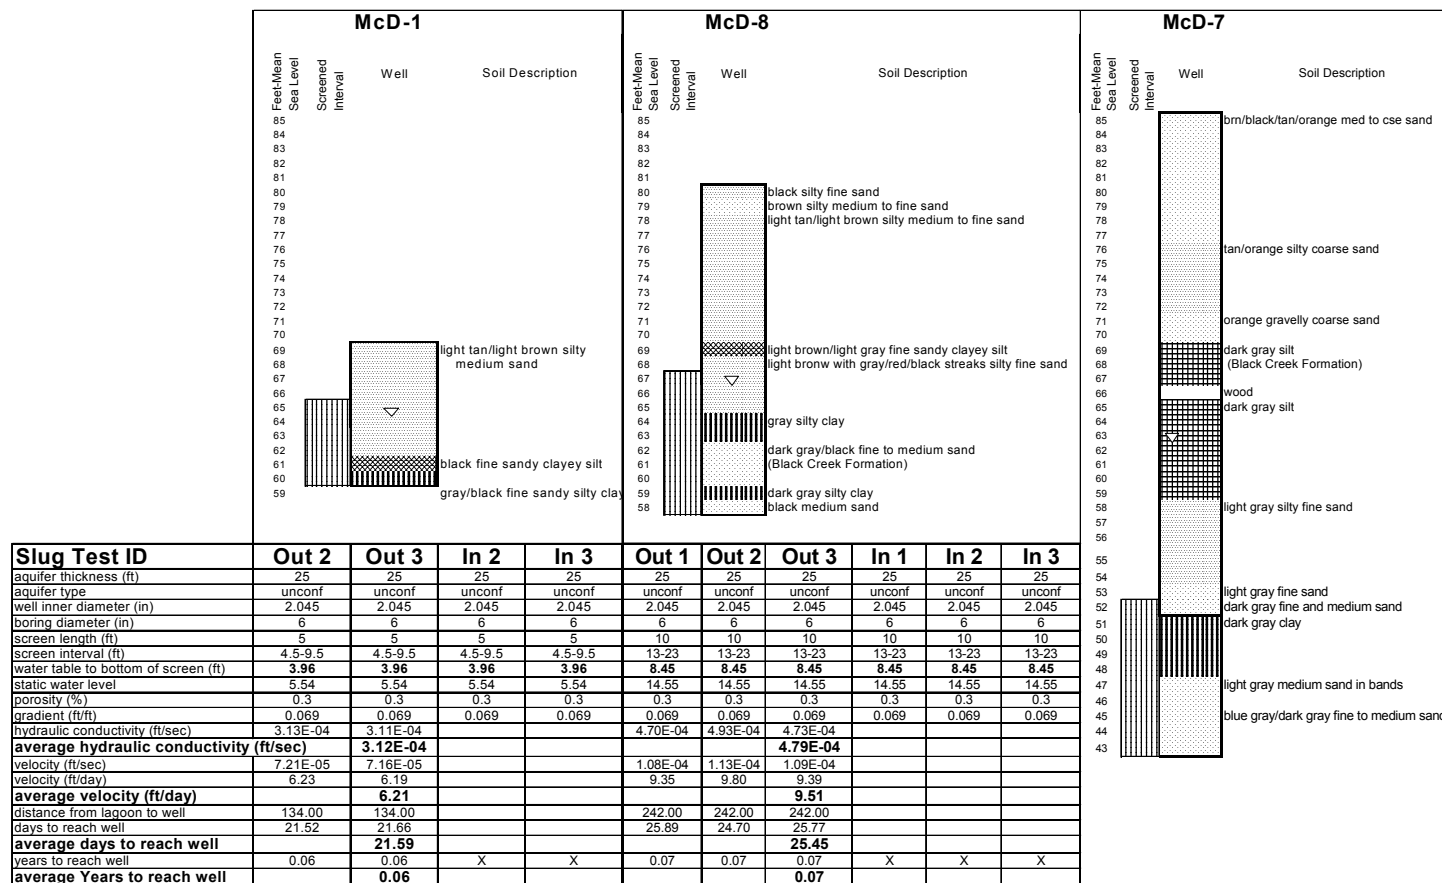
Figure 41

Due to the placement of wells and screened intervals, ground water flow and velocity cannot be determined at this site. During the time period covered in the original report, it was thought that wells McD-3, McD-4, McD-7 and McD-8 were screened in the same aquifer. It is demonstrated, however, that wells McD-3 and McD-7 are most likely screened in a deeper confined aquifer (fig. 42). Based on topography, ground water should be flowing from well McD-4 toward well McD-8 and the intermittent stream, which is most likely situated above the confining layer (fig. 40).

Lagoon seepage indicators have been detected in well McD-4 on a somewhat continuous basis. The ground water flow direction from well McD-4 would need to be determined and monitoring wells placed downgradient in the shallow aquifer to determine if seepage indicators are decreasing. Additional monitoring wells would also need to be placed to the west-northwest and the southeast of the lagoon to monitor shallow ground water before any determination could be made about whether ground water is being protected from lagoon leakage (fig. 40).
