# **IMPACT OF ANIMAL WASTE LAGOONS ON GROUND WATER QUALITY:**

**An Update on Data Collected from  
March 1998 through November 1999**

**Report of Groundwater Investigation Number 18**

**GROUNDWATER SECTION  
DIVISION OF WATER QUALITY**

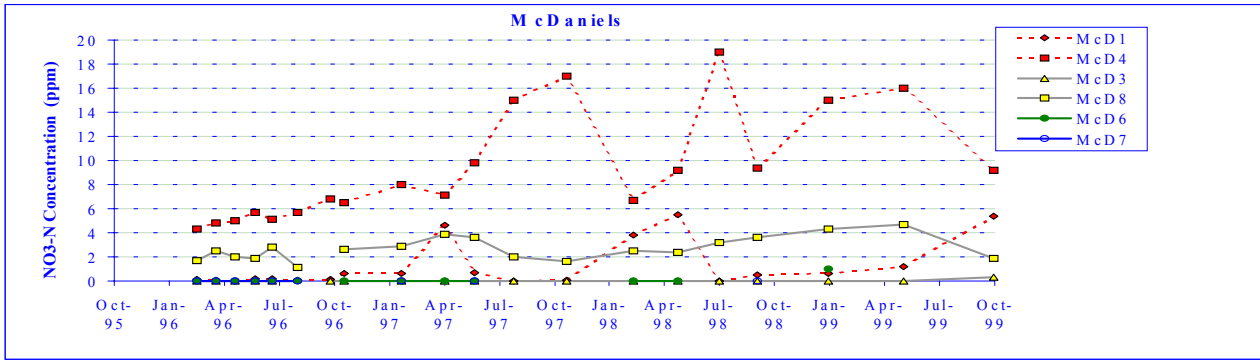
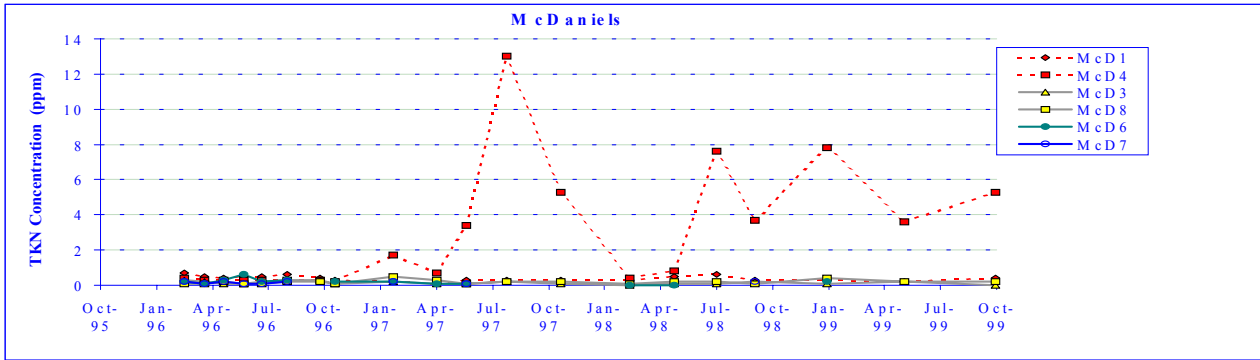
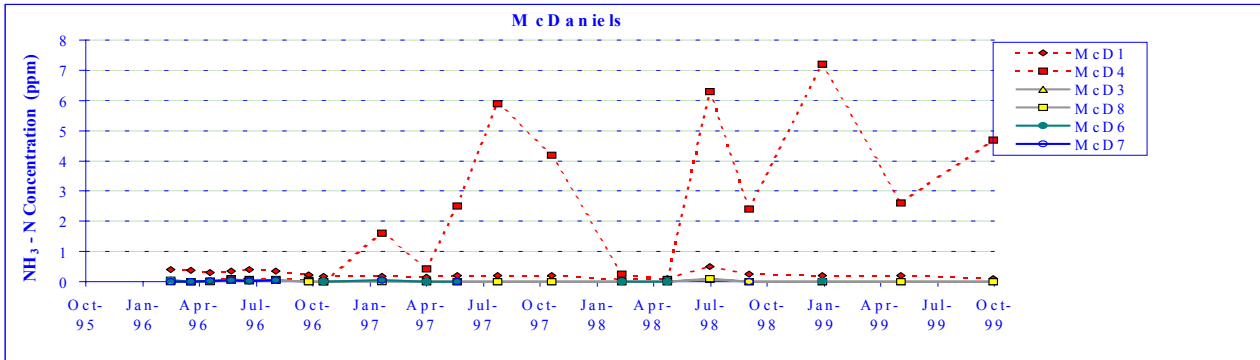
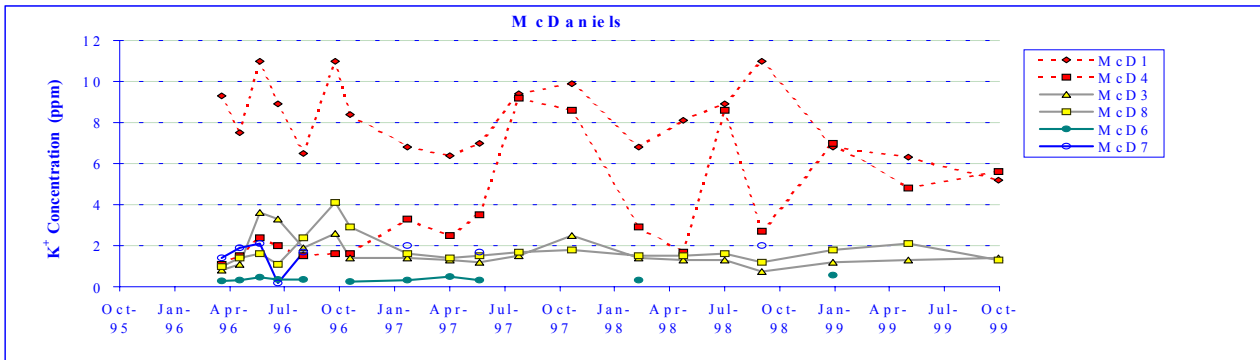
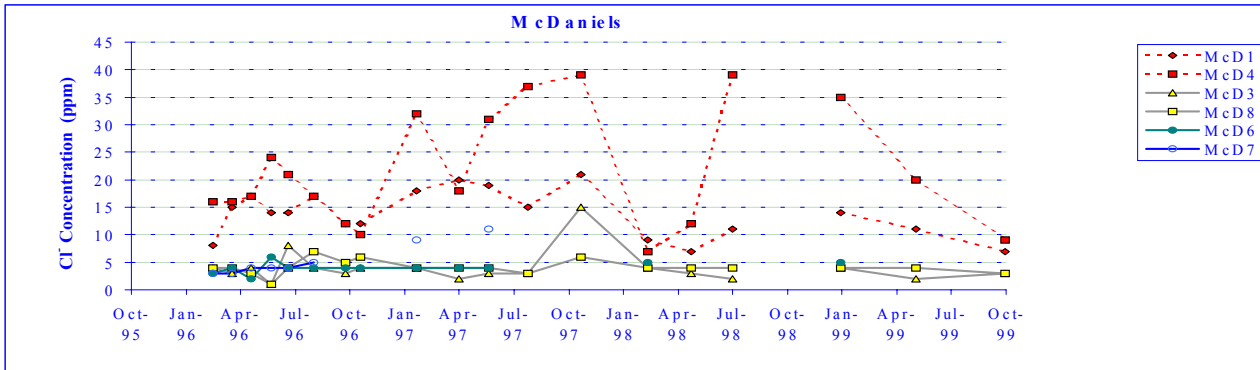
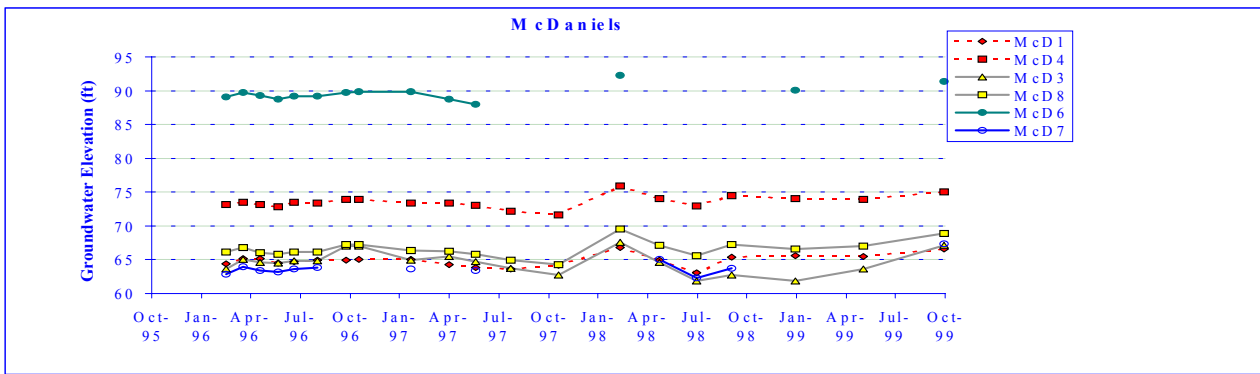
Figure 44 (1 of 2)

Monitoring wells at this site were sampled five additional times since the publication of the original report (fig. 44). NO<sub>3</sub> concentrations were exceeding state ground water standards in well McD-4 at the time the original report was published. These concentrations have been cyclical since then. Concentrations of Cl have also exhibited this trend during the same time period in well McD-4.

Lagoon seepage indicators have been detected in well McD-4 on a somewhat continuous basis. The ground water flow direction from well McD-4 would need to be determined and monitoring wells placed downgradient in the shallow aquifer to determine if seepage indicators are decreasing. Additional monitoring wells would also need to be placed to the west-northwest and the southeast of the lagoon to monitor shallow ground water before any determination could be made about whether ground water is being protected from lagoon leakage (fig. 40).

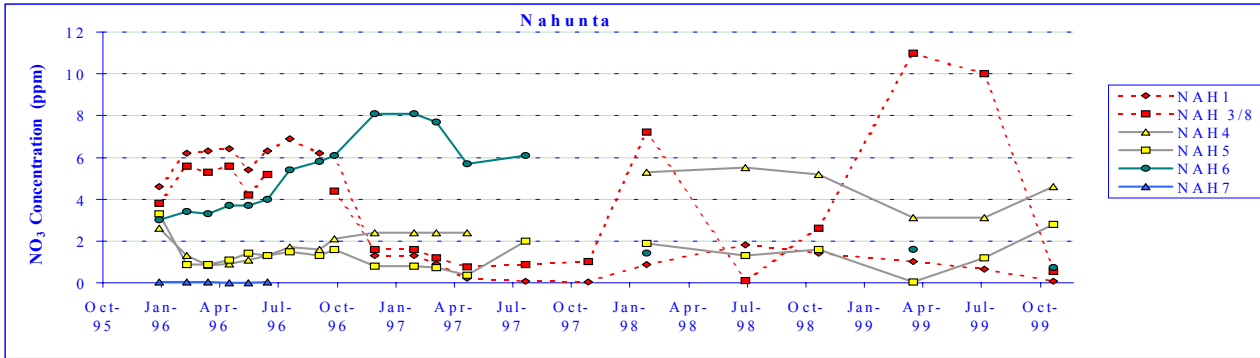
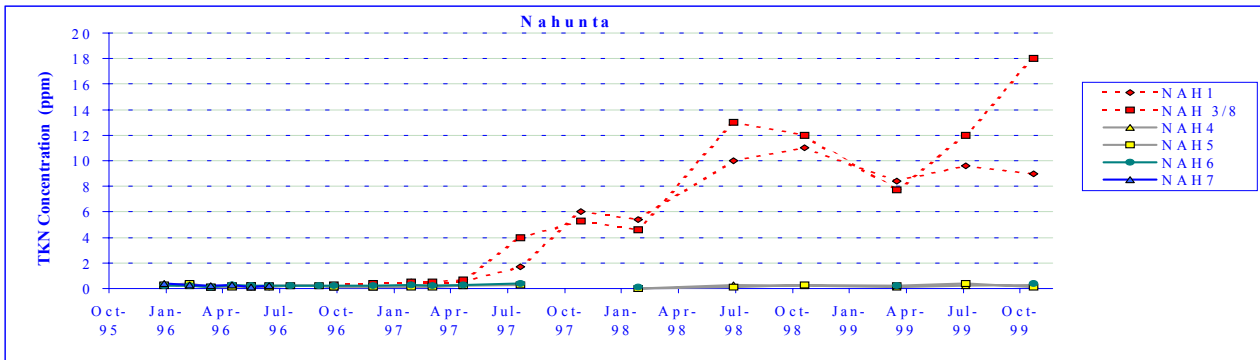
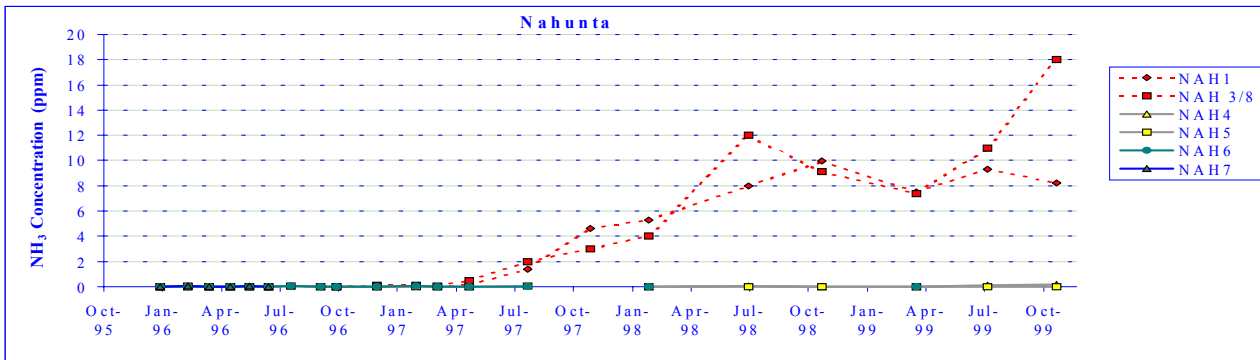
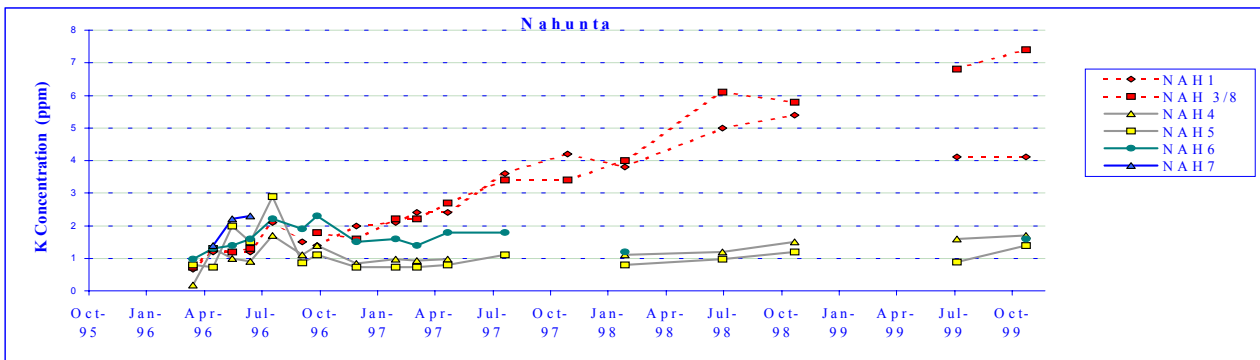
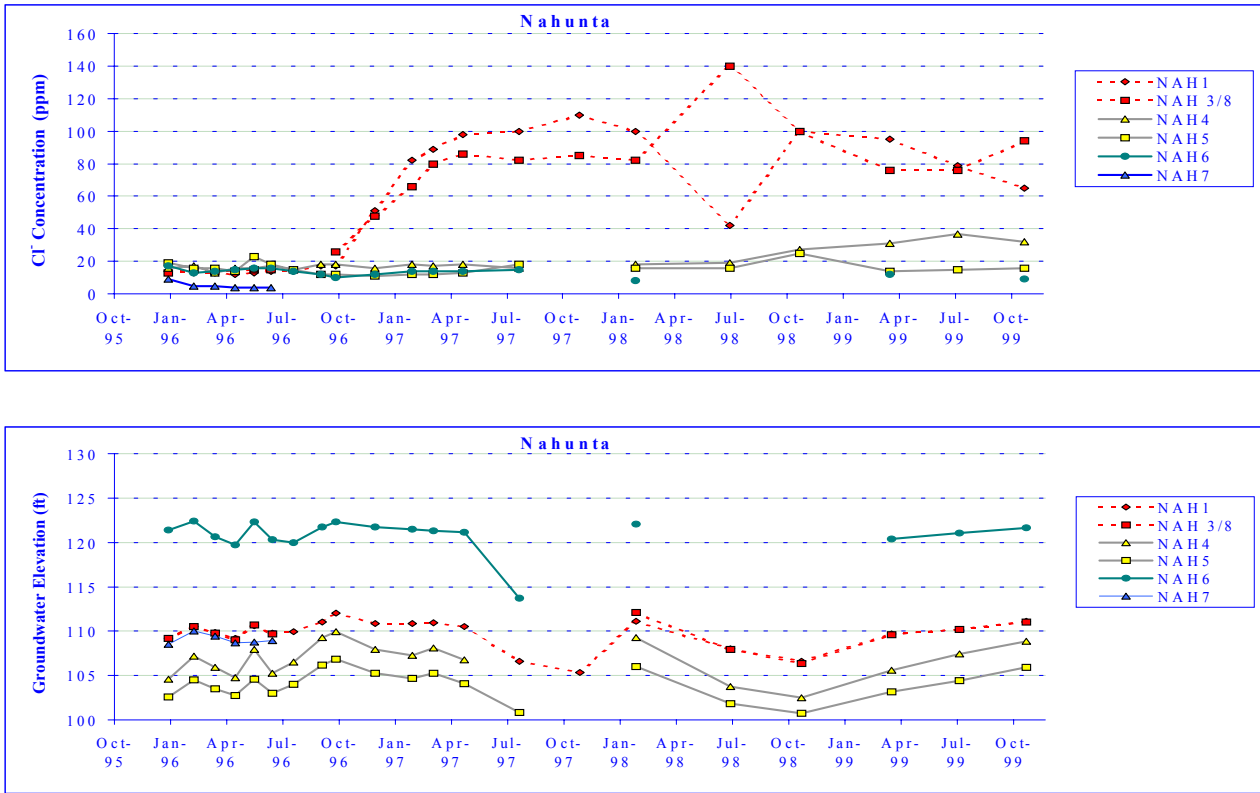
Figure 49 (1 of 2)

Monitoring wells at this site were sampled five additional times since the publication of the original report (fig. 49). Well Nah-8 was installed in October 1996 to replace Nah-3, which was damaged by farm machinery.

The concentrations of Cl and K began rising in wells Nah-1 and Nah-8 in October 1996. Cl and K are typically the first constituents to reach a well being impacted by lagoon seepage. During the February 1997 sampling, an accidental surface discharge of lagoon liquid was discovered, as it had become severe enough to be flooding the area surrounding these two wells. The leak was quickly repaired, but the lagoon liquid infiltrated the ground water and impacted the wells in a similar fashion to a seepage plume. As is typical with lagoon liquid impacting ground water, NO<sub>3</sub>-N rose then fell as the anaerobic front of the plume reached the wells. During that time, NH<sub>3</sub> and TKN – the reduced forms of nitrogen – continued to rise. After the plume passed, levels of NH<sub>3</sub> and TKN began to fall along with levels of Cl and K. As oxidizing conditions were restored, nitrate (the oxidized form of nitrogen) concentrations again rose. The event seemed to have passed by summer 1999, but none of the levels had returned to background levels. This event, although typical in its effects on impacted wells was rather small in size and duration and did not produce constituent levels above state ground water standards in the impacted wells.

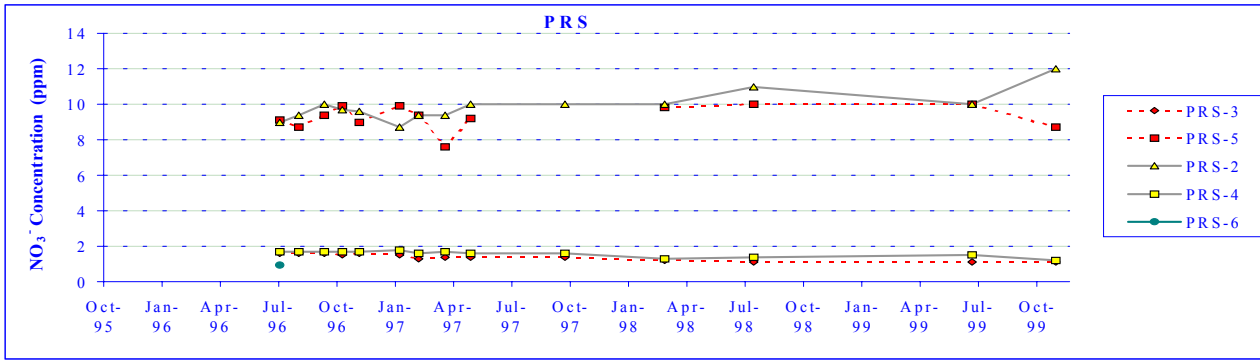
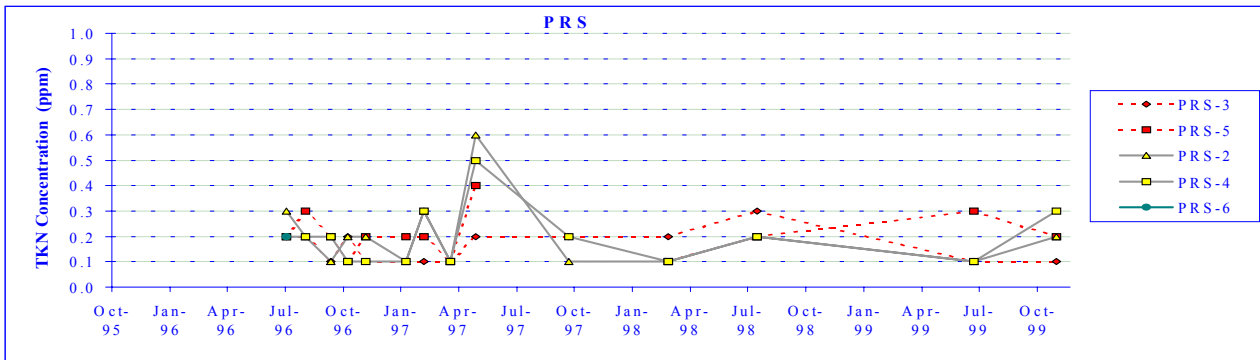
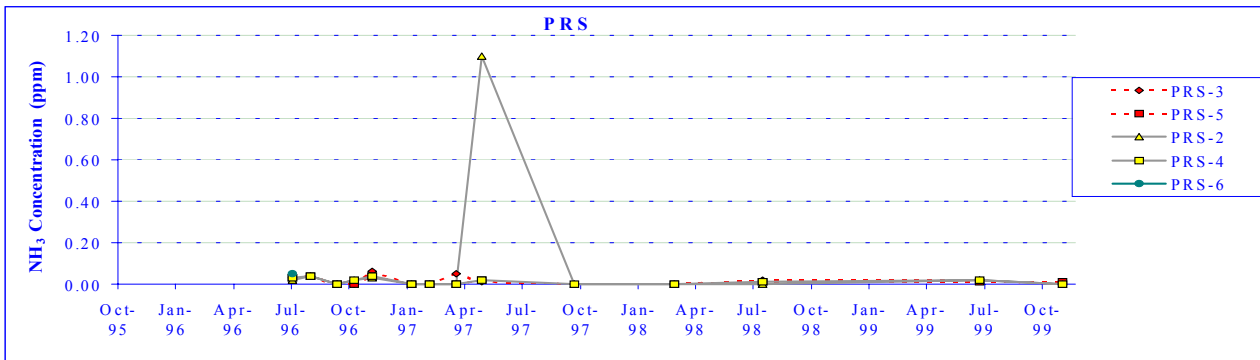
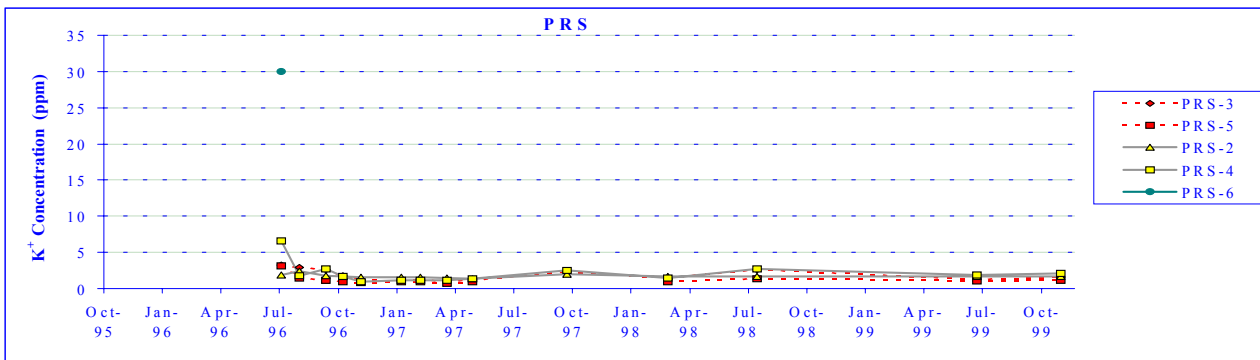
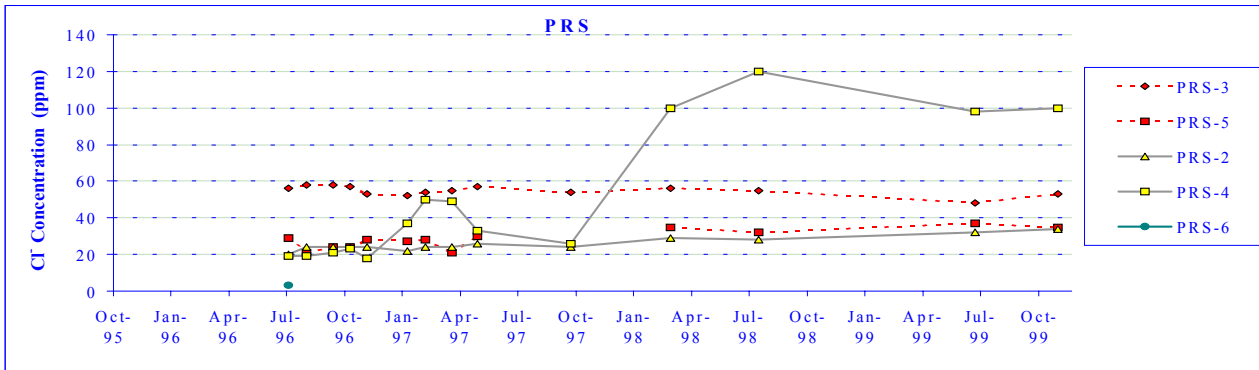
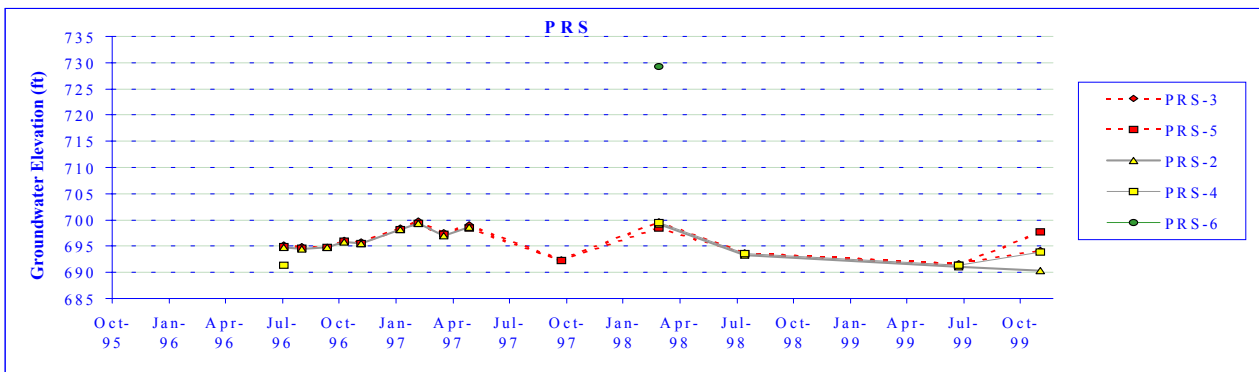
Fig 54 (1 of 2)

Monitoring wells at this site were sampled three additional times since publication of the original report, and there have been no significant changes in analyte concentrations with the exception of Cl in well PRS-4 (fig. 54). Cl concentrations increased to 120 parts per million in July 1998 and then started a slow decrease. The state ground water standard for Cl is 250 ppm. Well PRS-3 showed no increase in Cl concentrations during this time, so it is unlikely that the lagoon is the source of Cl in well PRS-4 as both are drawing water from the same sand unit as shown in the boring logs (fig. 52). Due to the characteristics of the regolith in the Piedmont, however, it is possible that Cl could travel from the lagoon to well PRS-4 without impacting well PRS-3. In the original report, the continued elevated concentrations of NO<sub>3</sub> in well PRS-2 and PRS-5 were attributed to grazing of cattle in the fields where the wells were installed; the lagoon was not suspected because no other seepage indicators were detected in the wells.

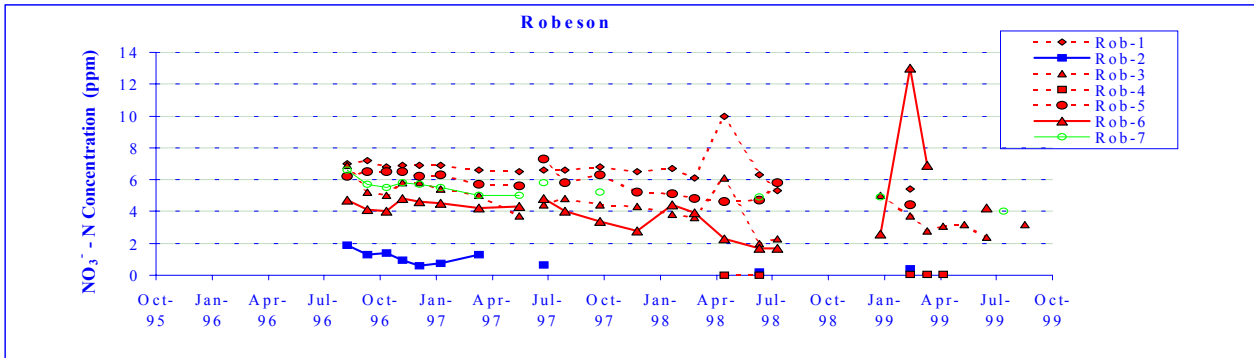
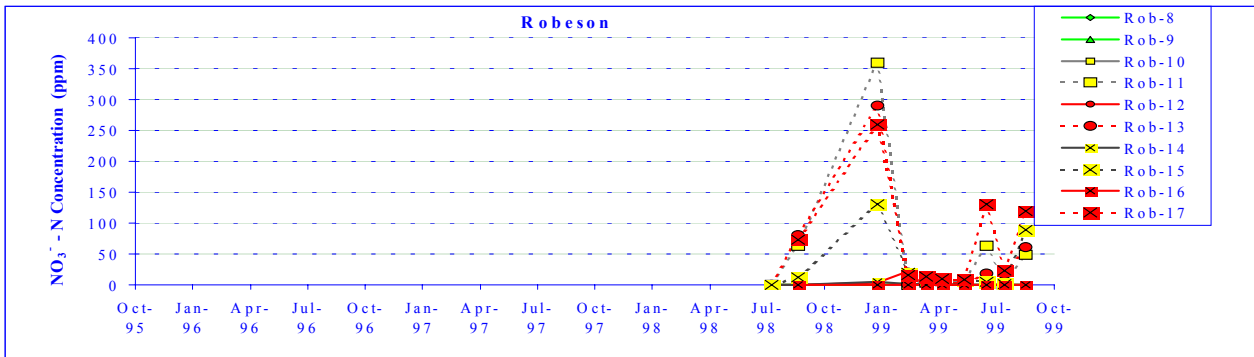
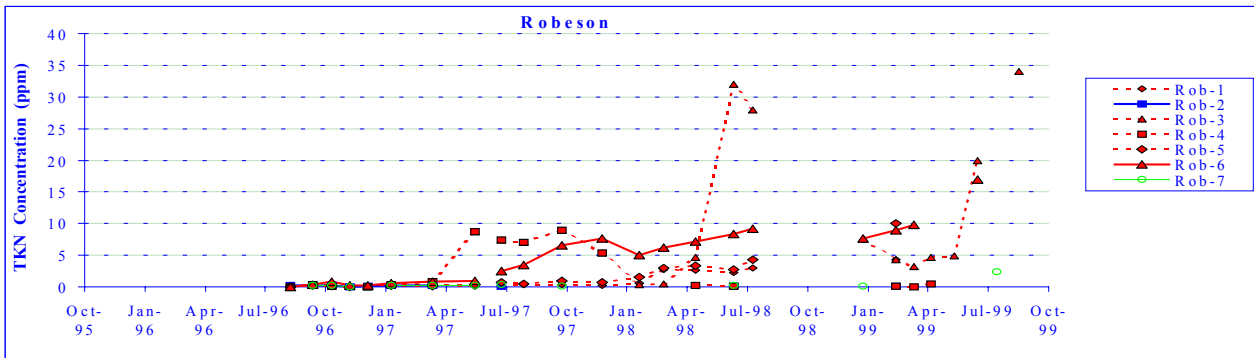
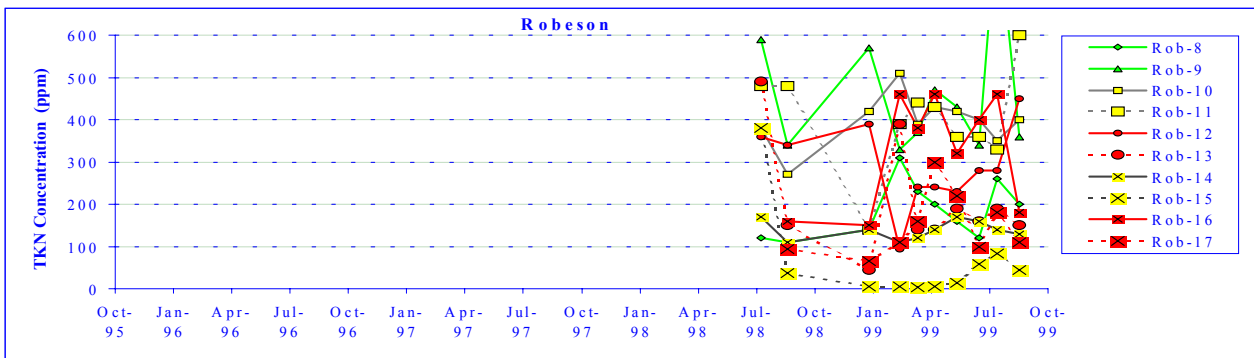
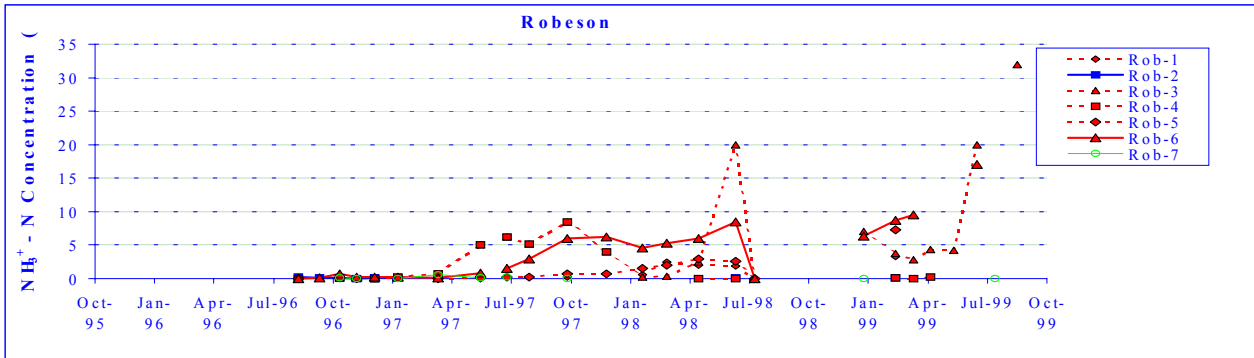
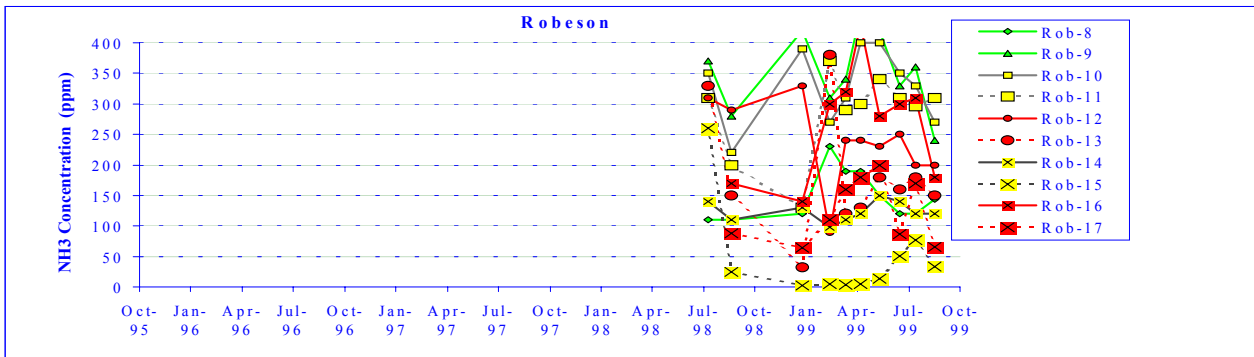
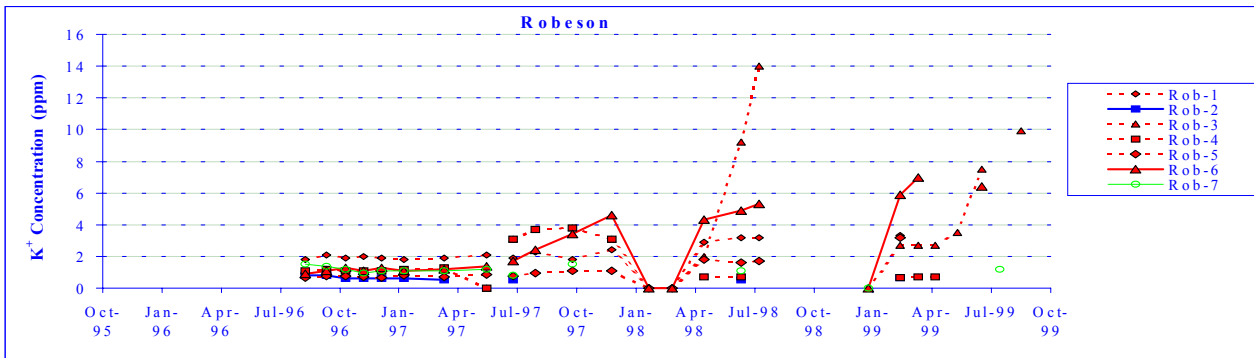
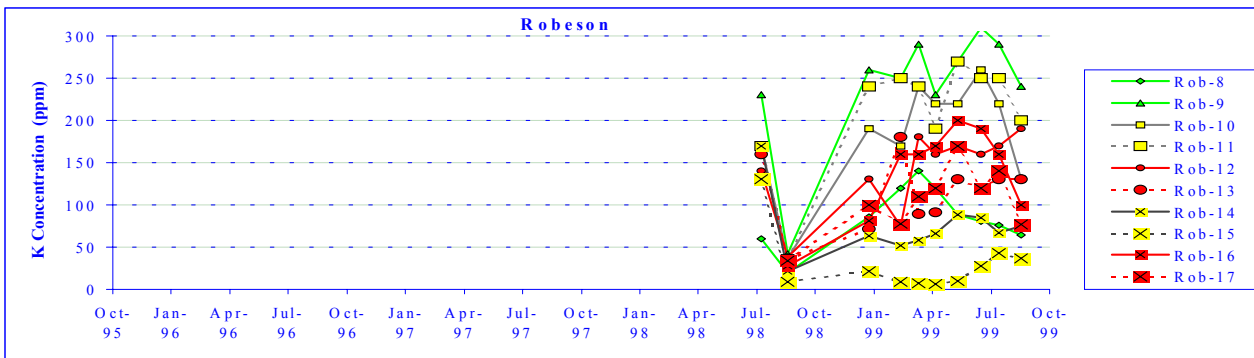
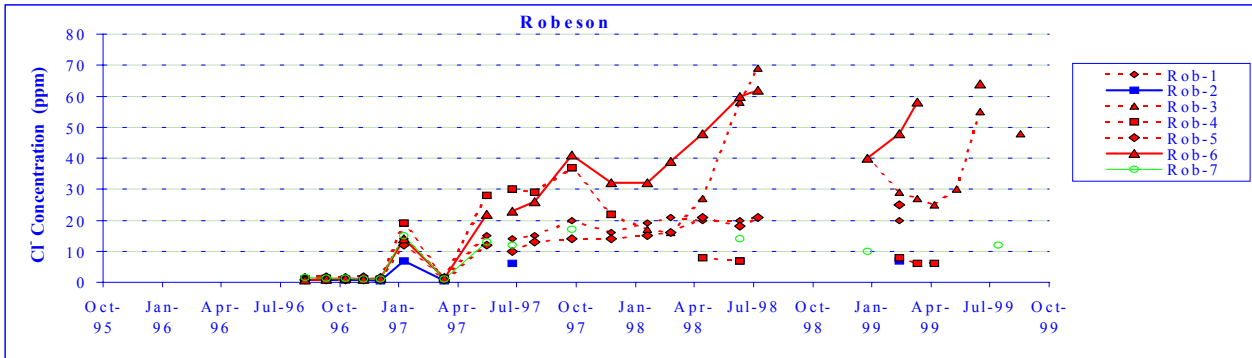
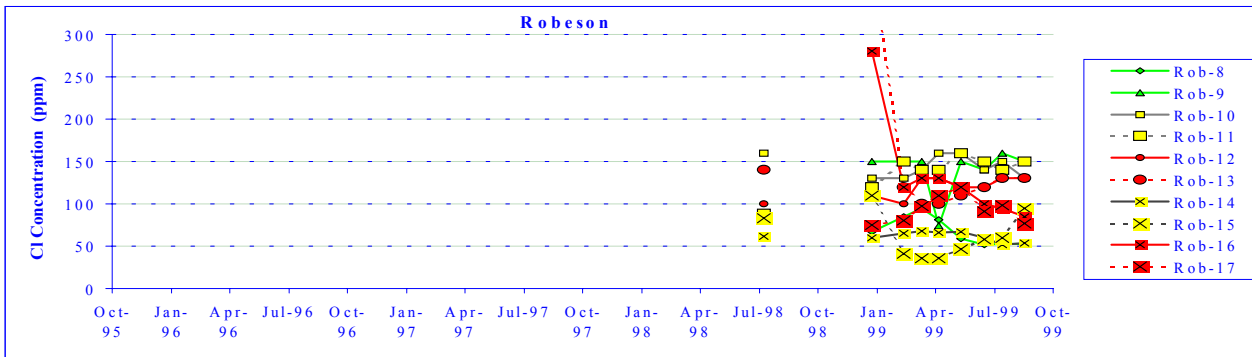
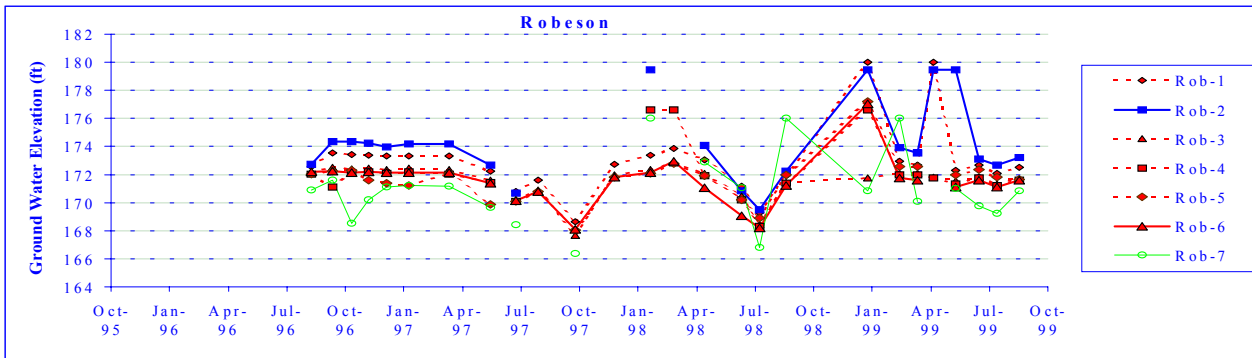
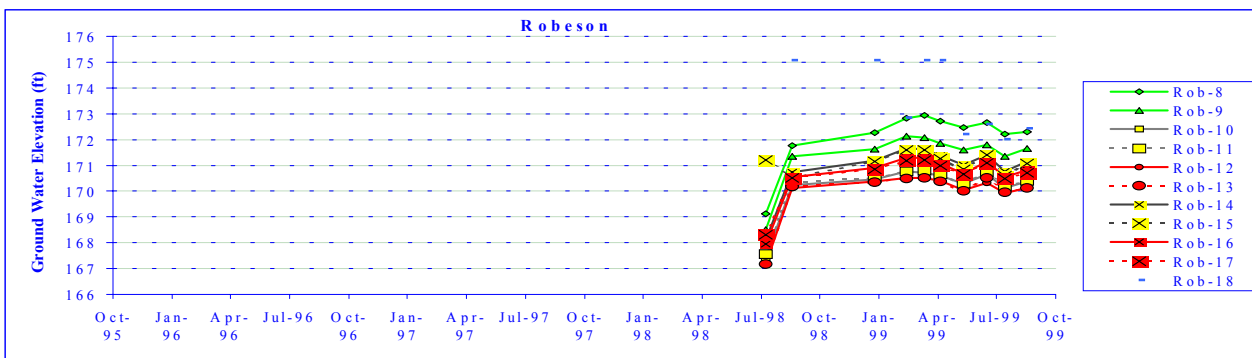
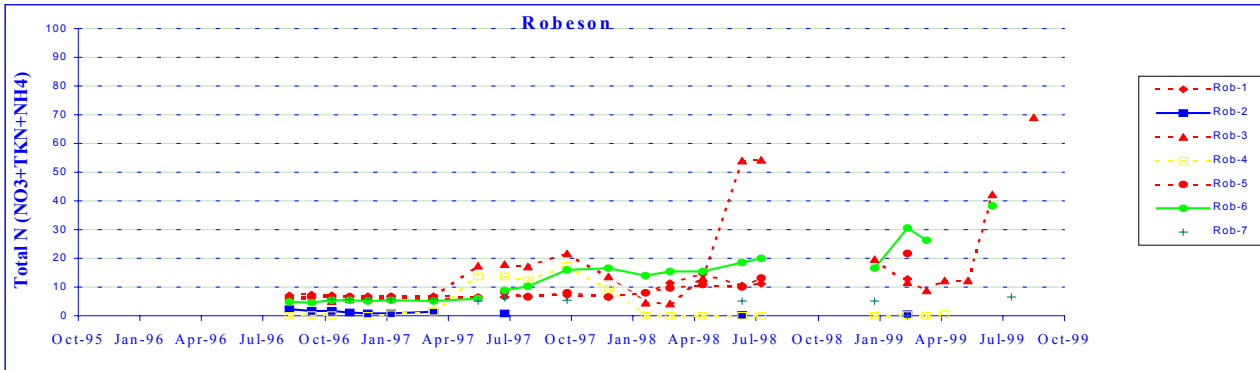
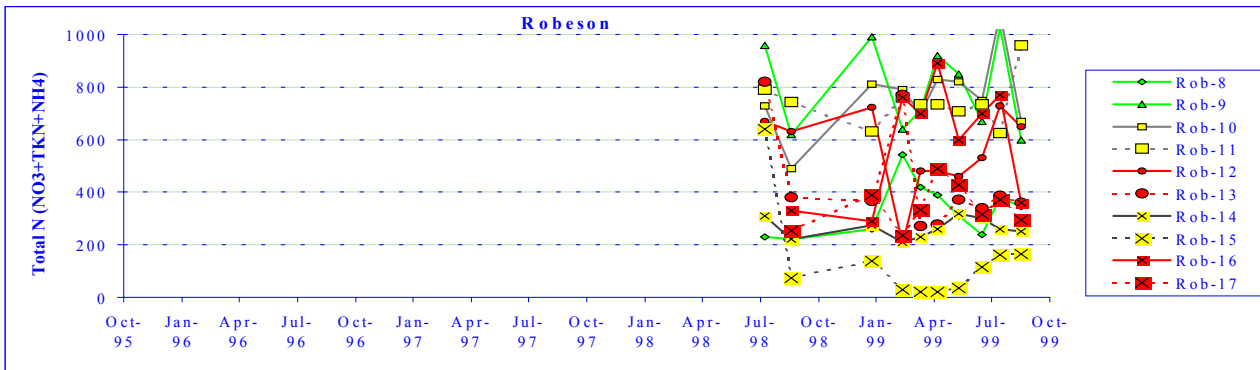
Figure 59 (1 of 4)

There have been 10 sampling events at this site since publication of the original report in June 1998 (fig. 59). Minor elevations of seepage indicators were detected in wells Rob-1 – Rob-6; however, major contaminant concentrations of TKN, NH<sub>3</sub> and K were consistently detected in most of the monitoring wells installed in the EM-detected plume. NO<sub>3</sub>-N spiked in January, July and August 1999 in these newer wells.

Results generally indicate that the shallower wells were affected by oxidizing conditions as evidenced by high nitrate values. Seasonal variations in rainfall led to dilution and less oxidizing conditions in shallow wells during winter. Grab samples were taken from the stream located downgradient from the lagoon on August 31, 1999, and no seepage indicators were detected.

Contaminants from the lagoon are leaking into the ground water, and North Carolina ground water standards are being exceeded 250 feet from the lagoon. EM surveys detected the presence of the ground water contaminant plumes originating from this lagoon, and these surveys were successfully used to place additional monitoring wells to measure contaminant concentrations at this site.
