Impact of Animal Waste Lagoons on Ground Water Quality

Section 319, Clean Water Act
Grant Year, FY 94
Final Report

Division of Water Quality, Groundwater Section
June, 1998

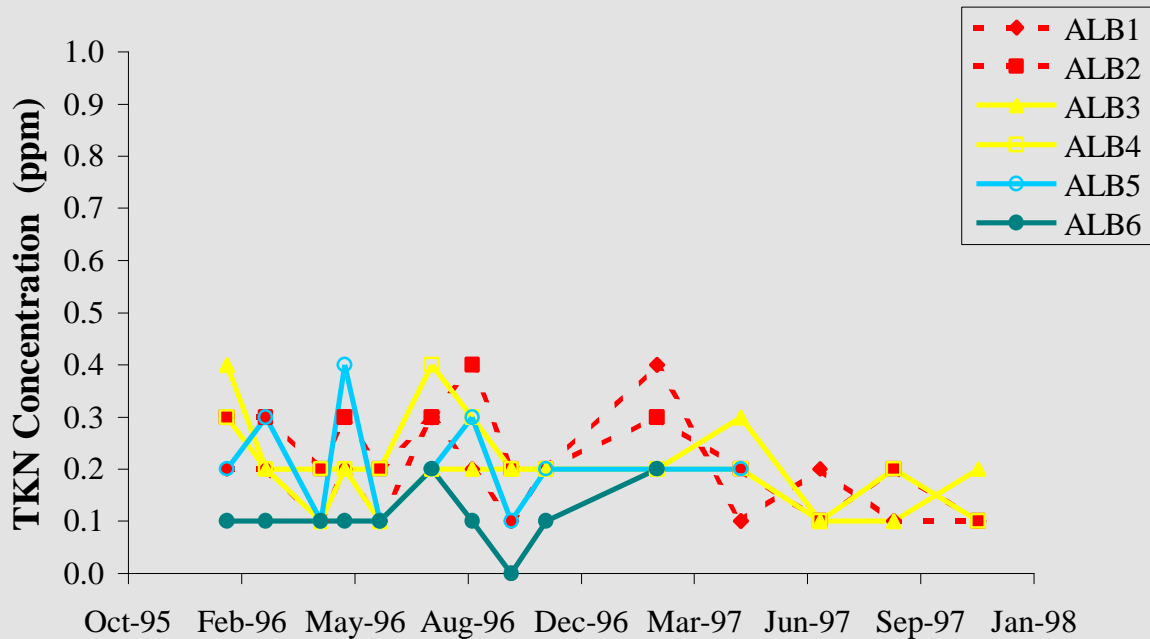
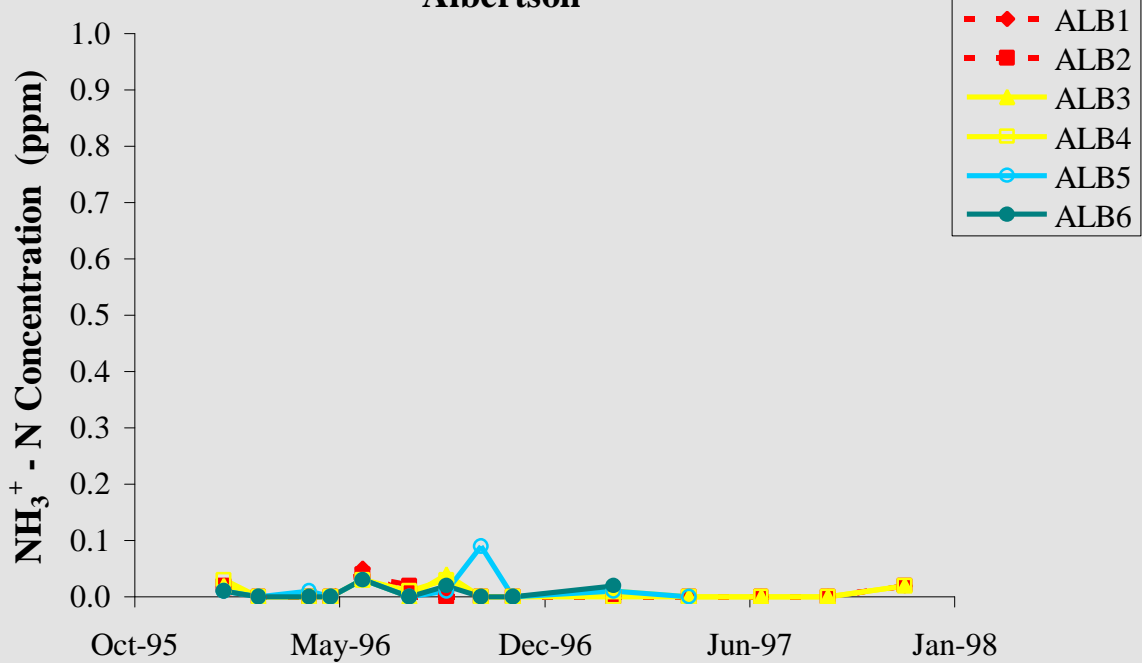
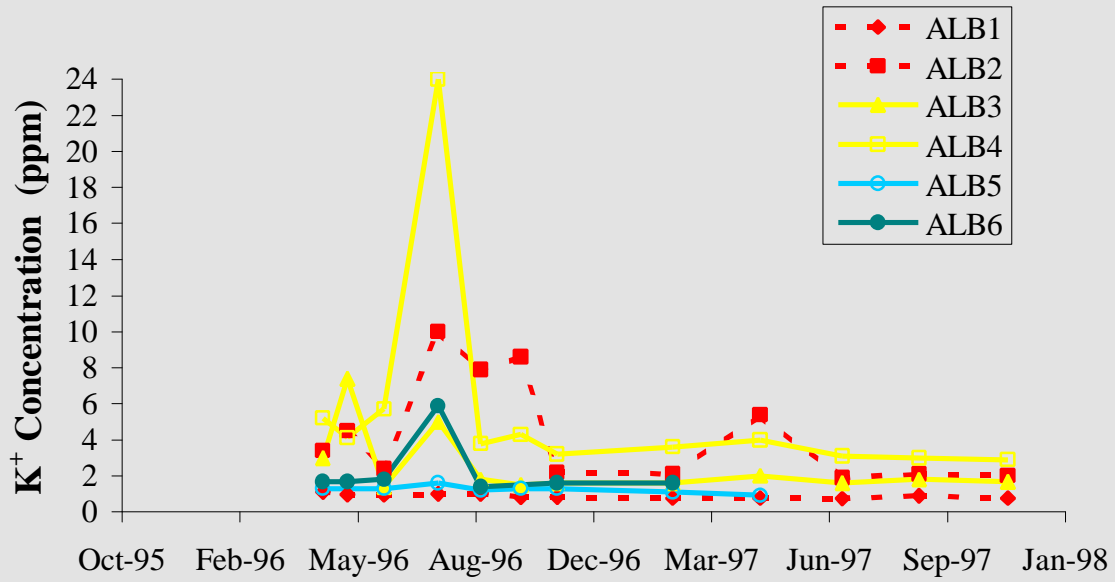
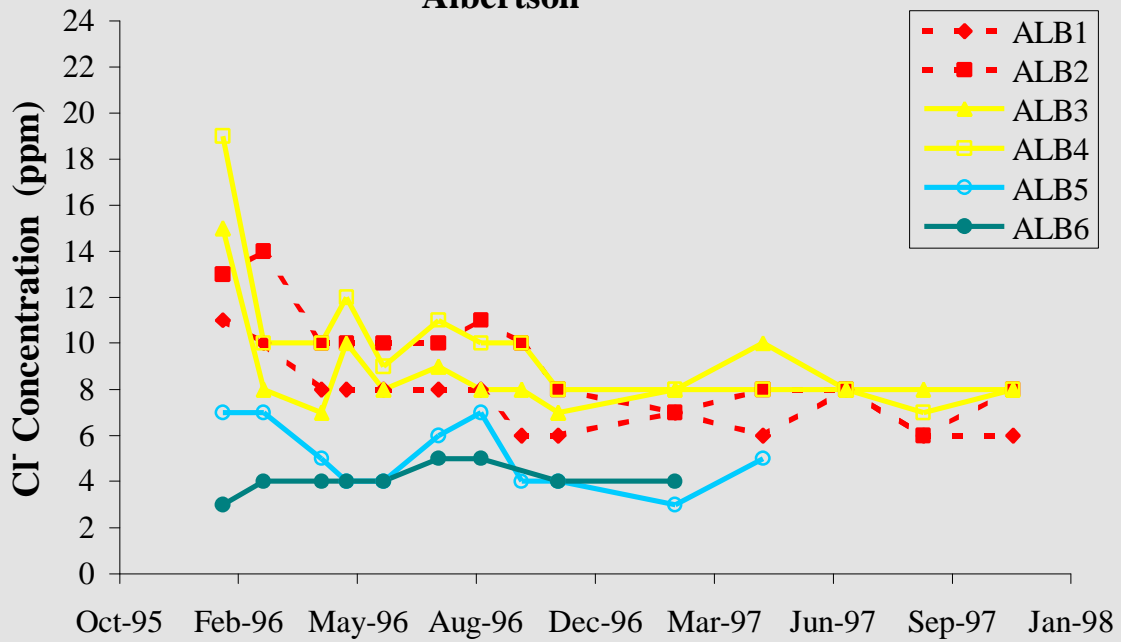
None of the seepage indicators except for nitrate-nitrogen were found in the wells at Albertson at concentrations that indicate lagoon seepage has occurred. The presence of nitrate in ground water at this site appears to be related to previous agricultural activities rather than the lagoon because the concentration levels were relatively consistent from the first sampling event through the first 18 months of the study. Also, no other seepage indicators were present in the ground water samples. In order to form conclusions about the potential for lagoon seepage to contaminate ground water, sufficient time must be allowed for movement of ground water beneath the lagoon to the monitoring wells.

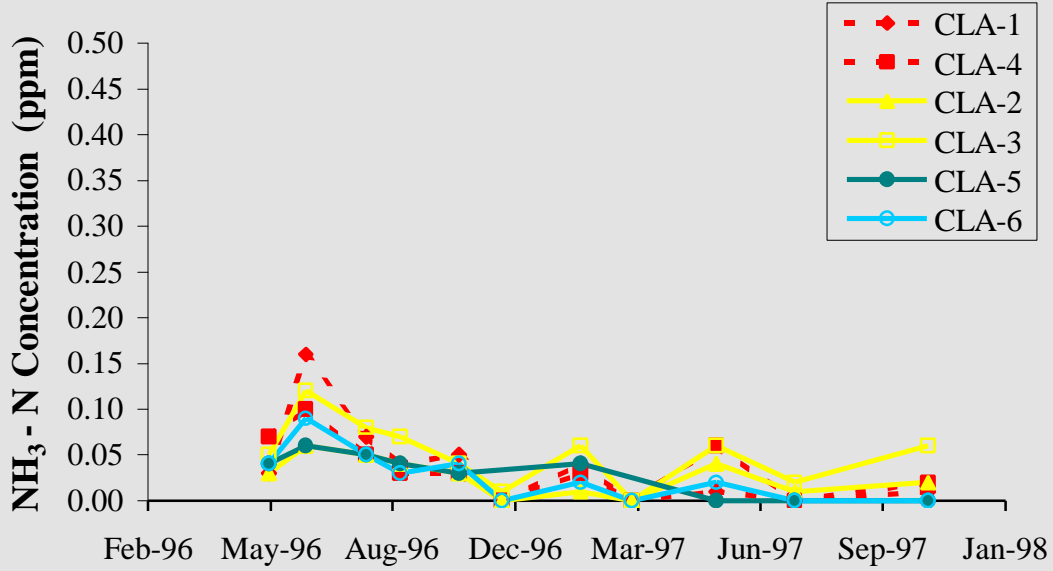
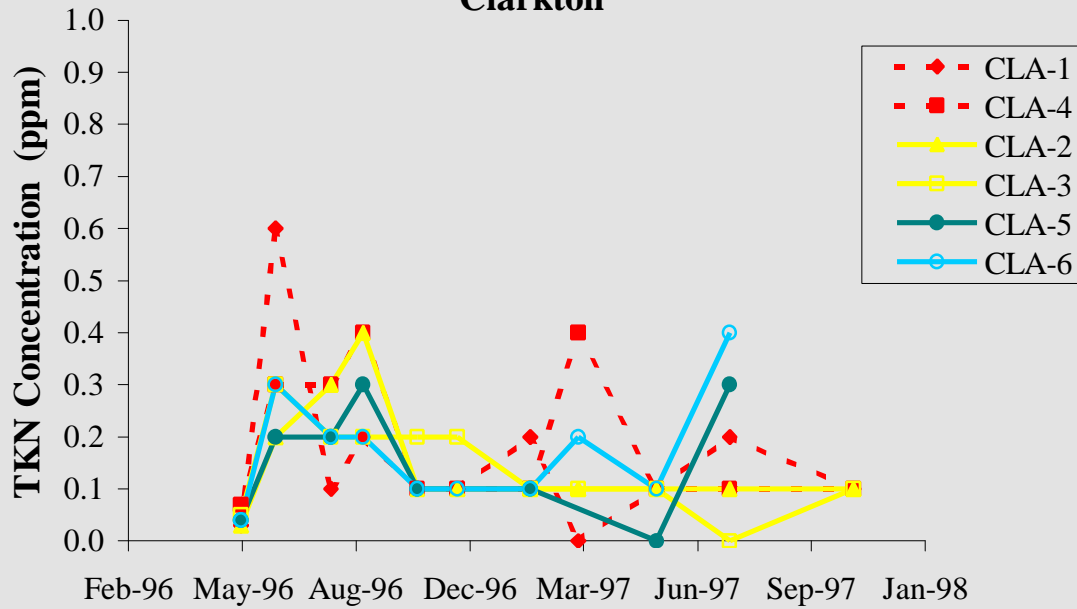
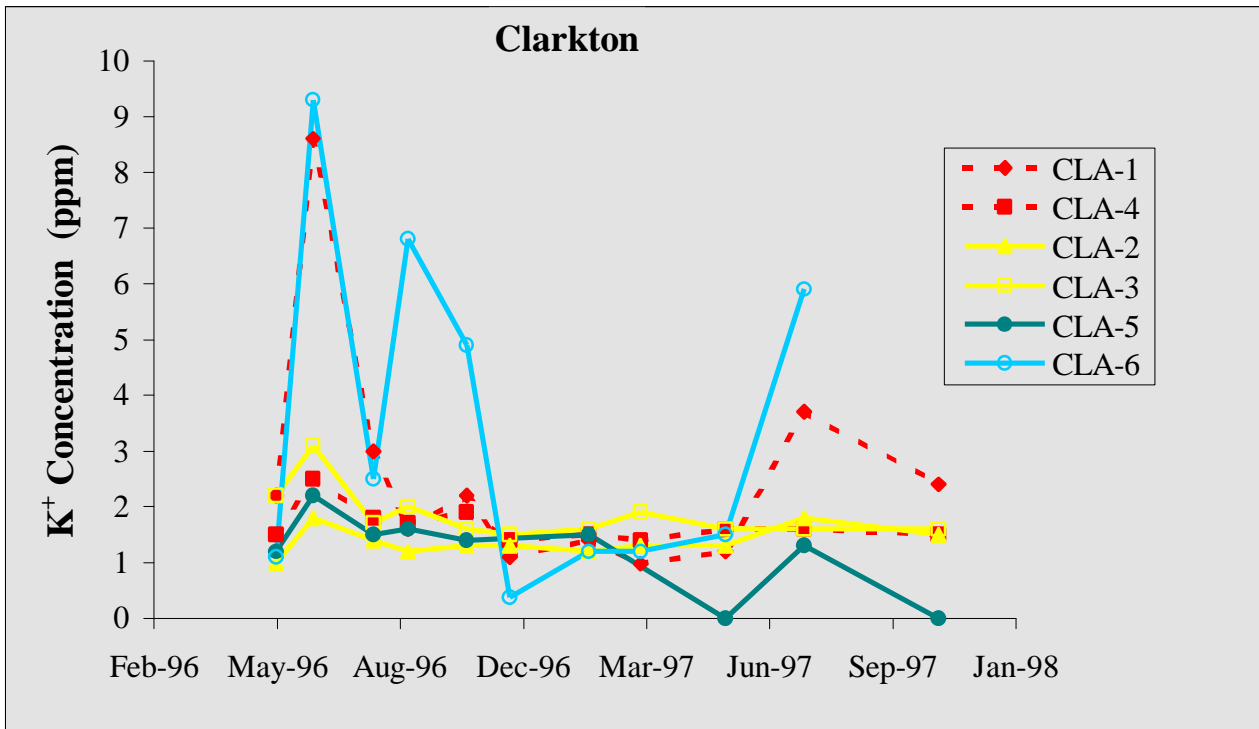
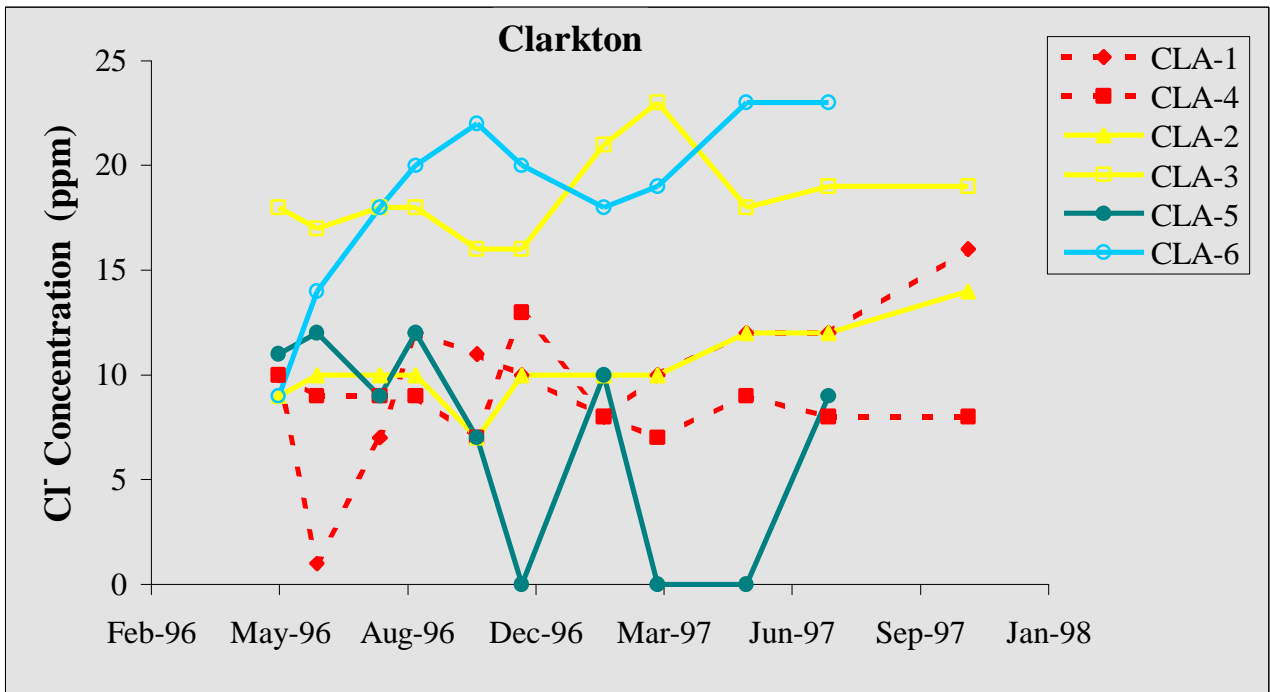
None of the indicators of lagoon seepage were consistently found in the four downgradient wells at Clarkton. The upgradient well, CLA-6, does show an increasing trend of both nitrate-nitrogen and chloride concentrations. These increasing trends may be the result of influence of the spray irrigation practices. This well was sited near spray irrigation activities because there was no other location suitable to the cooperator.

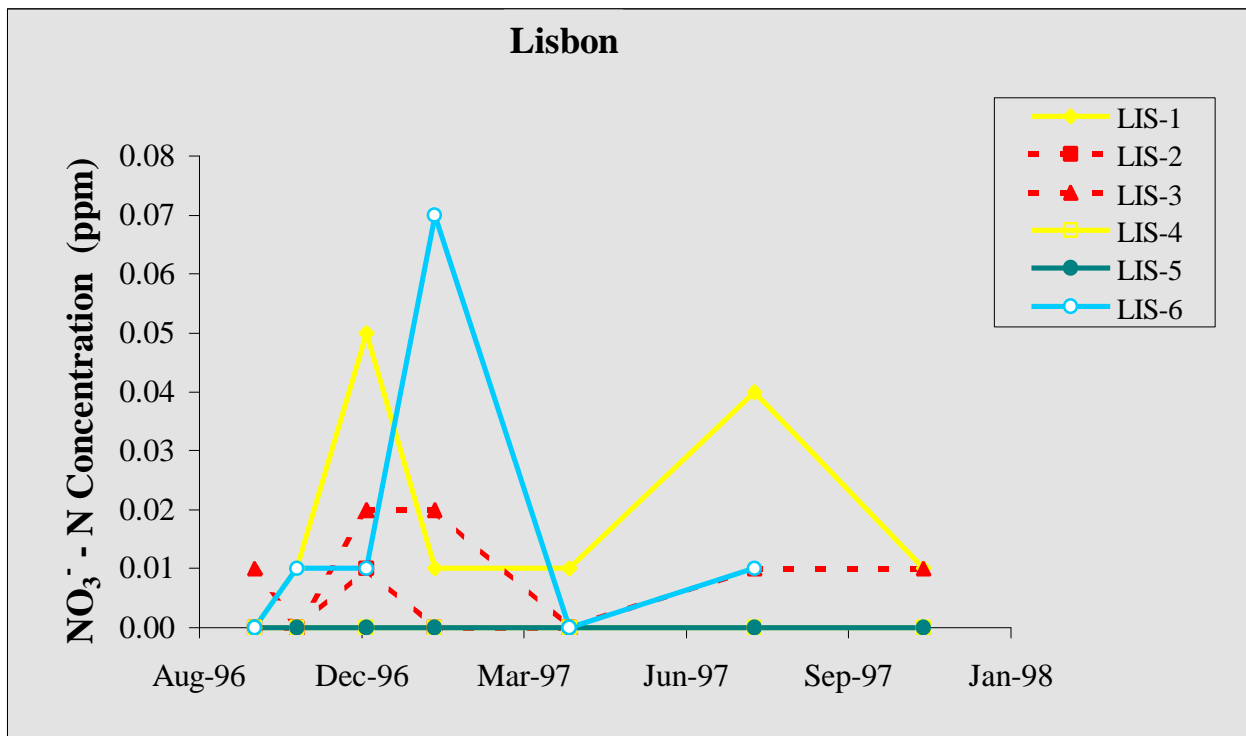
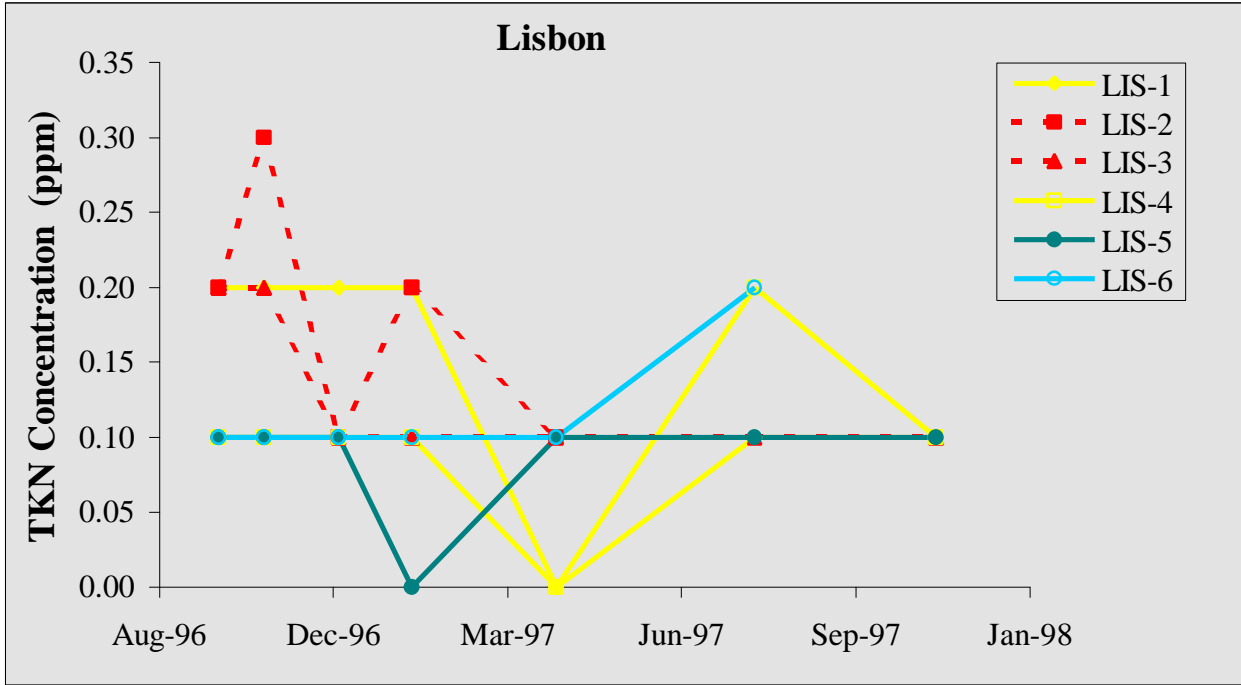
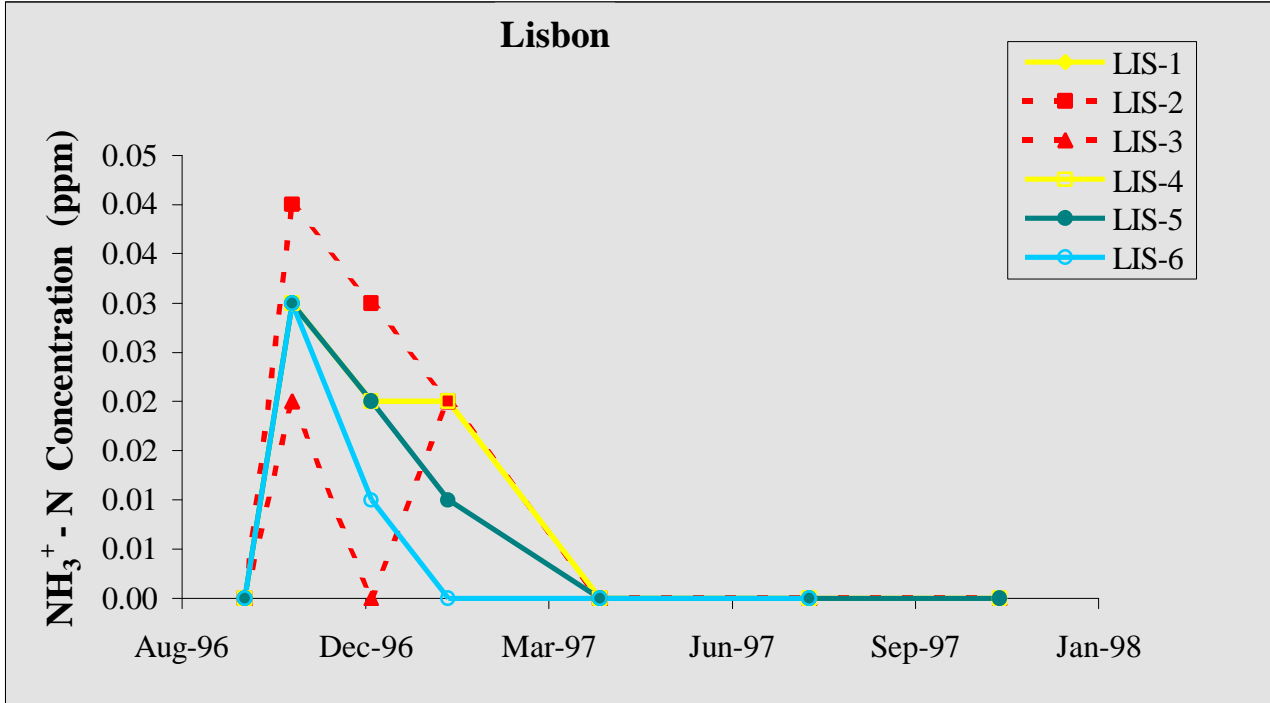
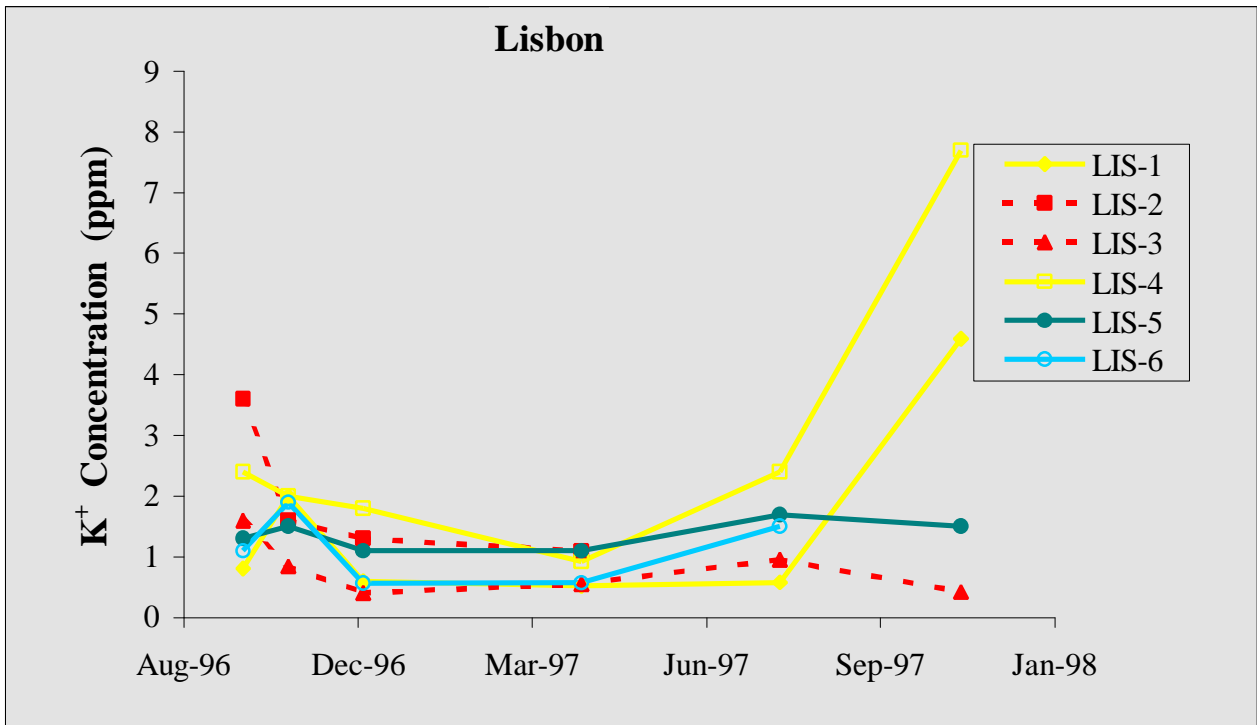
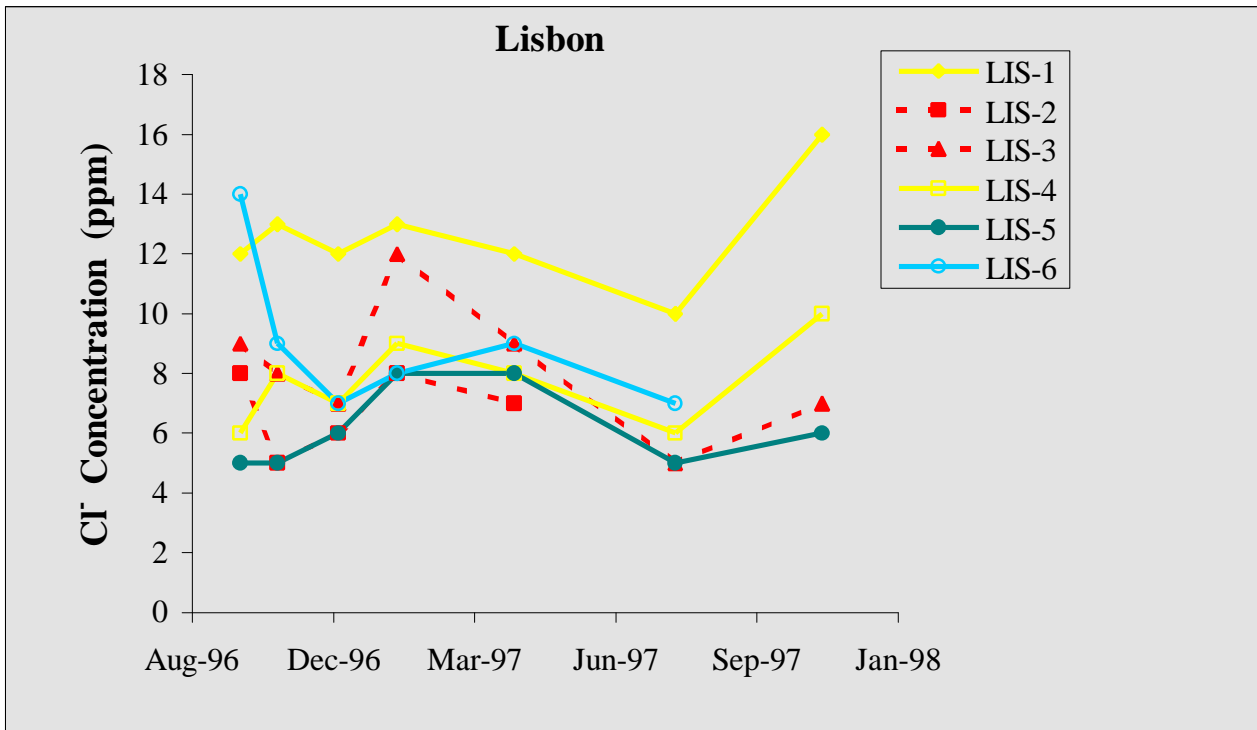
None of the seepage indicators were consistently found in the wells at Lisbon at concentrations that indicate any lagoon seepage. In order to form conclusions about the potential for lagoon seepage to contaminate ground water, sufficient time must be allowed for movement of ground water beneath the lagoon to the monitoring wells.

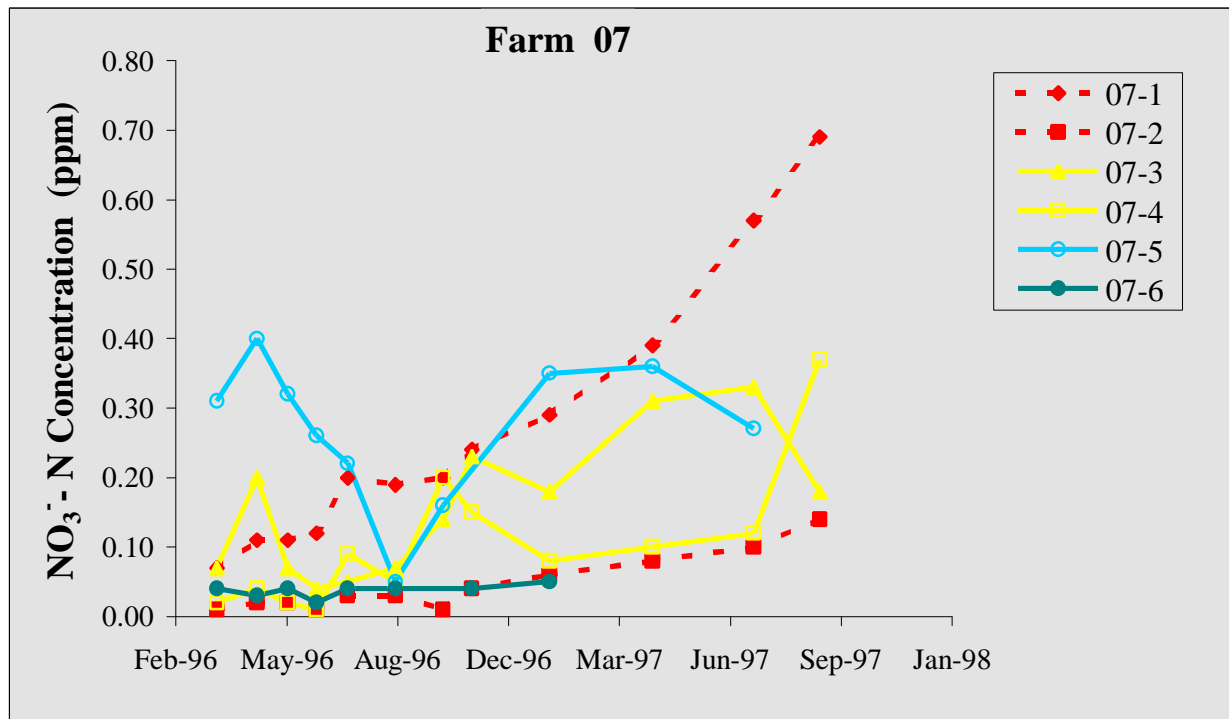
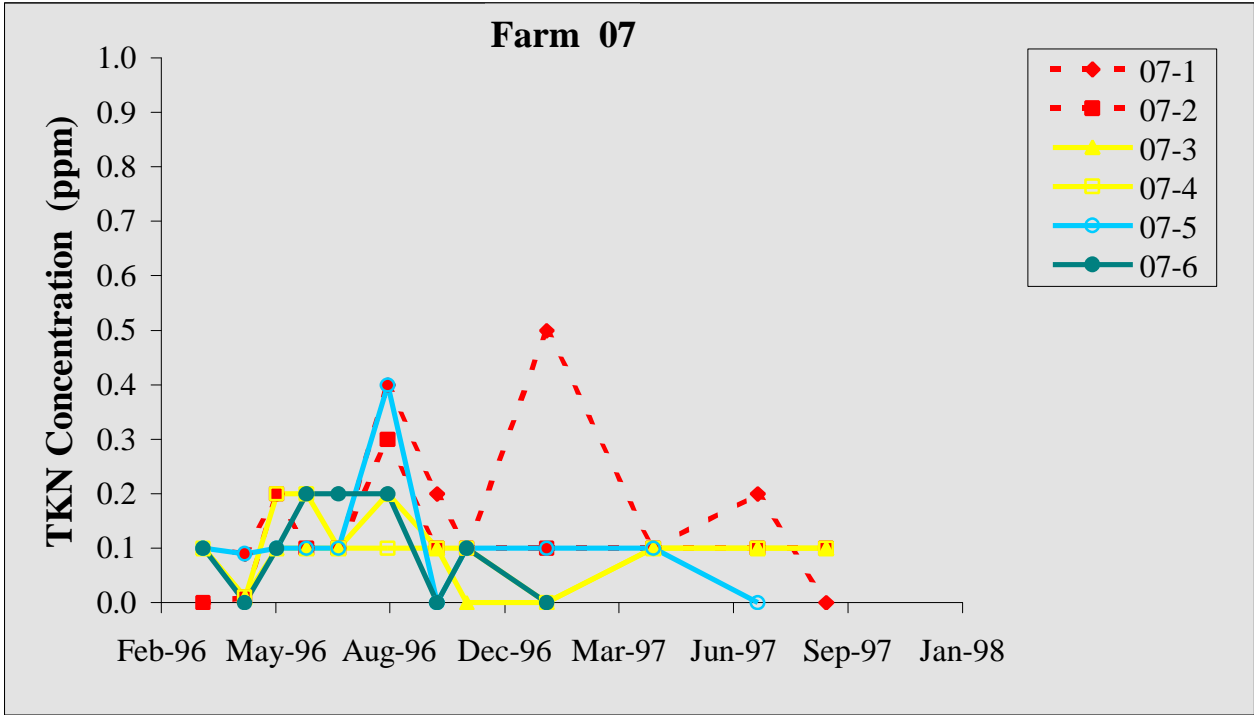
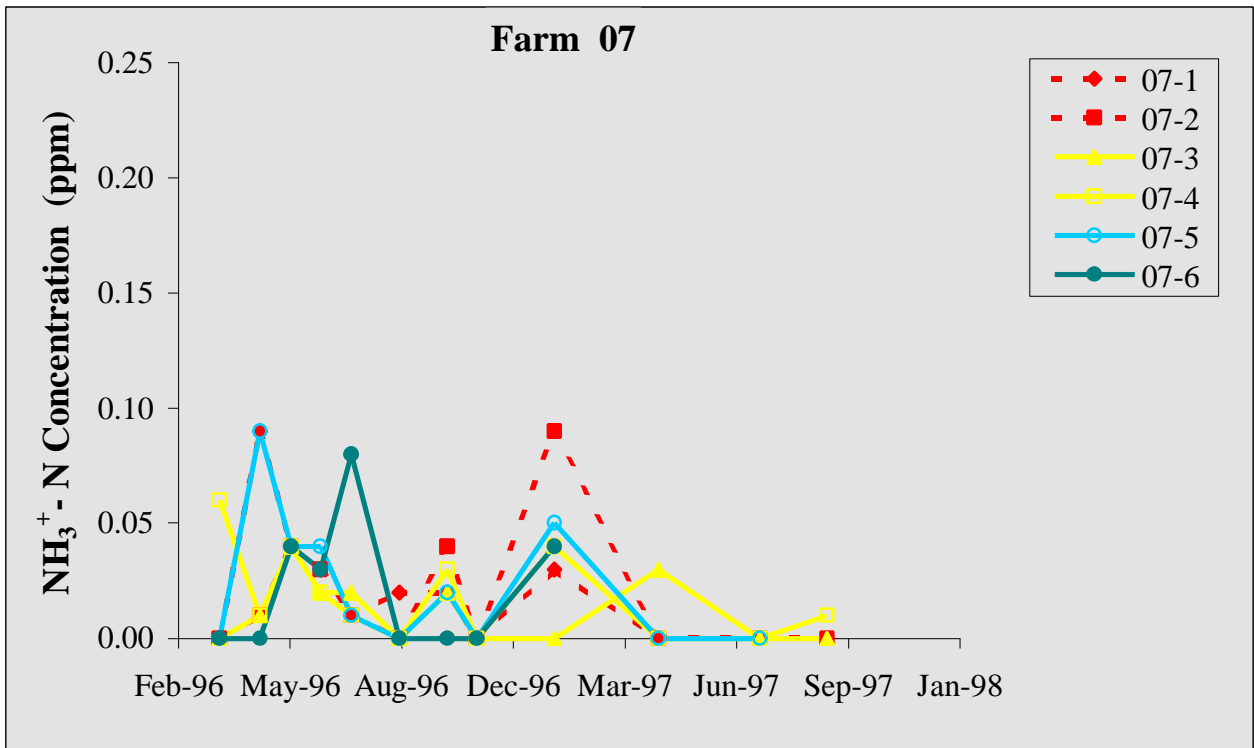
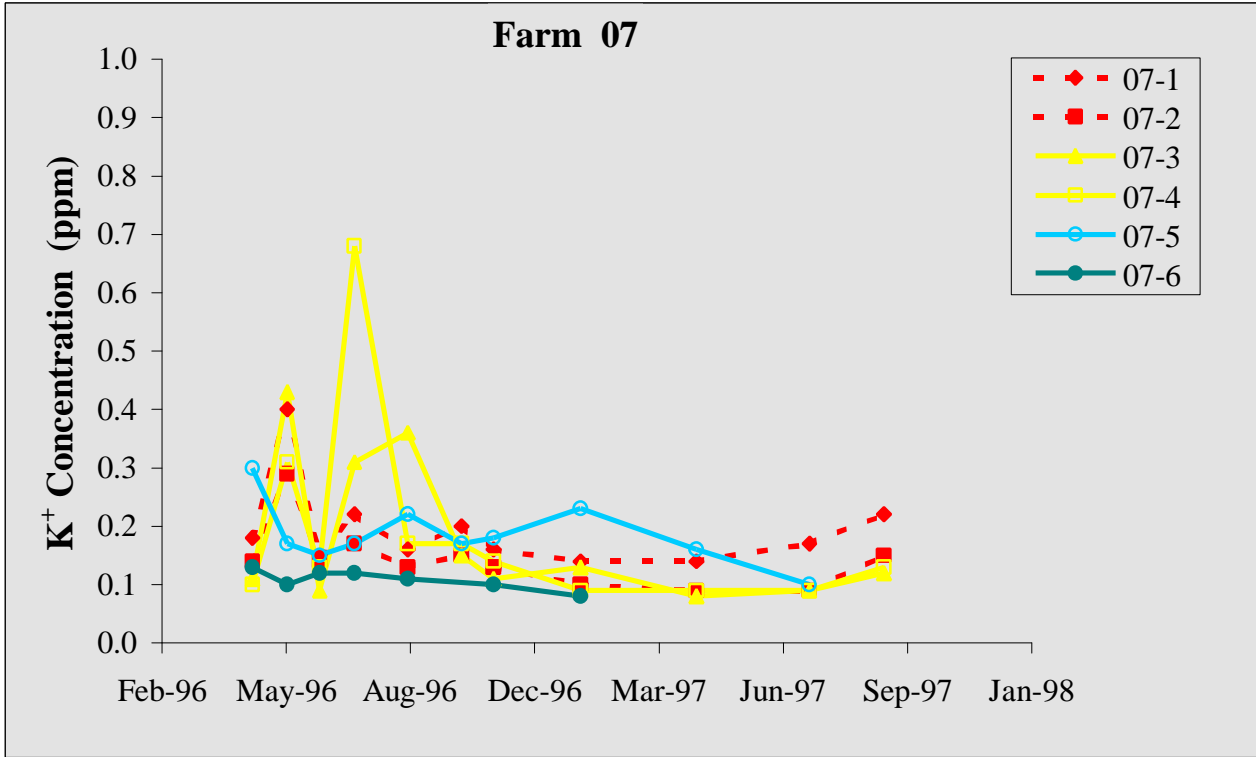
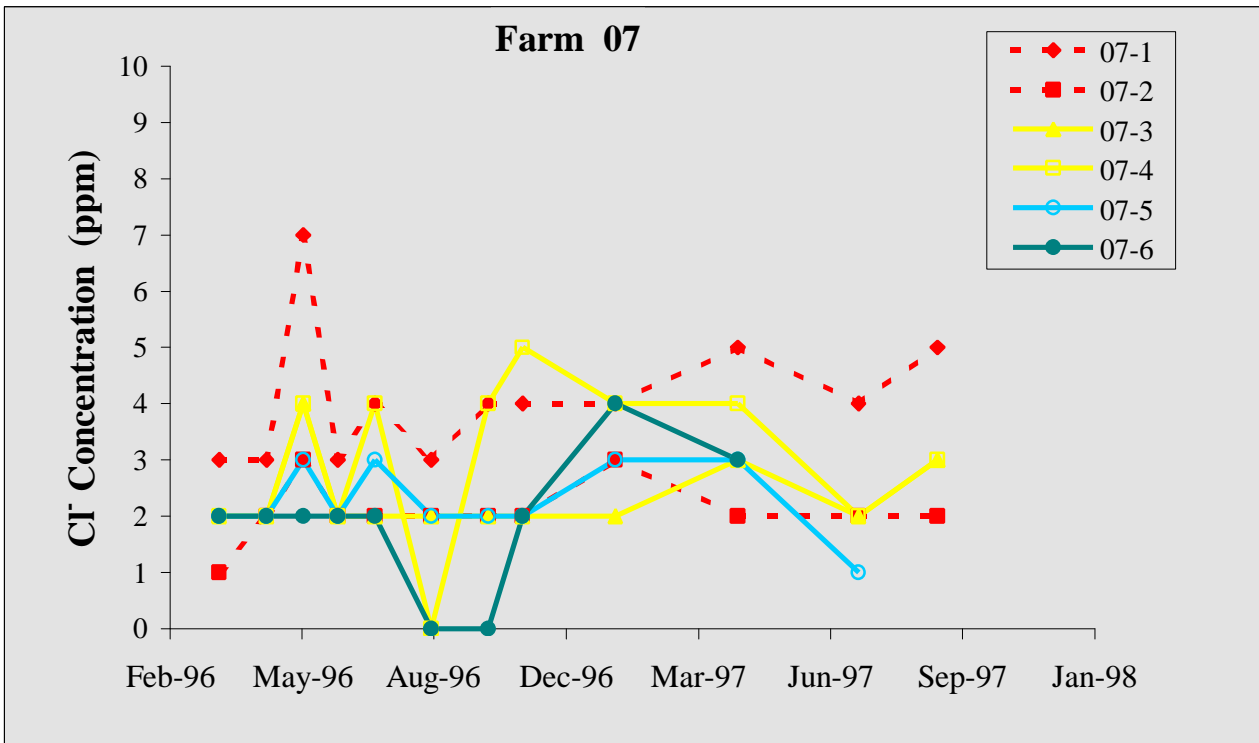
None of the seepage indicators were consistently found in the wells at the 07 site at concentrations that indicate any lagoon seepage. In order to form conclusions about the potential for lagoon seepage to contaminate ground water, sufficient time must be allowed for movement of ground water beneath the lagoon to the monitoring wells.

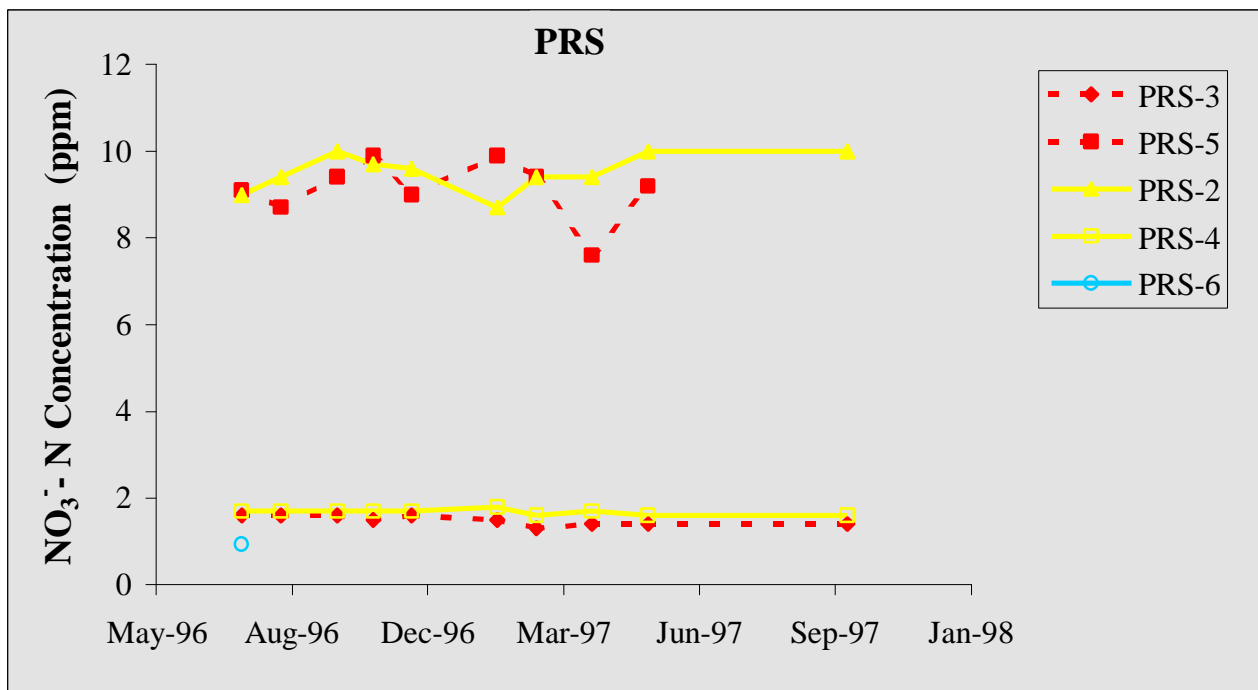
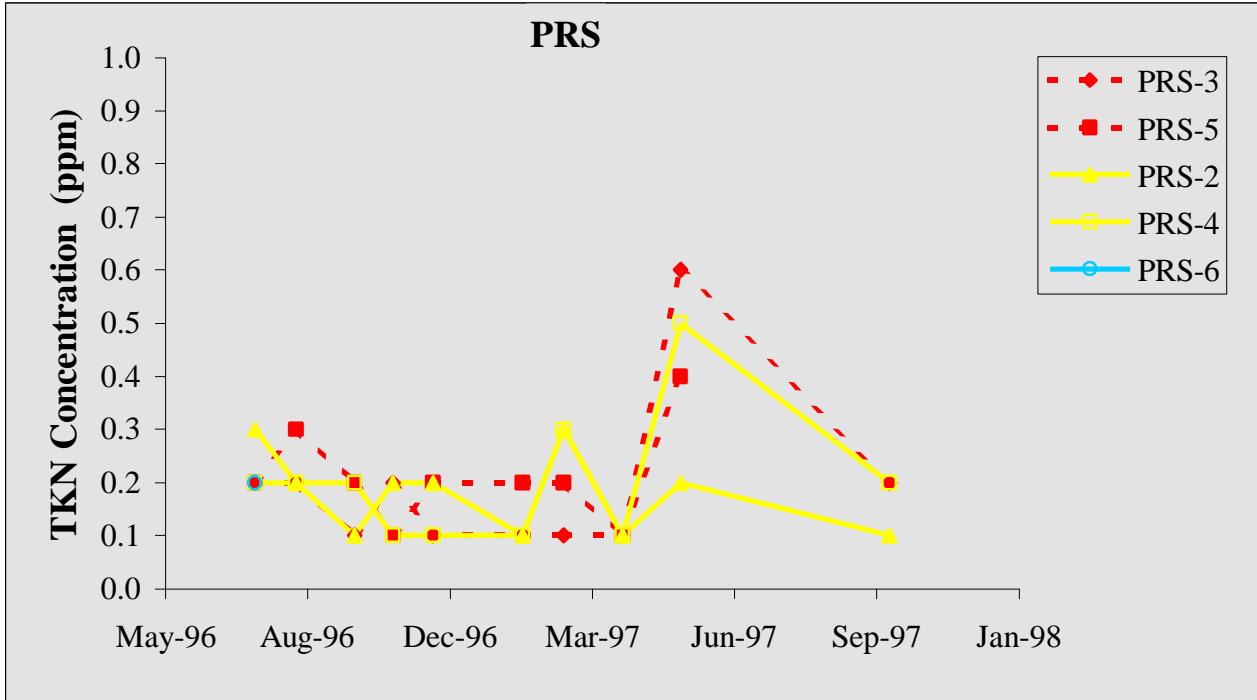
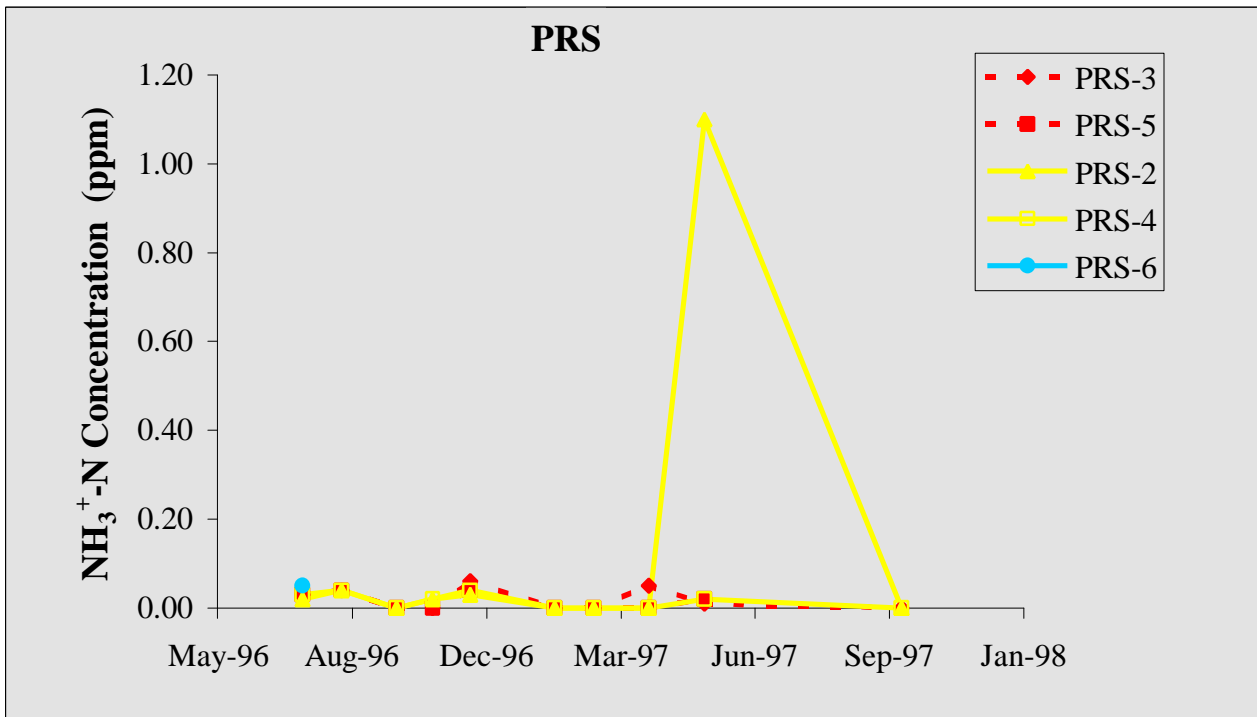
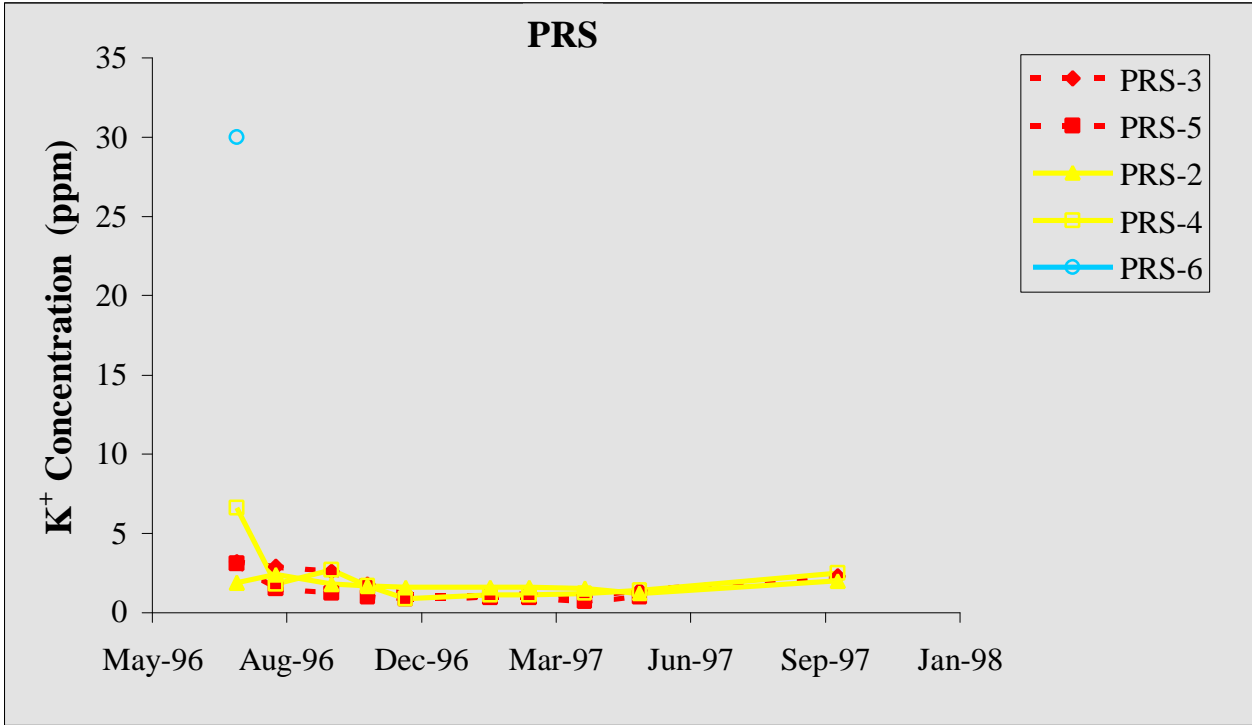
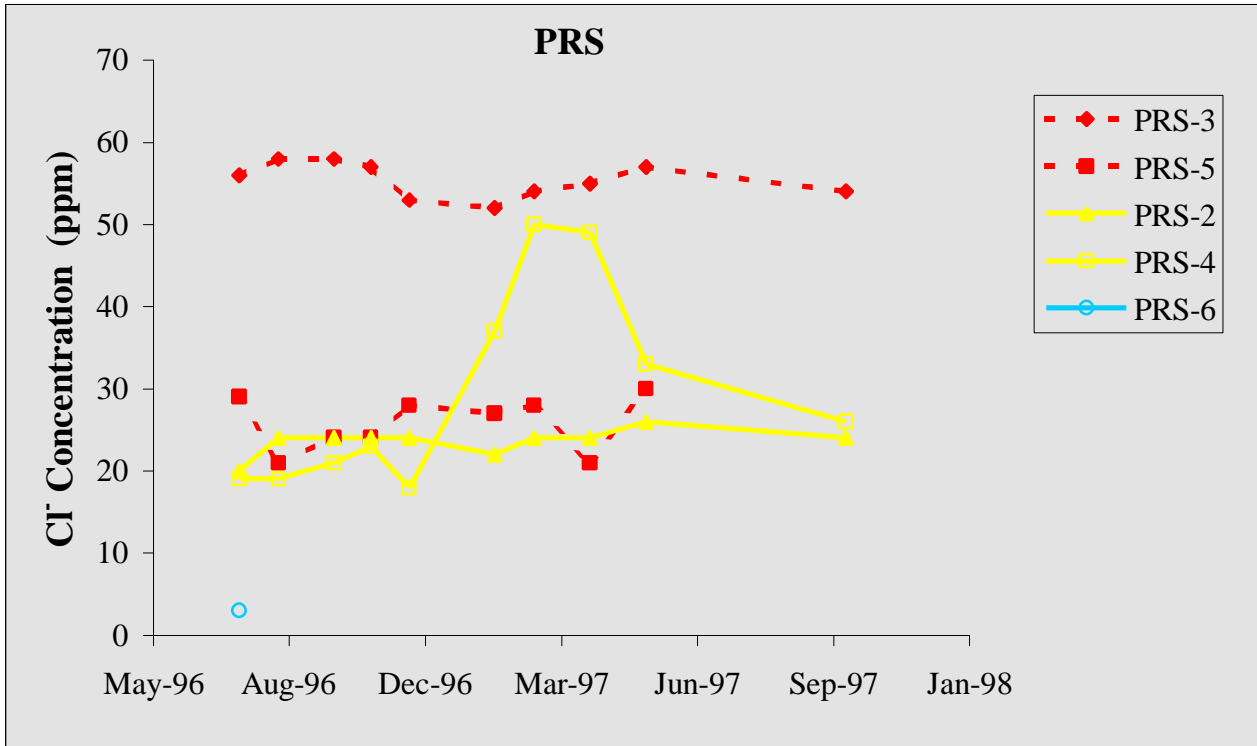
The wells were sited here because there was no alternative place on the farm downgradient from the lagoon. Since no other lagoon seepage indicators were detected in the wells, it is unlikely that lagoon seepage contributed to the nitrate concentrations in ground water.
