Impact of Animal Waste Lagoons on Ground Water Quality

Section 319, Clean Water Act
Grant Year, FY 94
Final Report

Division of Water Quality, Groundwater Section
June, 1998

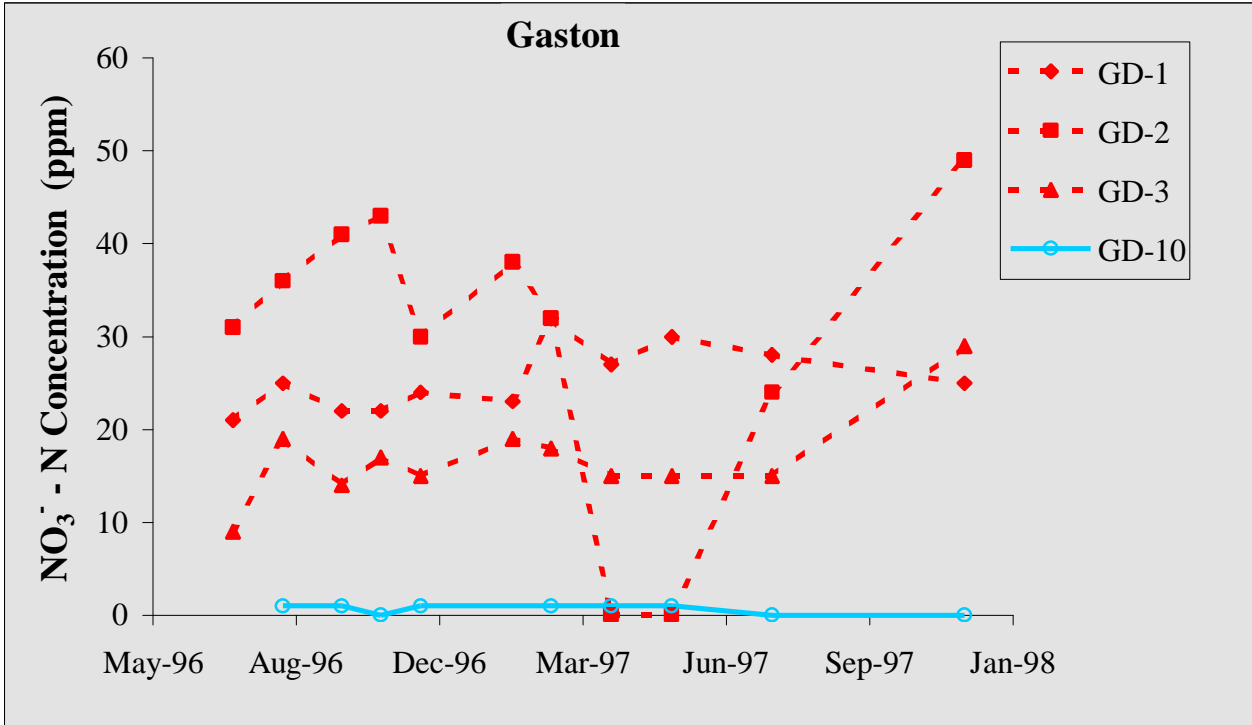
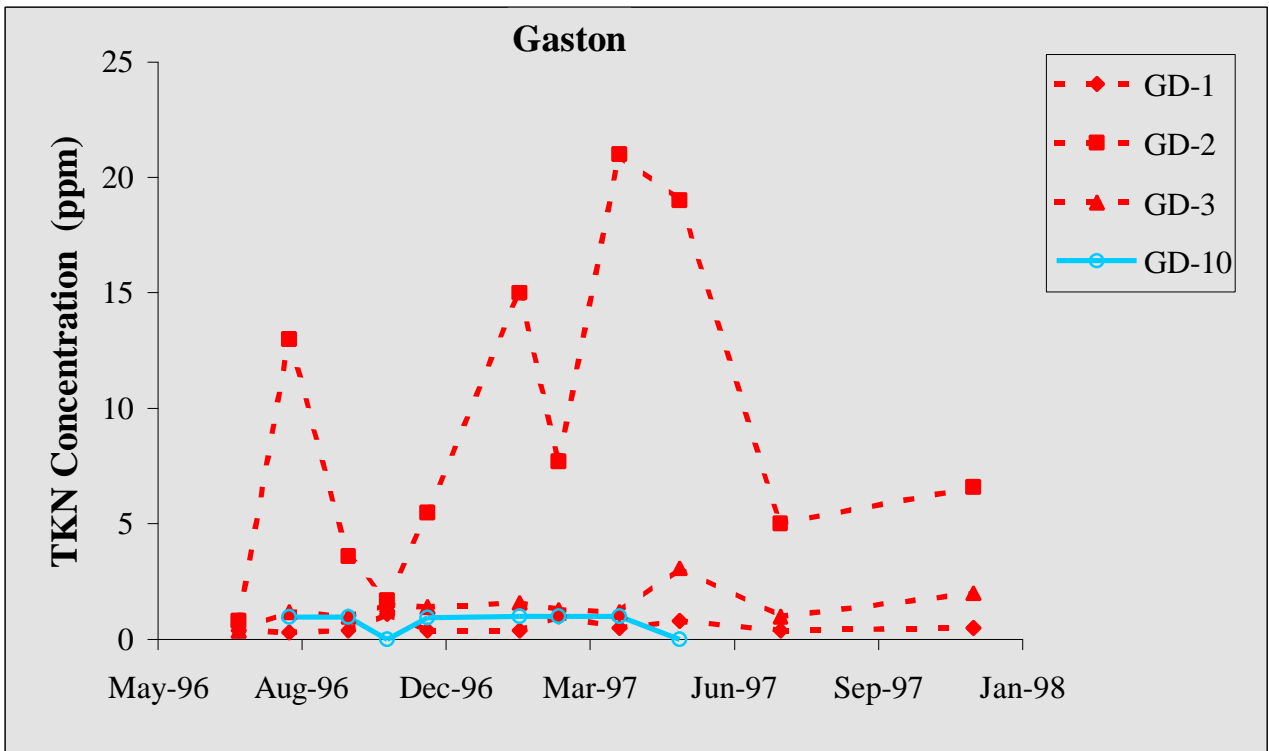
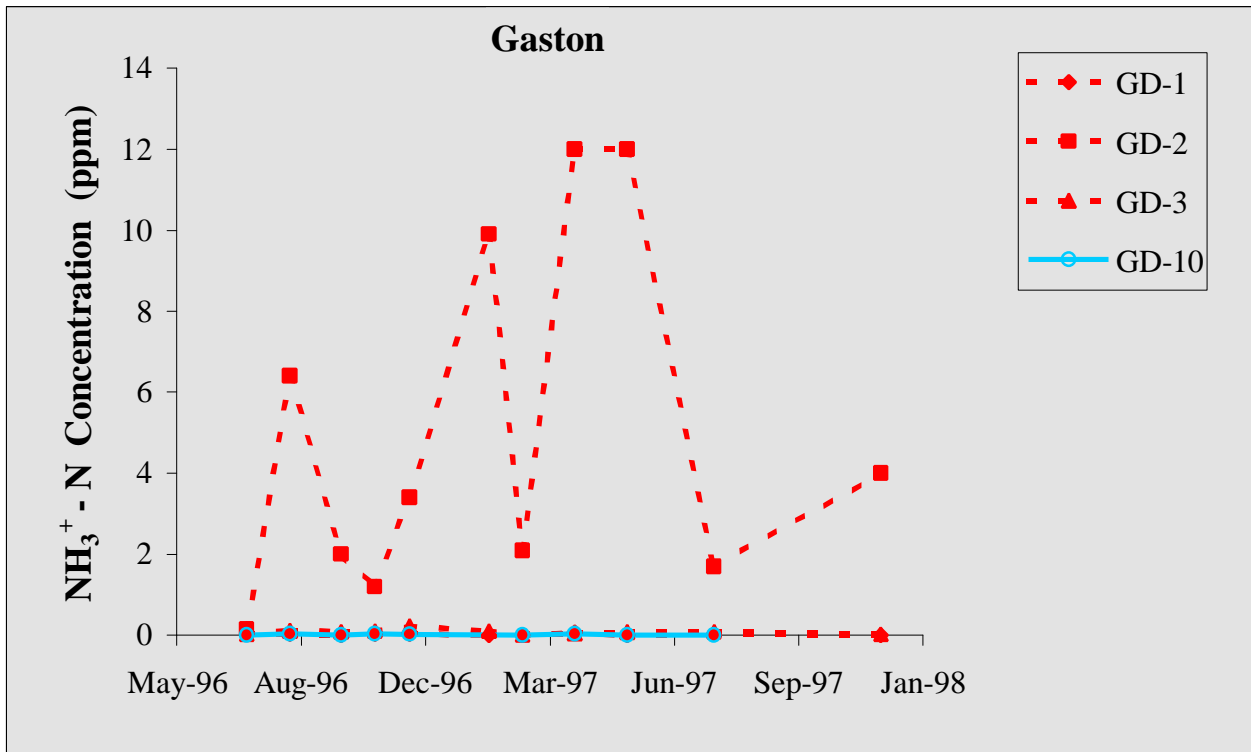
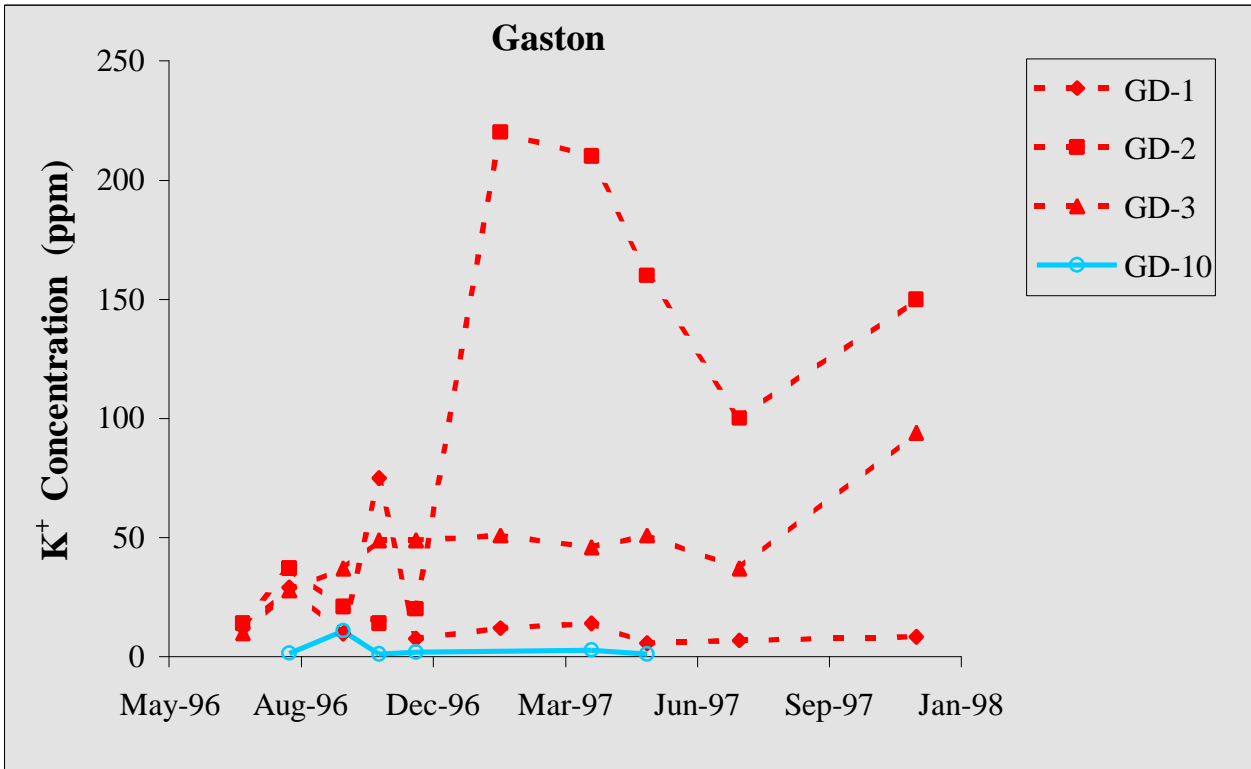
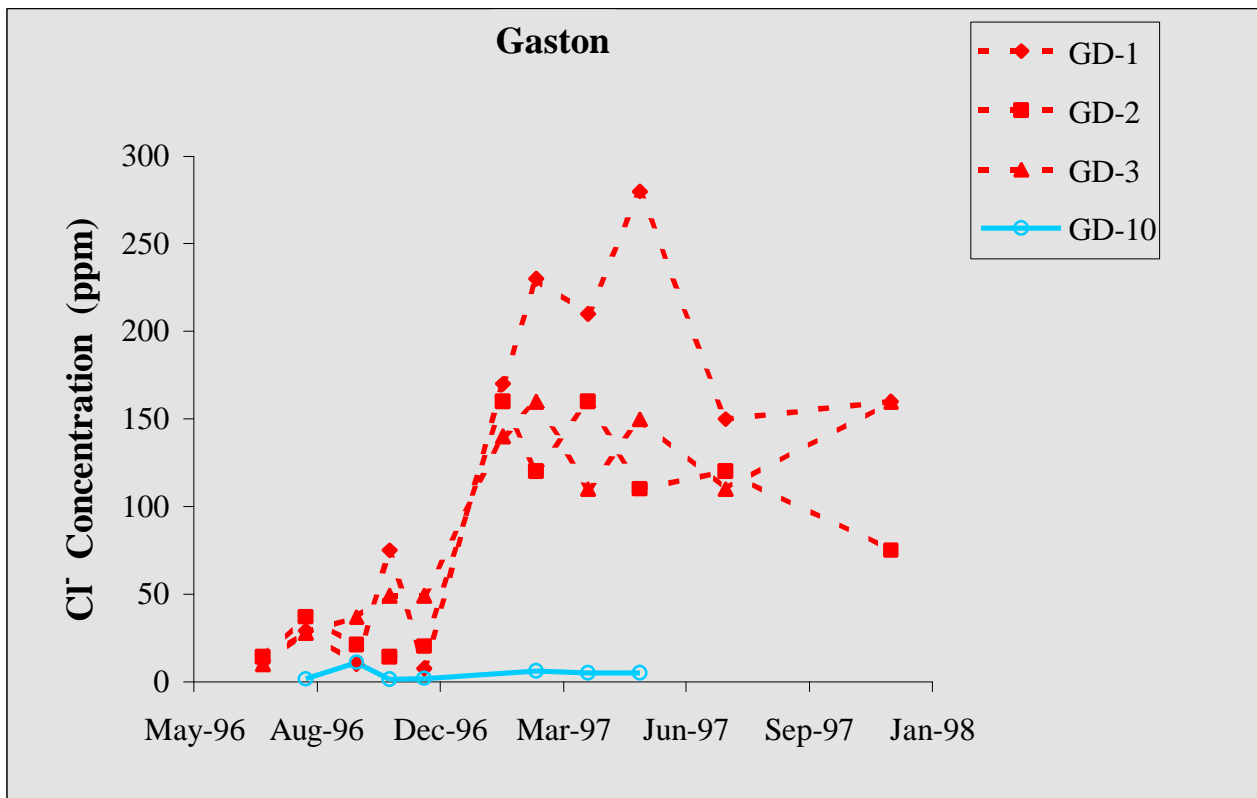
The one well with increasing ammonia and organic nitrogen also had a corresponding decreasing concentration trend for nitrate-nitrogen for two sampling periods, followed by a gradual return to the background concentration for nitrate-nitrogen. This could be explained by a change in oxygen concentration in the subsurface environment. Anaerobic conditions would favor the presence of ammonia-nitrogen in ground water. Aerobic conditions would favor the presence of nitrate-nitrogen in ground water.

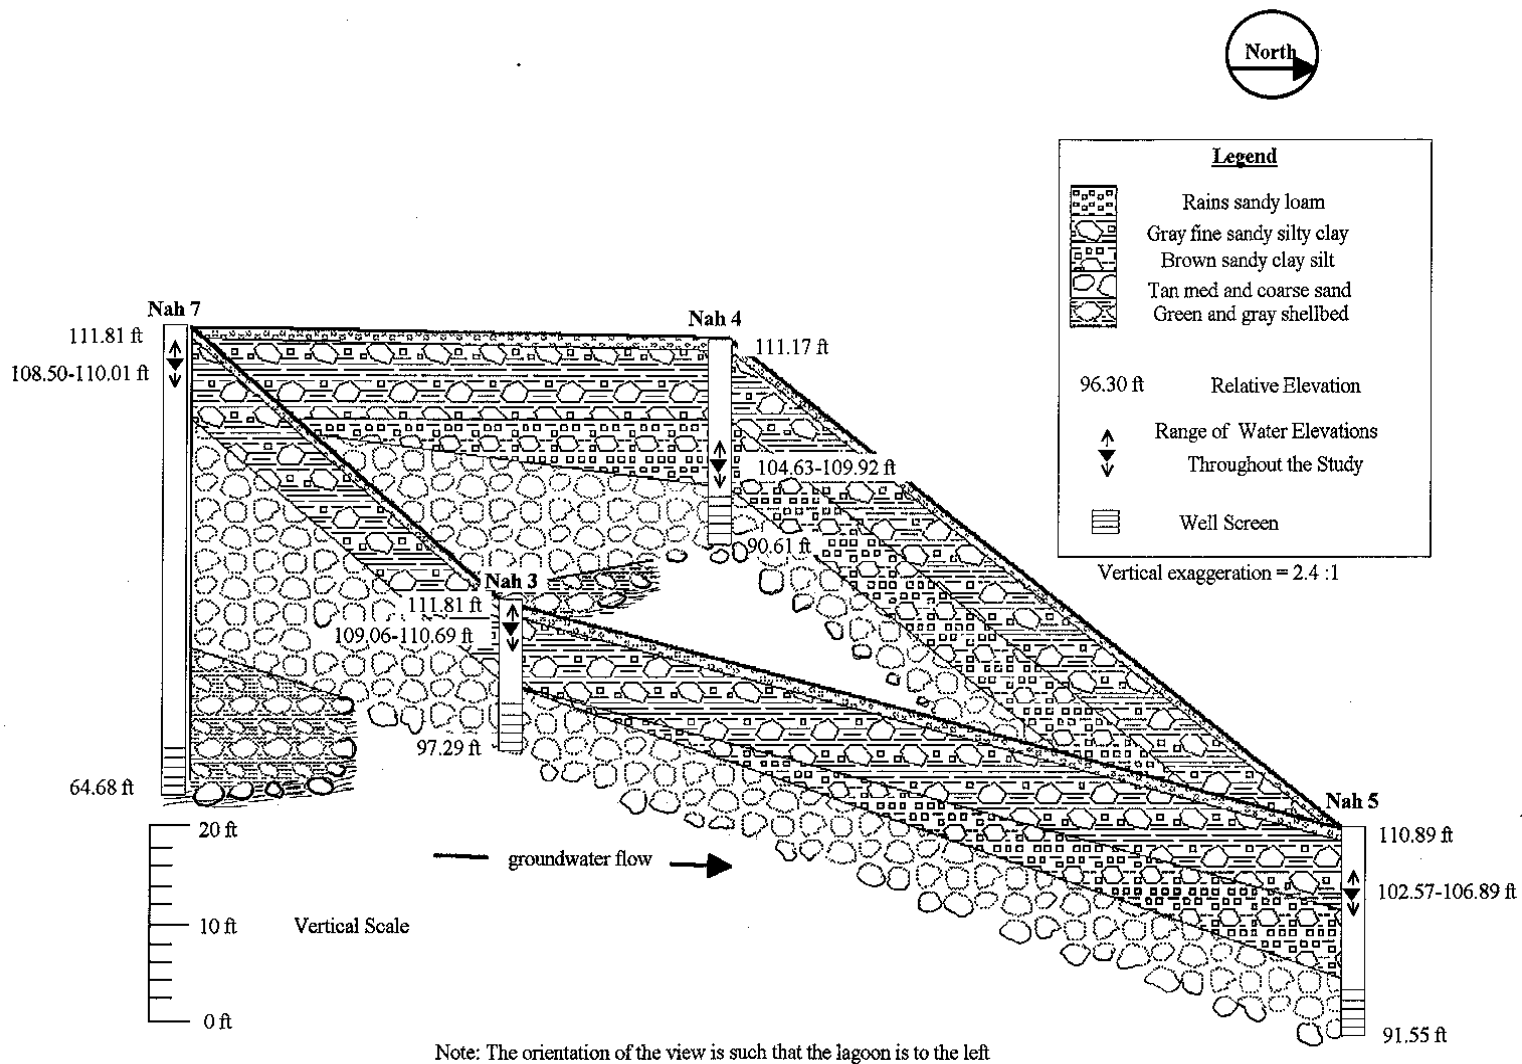
Borehole Stratigraphy of the Nahunta Site in Wayne County

Measured elevations of the water table in the wells show a general ground water flow direction from the lagoon toward the shallow downgradient monitoring wells (also shown on the fence diagram).

Water table elevations measured over time did not show significant variation in ground water flow direction. Distance from the shallow downgradient monitoring wells to the nearest discharge feature is approximately 1,500 feet.

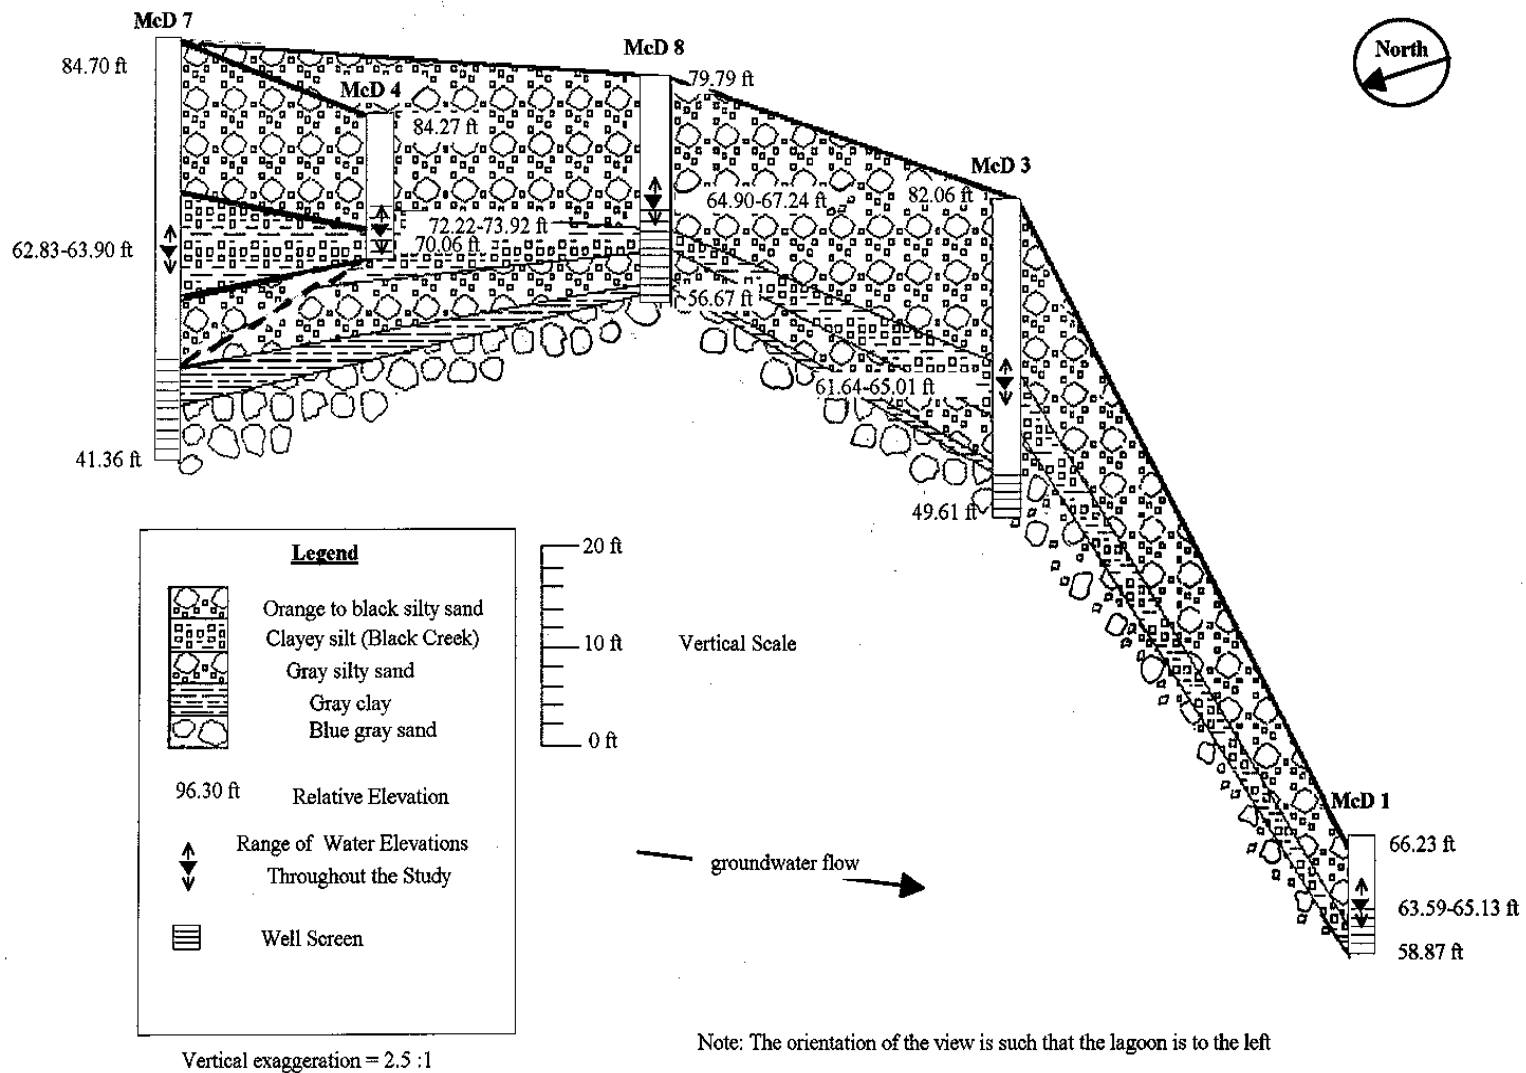
Borehole Stratigraphy of the McDaniels Site in Sampson County

Measured elevations of the water table in the wells show a general ground water flow direction from the lagoon toward the shallow downgradient monitoring wells (also shown on the fence diagram).

Water table elevations measured over time did not show significant variation in ground water flow direction. Distance from the shallow downgradient monitoring wells to the nearest discharge feature is approximately 2,000 feet.

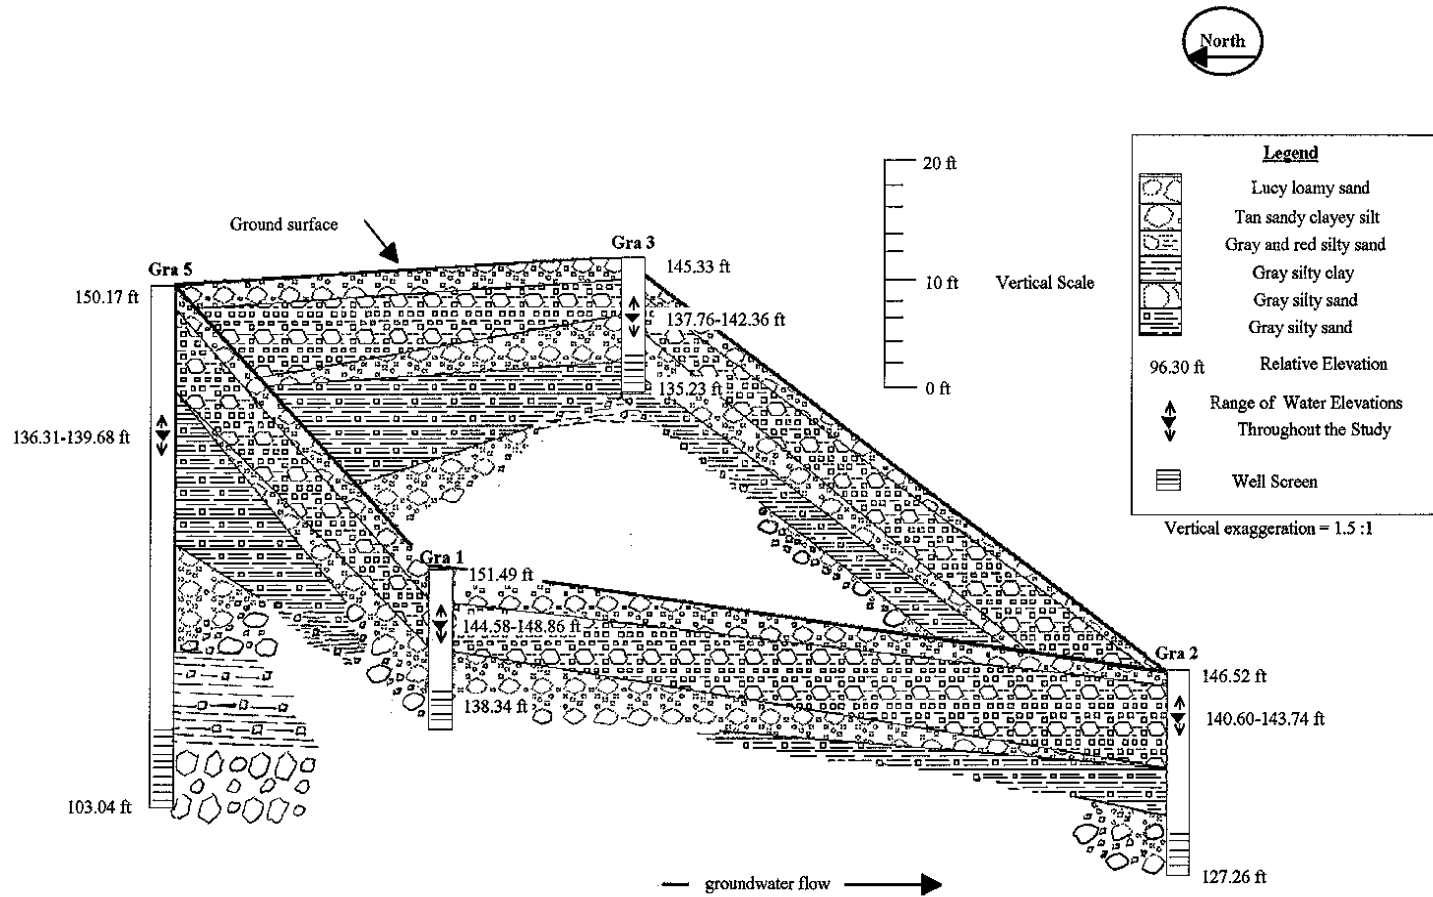
Borehole Stratigraphy of the Grantham Site in Wayne County

Measured elevations of the water table in the wells show a general ground water flow direction from the lagoon toward the shallow downgradient monitoring wells (also shown on the fence diagram).

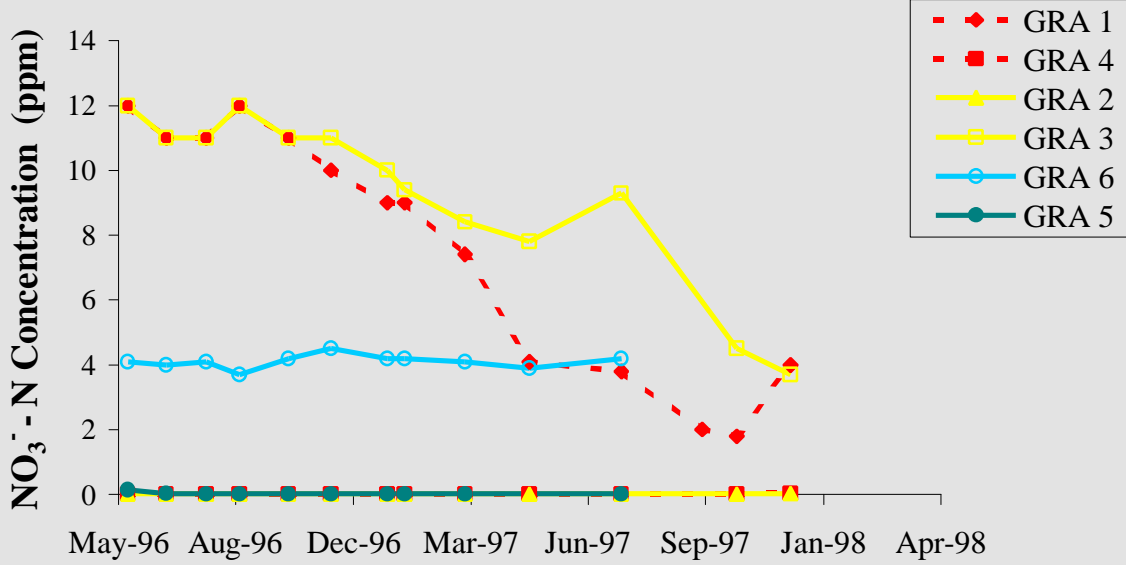
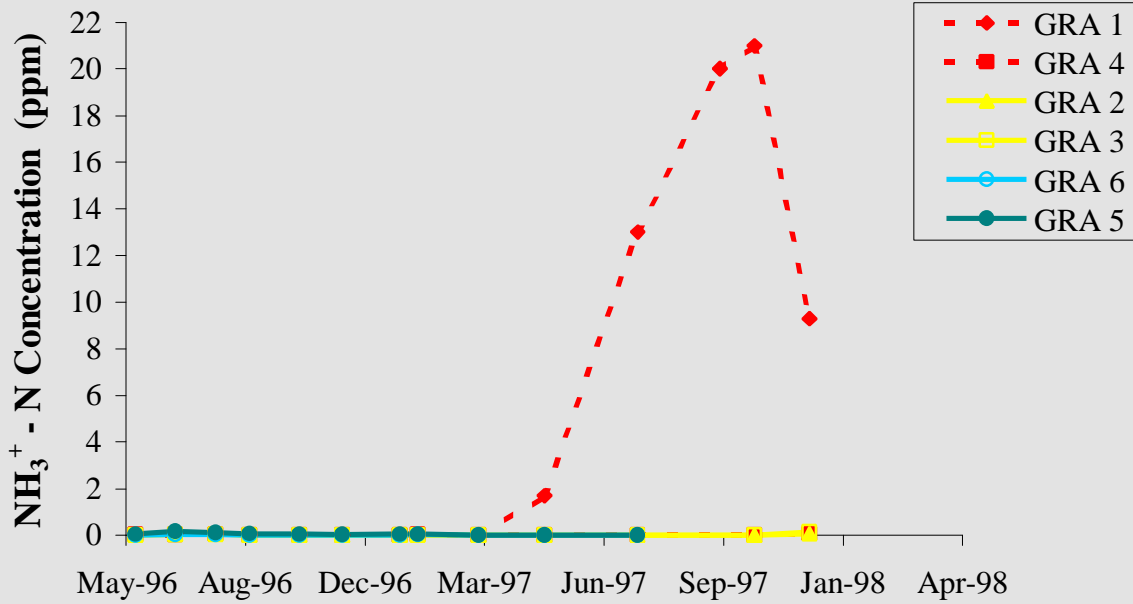
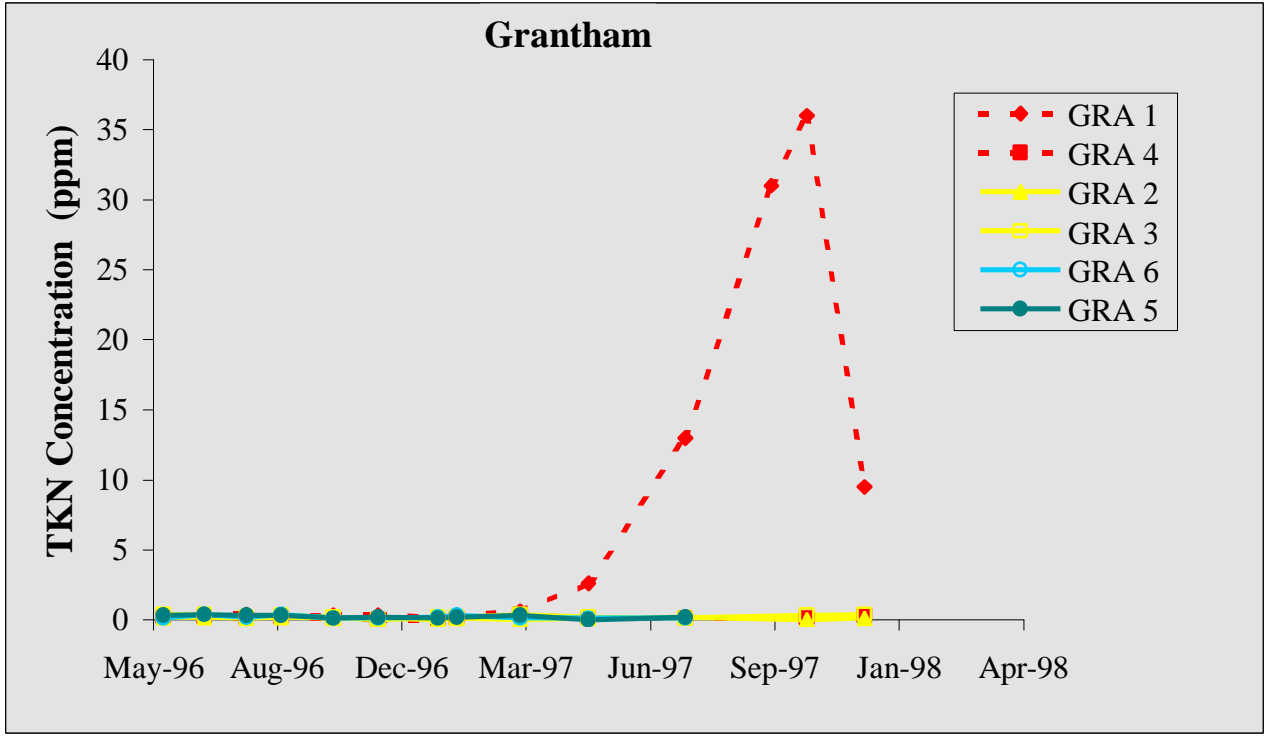
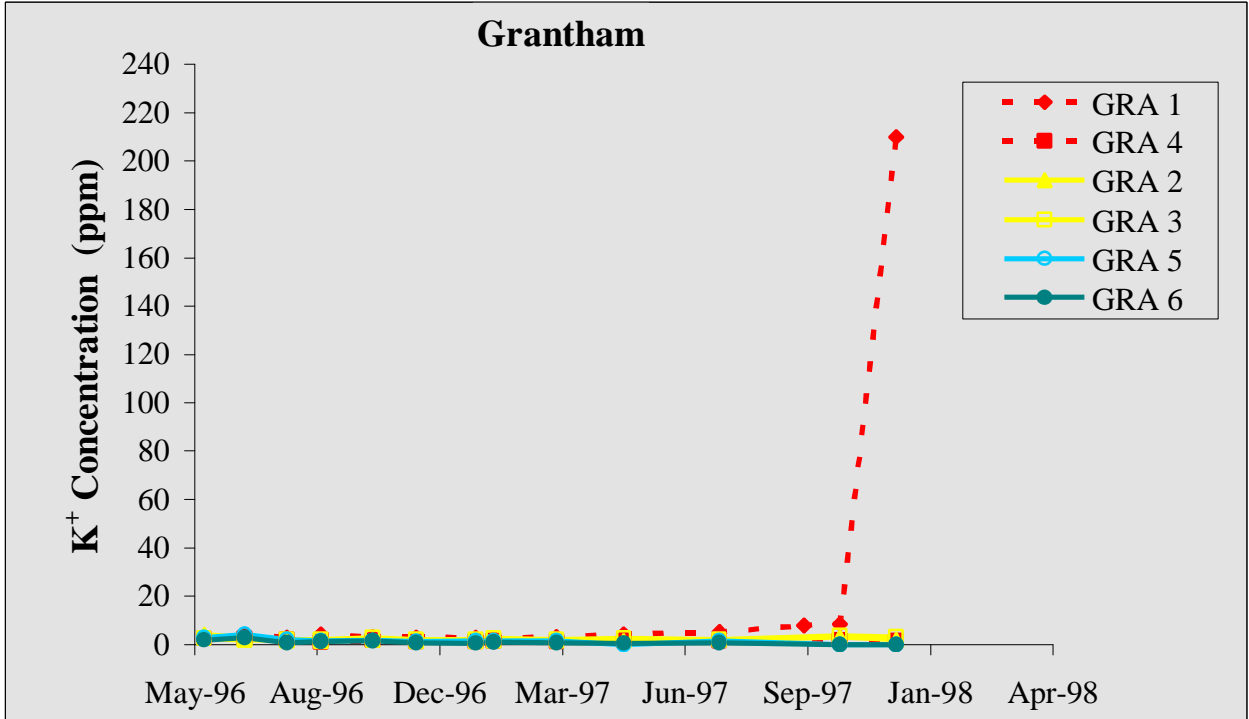
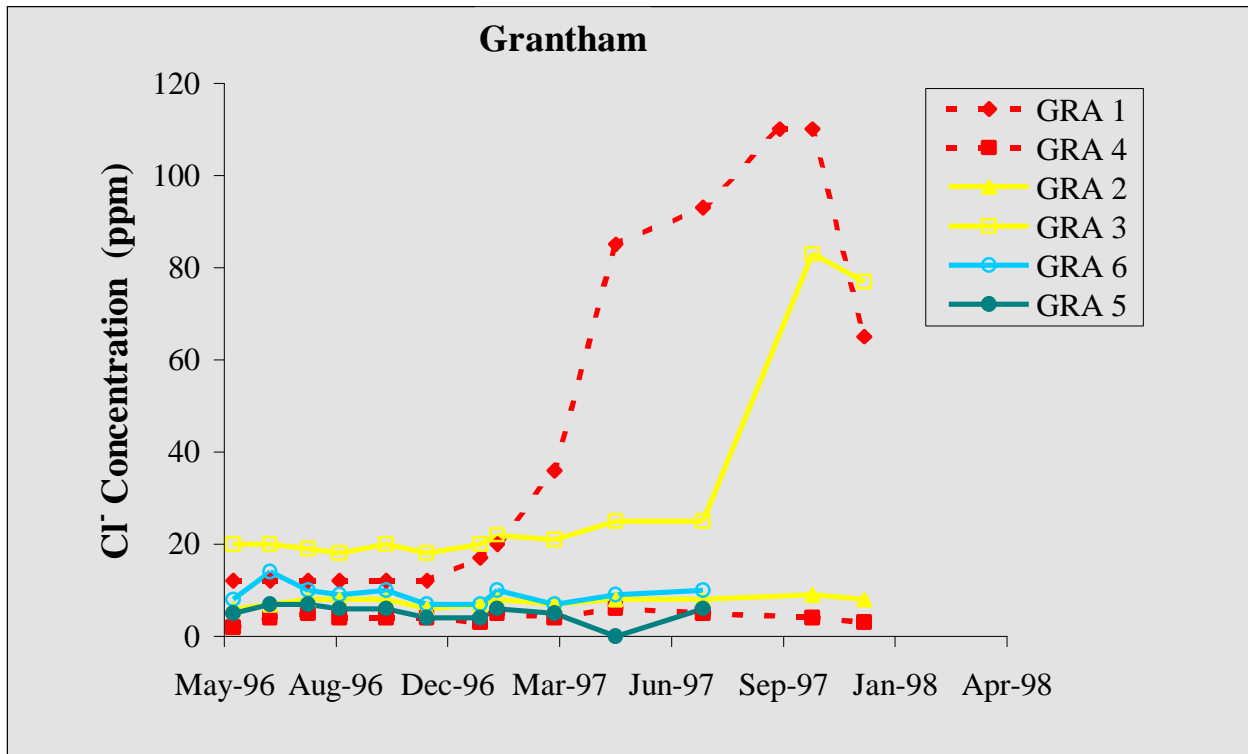
Grantham

Nitrate-nitrogen concentrations in one well, GRA-1 located approximately 125 feet downgradient from the lagoon berm, began in the 10 to 12 ppm range and now are in the 2 to 4 ppm range. The other nitrogen species have had increasing trends for four sampling periods, followed by a decreased value for the final sampling period of the study. This could be explained by the presence of lagoon seepage and an associated change in oxygen concentration in the subsurface environment. Anaerobic conditions would favor the presence of ammonia-nitrogen in ground water.

Aerobic conditions would favor the presence of nitrate-nitrogen in ground water. Chloride has been increasing in this well over the last six sampling periods to a level that is just under one half that of the lagoon waste concentration. Potassium was extremely low until the final sampling period when it was found at a concentration that is one third as high as the lagoon waste itself.

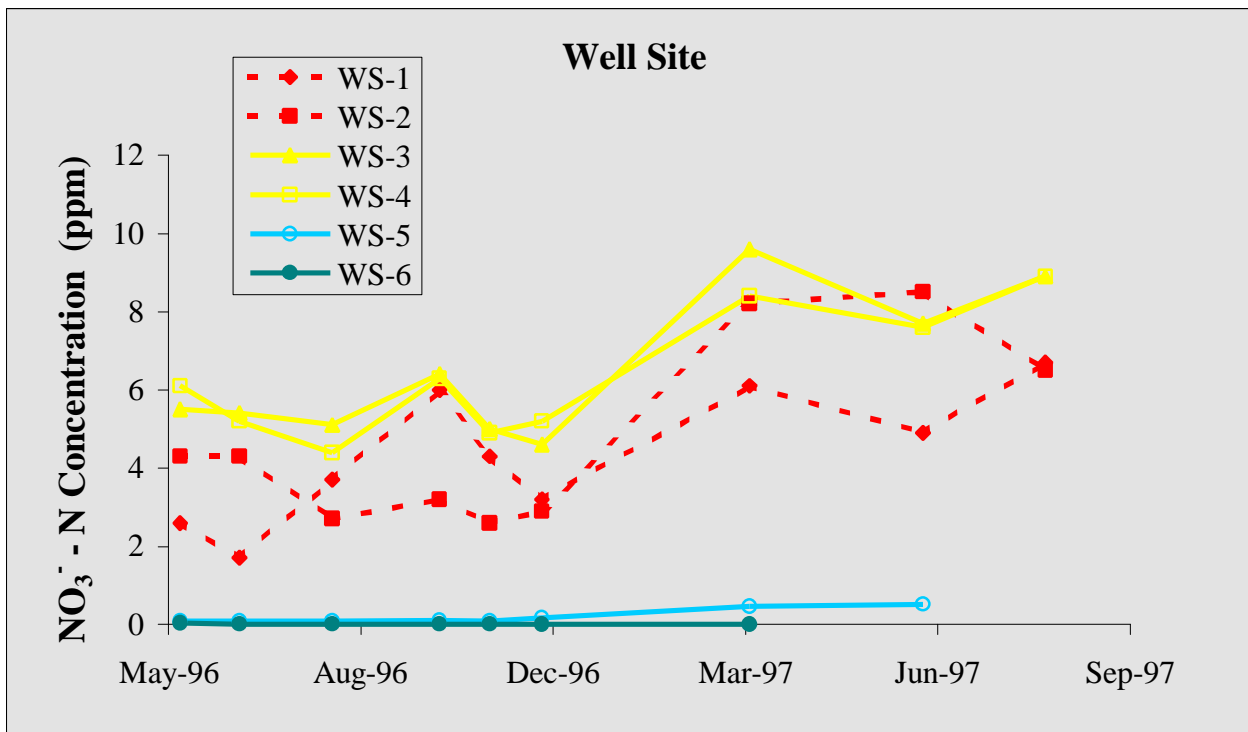
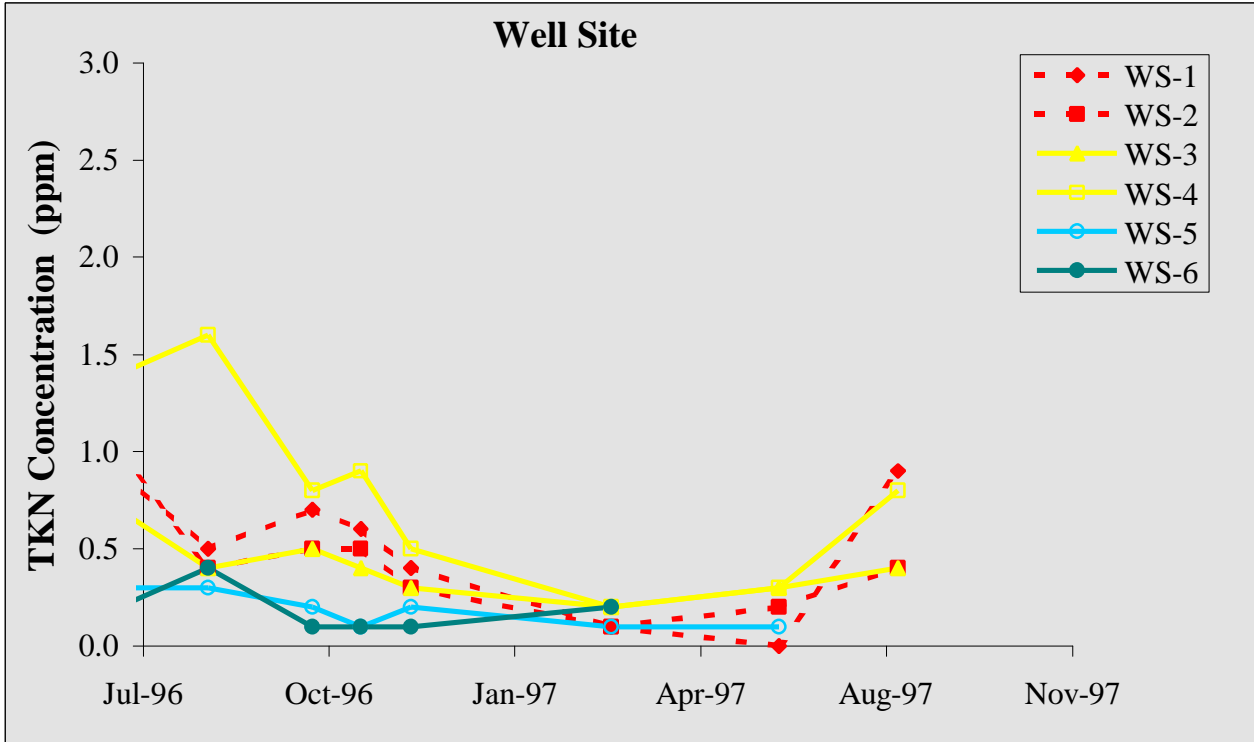
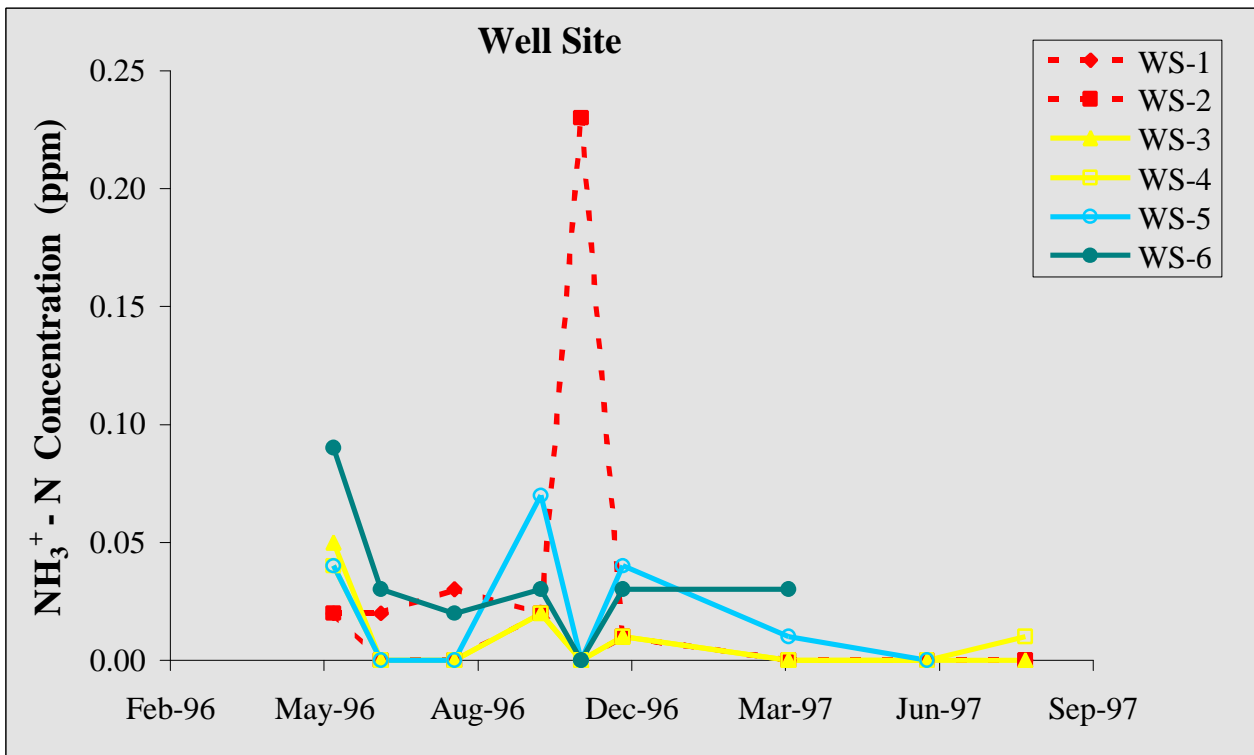
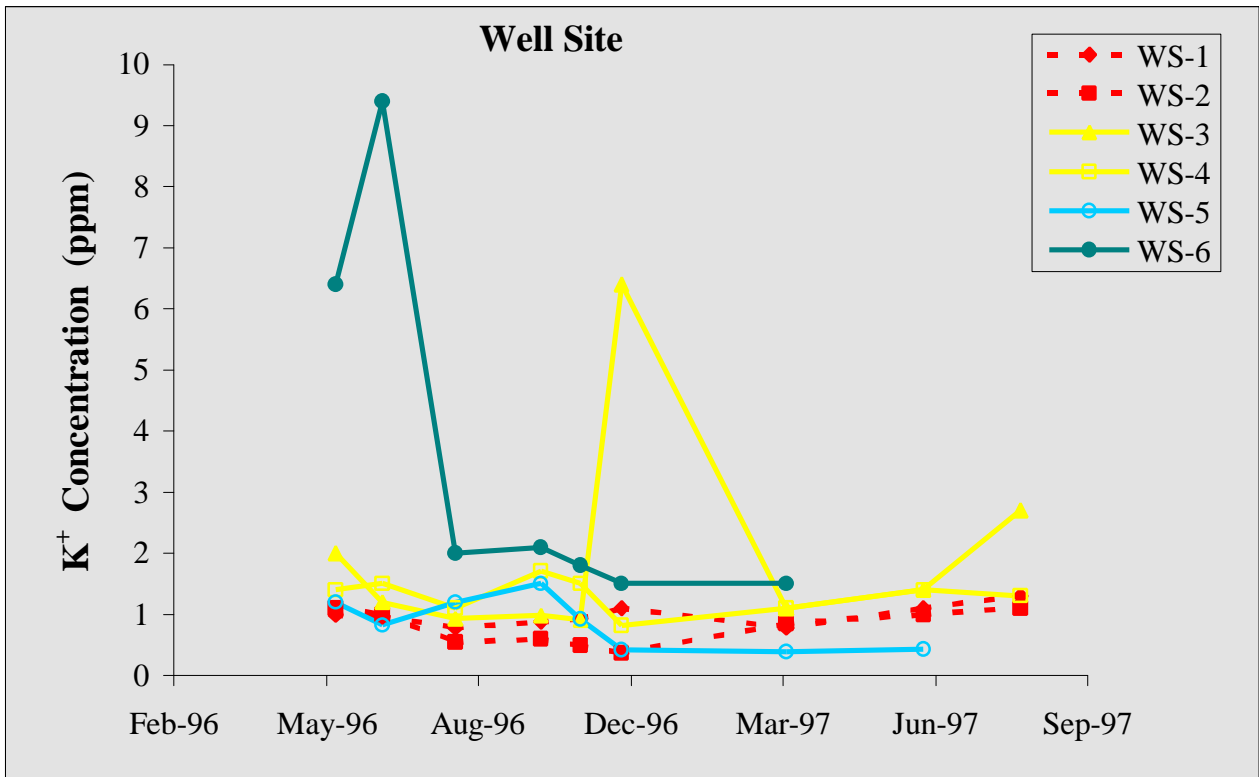
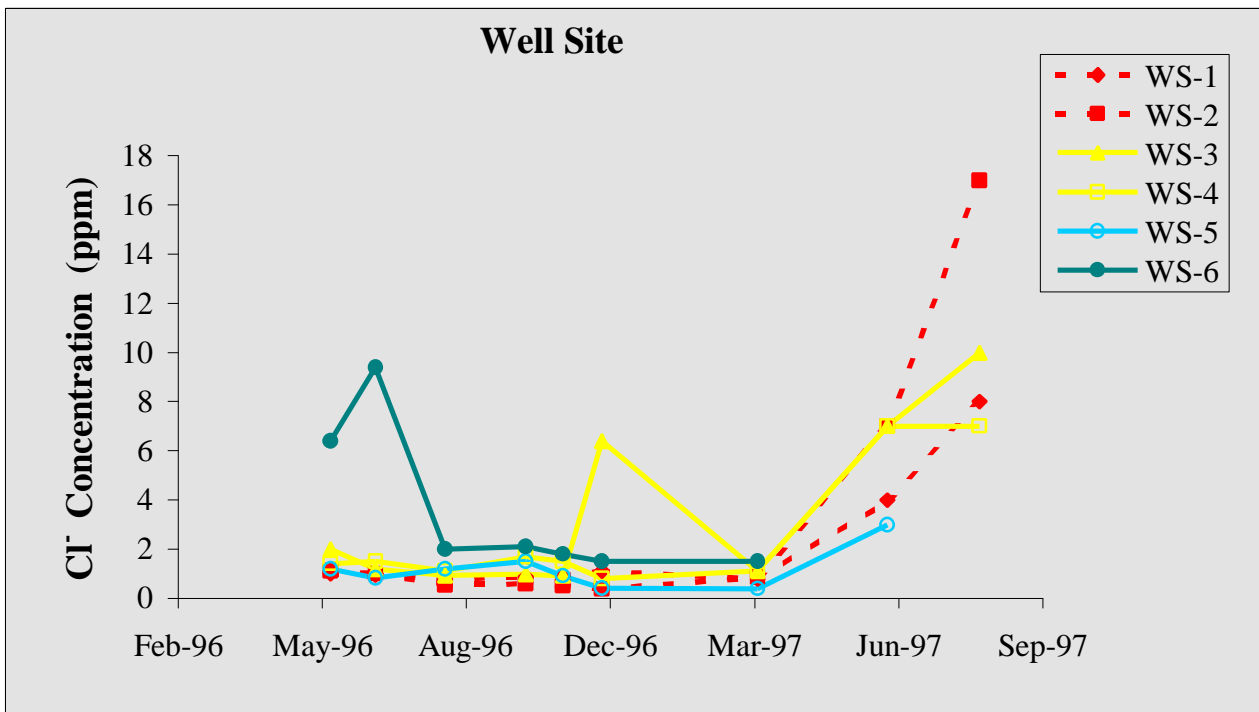
There does appear, however, to be possible increasing trends in both nitrate-nitrogen and chloride concentrations in a few of the wells. Without further site investigation, monitoring and cooperation the source of these increasing concentrations cannot be determined.

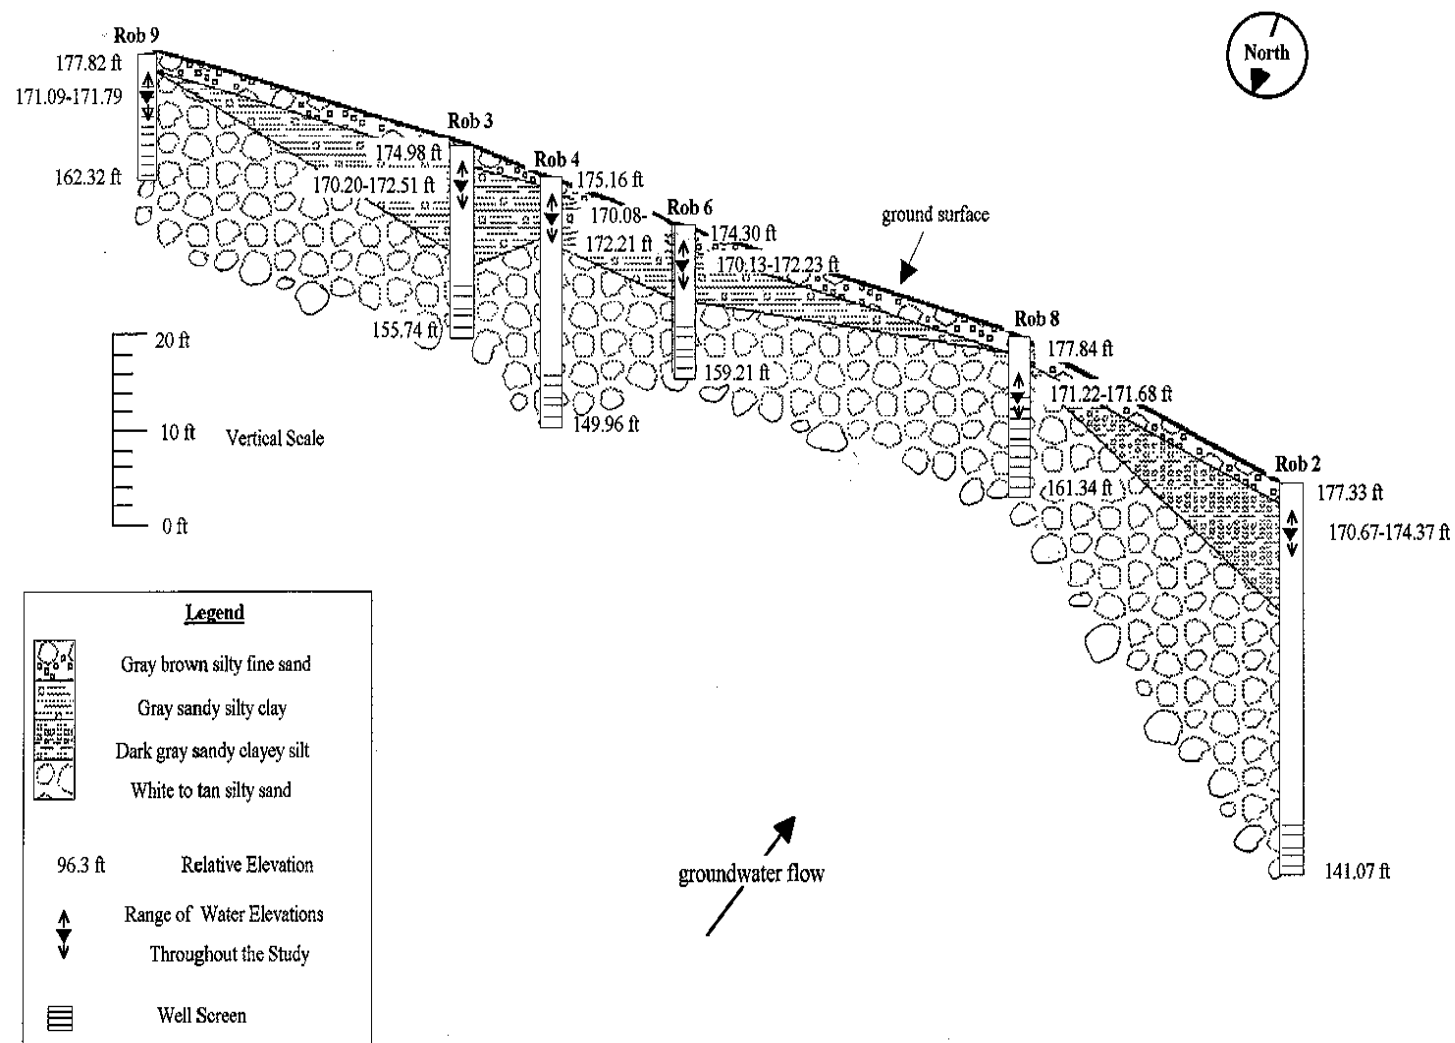
Borehole Stratigraphy of the Robeson Site in Robeson County

Measured elevations of the water table in the wells show a general ground water flow direction from the lagoon toward the shallow downgradient monitoring wells (also shown on the fence diagram).

It was estimated that there was no separation distance between the lagoon bottom and the water table. Stratigraphy data collected indicate no significant clay layer below the first 10 feet down to 35 feet below the ground surface. Based on this limited information, the Robeson site would generally be considered to have high to very high potential for lagoon seepage to contaminate ground water.
