Impact of Animal Waste Lagoons on Ground Water Quality

Section 319, Clean Water Act
Grant Year, FY 94
Final Report

Division of Water Quality, Groundwater Section
June, 1998

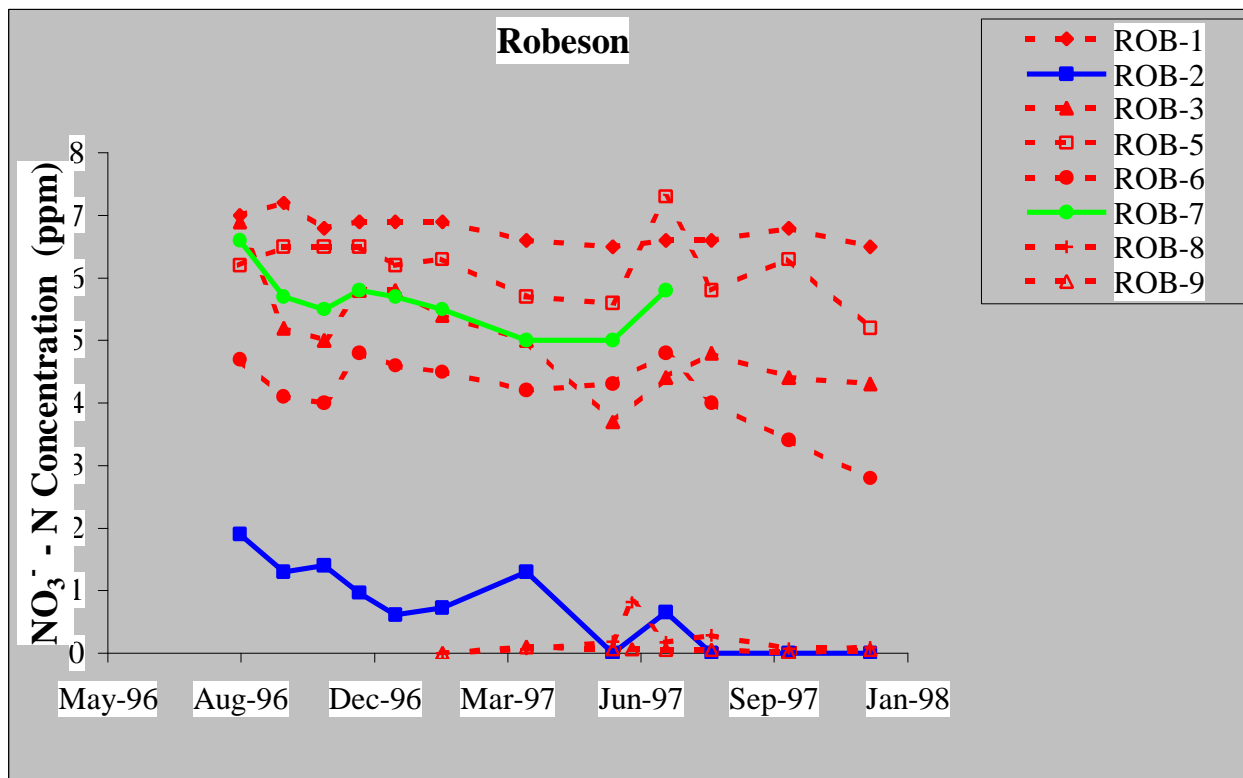
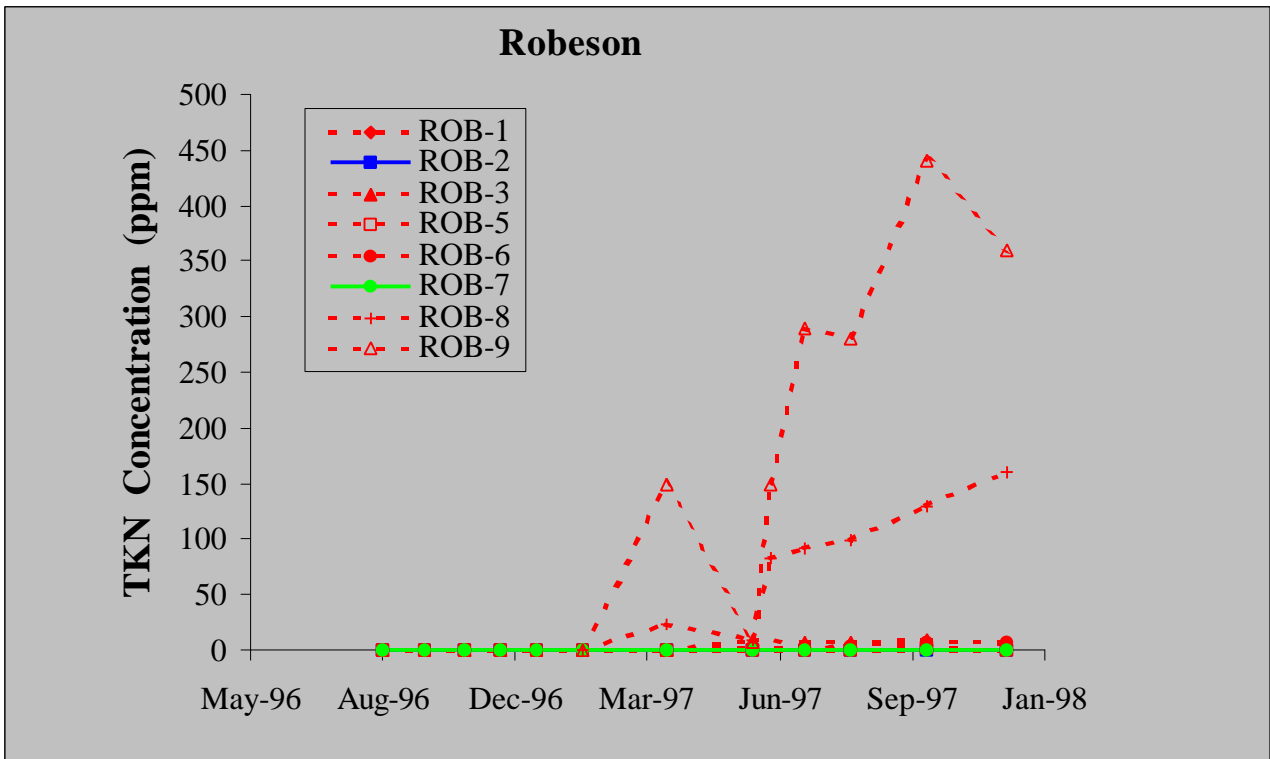
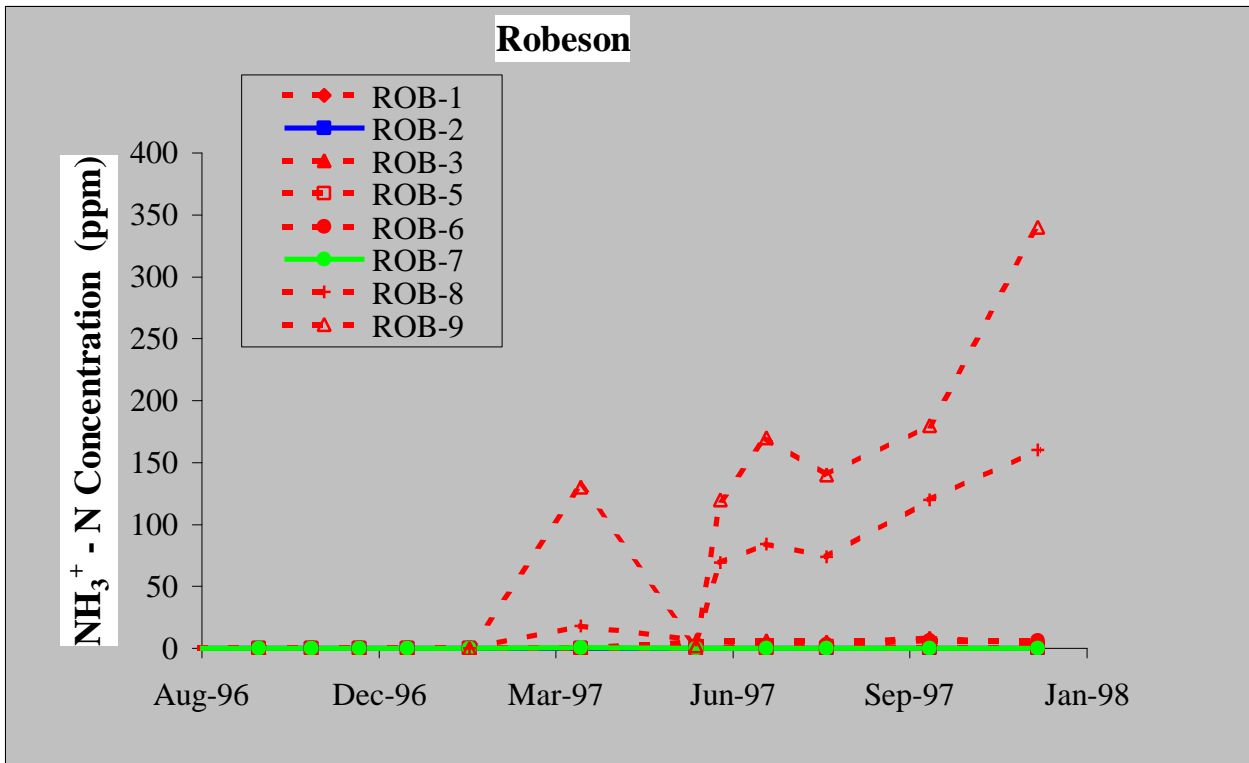
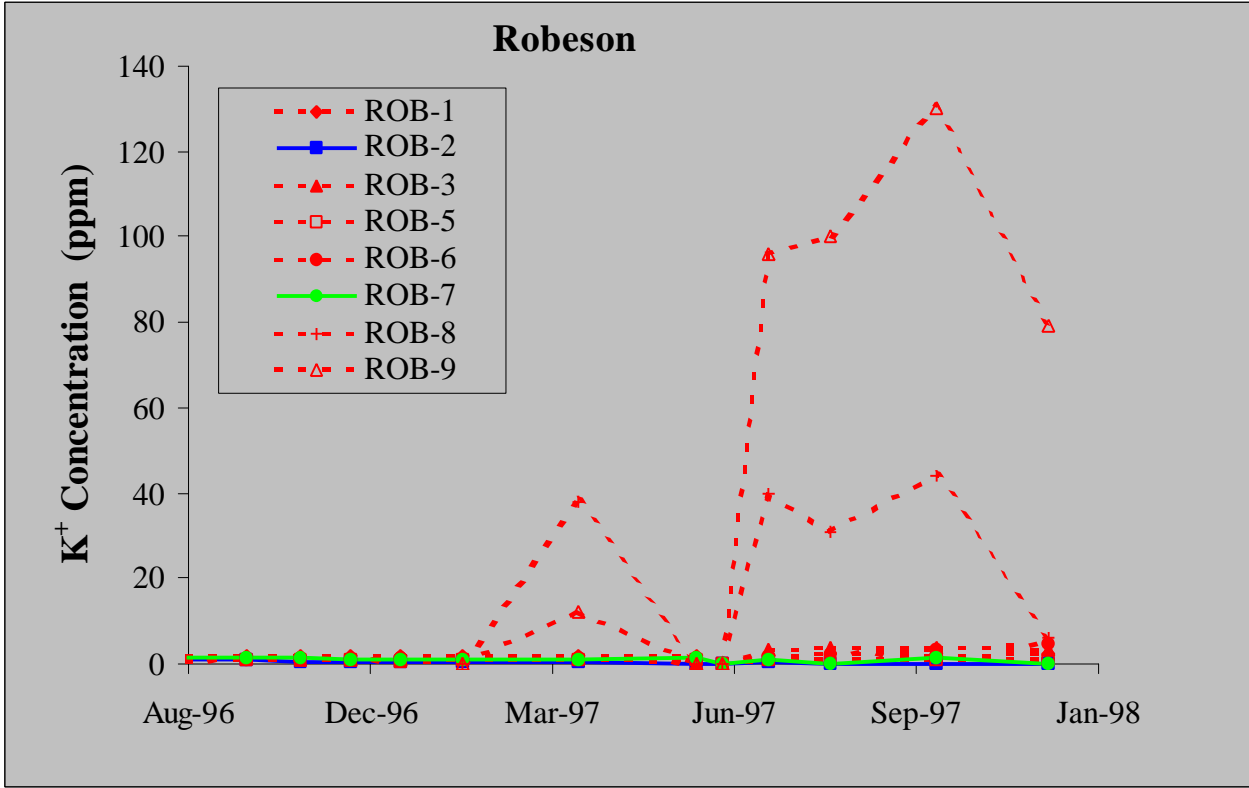
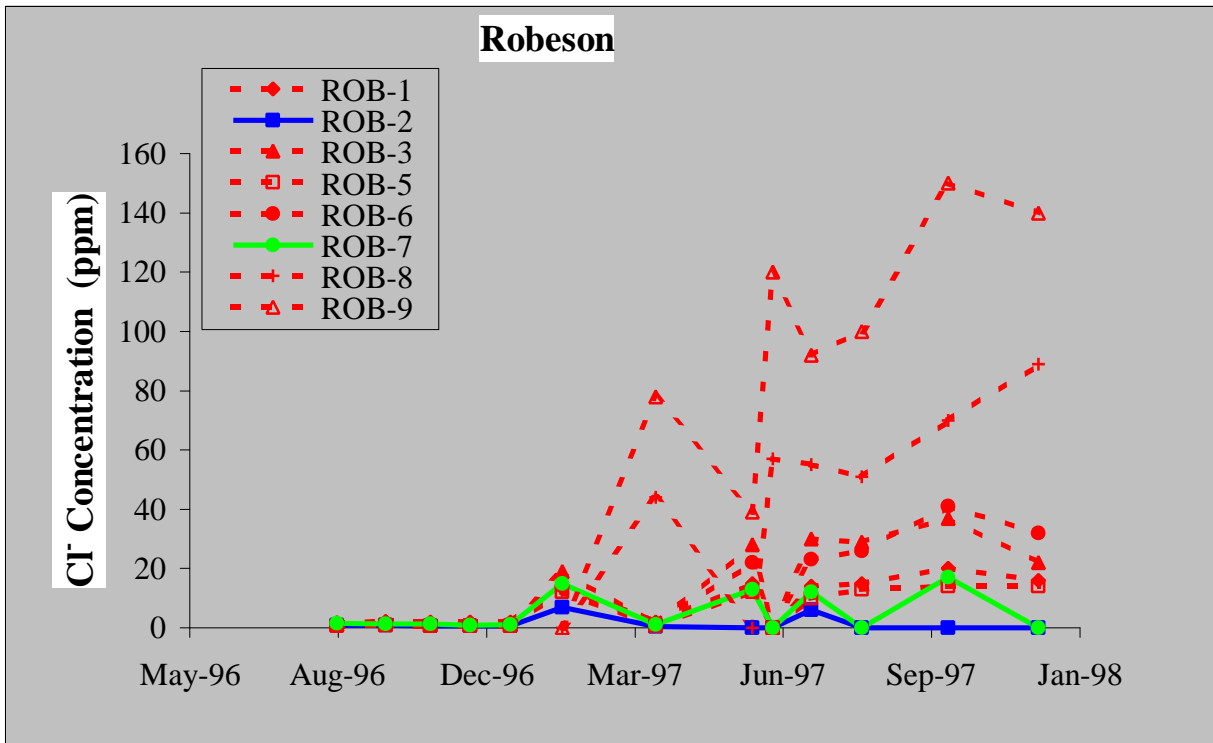
Results of the monitoring well analysis for the major seepage indicators are presented in the following five time-series graphs:

The contamination appears to be spreading; however, the EM has not been able to detect the movement. Perhaps the concentration of the lagoon seepage constituents is still relatively low. This site exhibits the highest degree of lagoon seepage ground water contamination in the study.

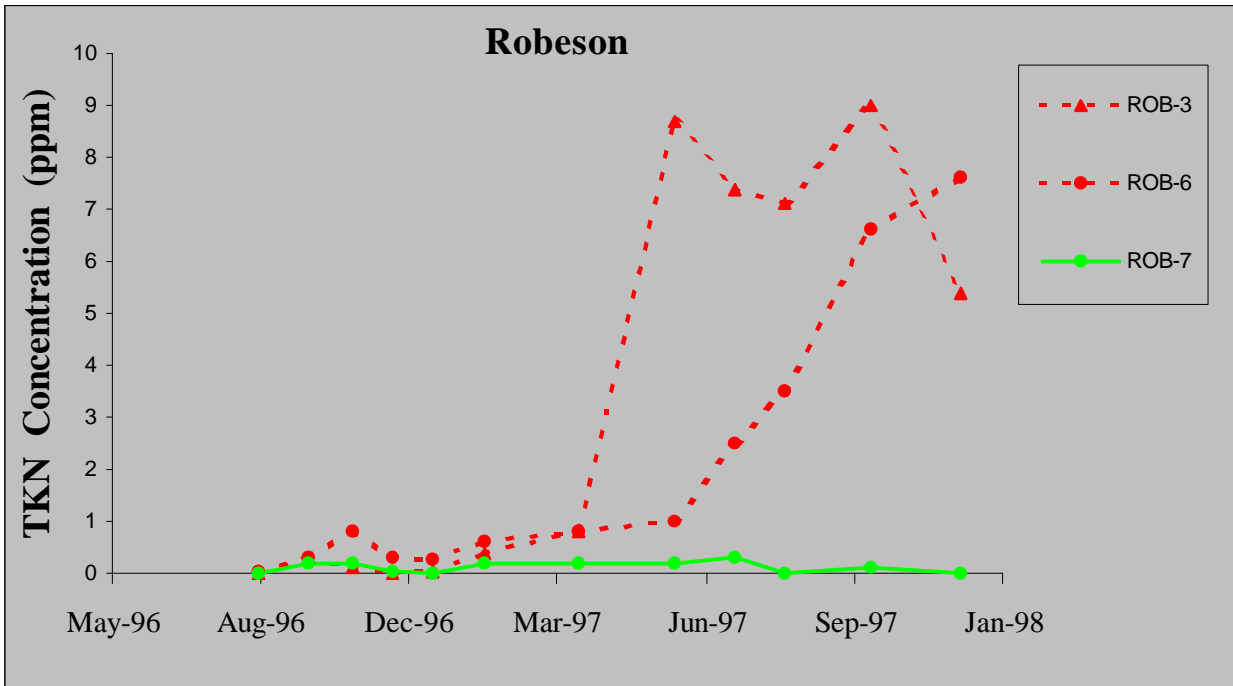
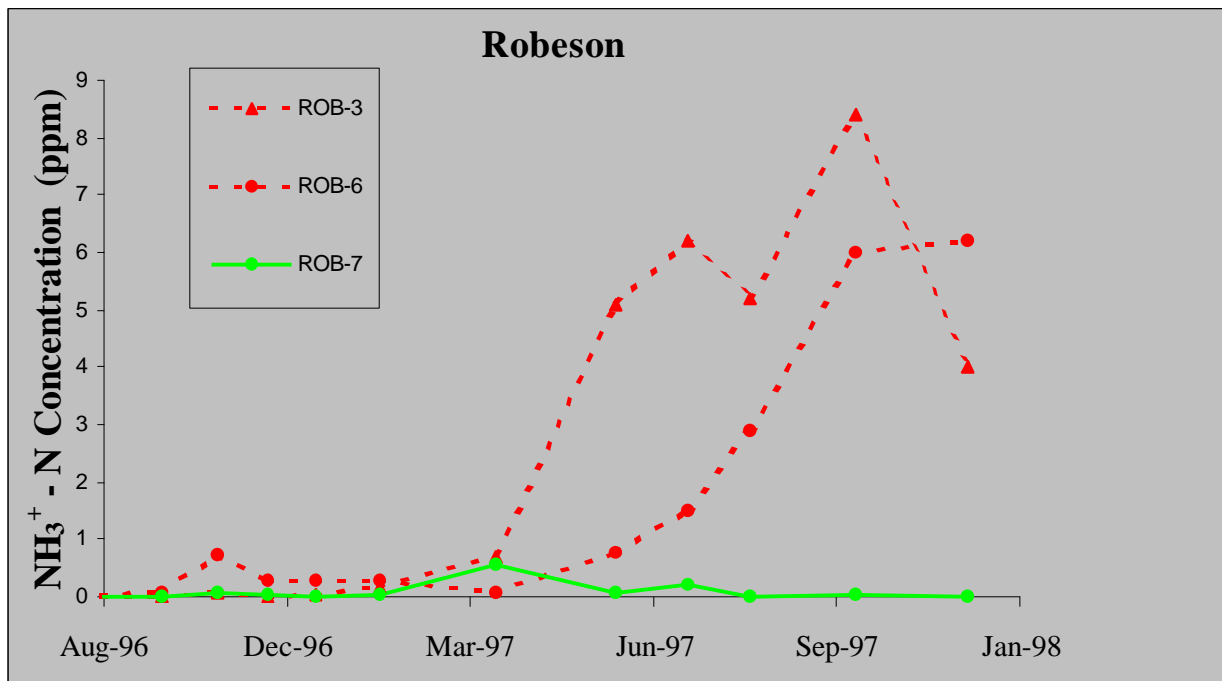
Wells ROB-8 and ROB-9 were constructed in June 1997, as previously mentioned. Concentrations of ammonia-nitrogen and organic nitrogen have been elevated each sampling period, and the levels in ROB-9 are currently close to that of the lagoon waste itself. Additional EM surveying has not shown any significant changes in the subsurface. However, concentrations of ammonia and organic nitrogen in two of the original monitoring wells have increased as shown in the following two time-series graphs (note different scale on y-axis):
